ΑΚΑΔΗΜΙΑ ΕΜΠΟΡΙΚΟΥ ΝΑΥΤΙΚΟΥ
Α.Ε.Ν ΜΑΚΕΔΟΝΙΑΣ

ΠΤΥΧΙΑΚΗ ΕΡΓΑΣΙΑ

Ro-Ro vessel safety: lessons learned from the cases of Herald of Free Enterprise and Estonia

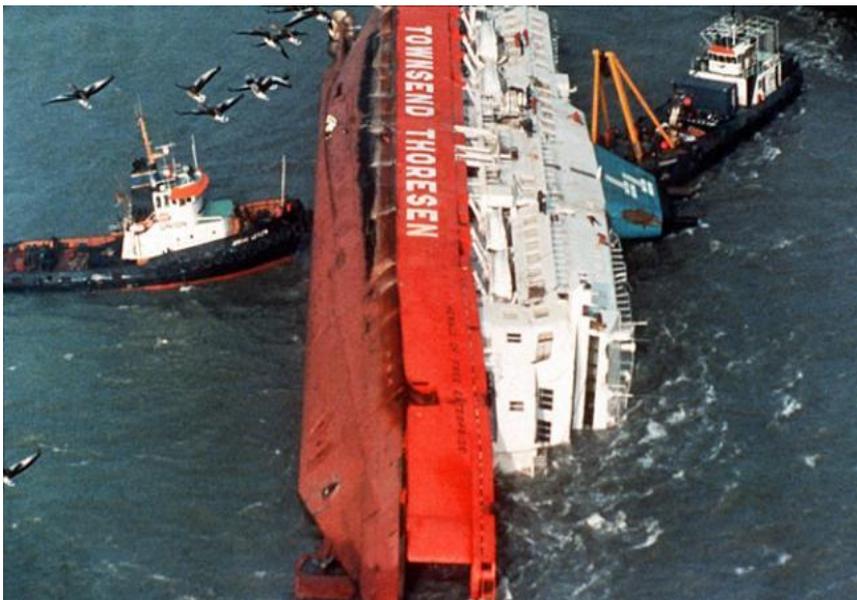
Picture 5

good weather. There was a light easterly breeze and very little sea or swell. Due to negligence of the bosun who felt asleep, her bow doors had not been closed before leaving the harbour. When the ferry reached 18.9 knots (33 km/h), water began to enter the car deck in large quantities. This destroyed her stability. Within seconds, the ship began to list 30 degrees to port. The entire event took place in less than a minute. The water quickly reached the ship's electrical systems, destroying both main and emergency power and leaving the ship in darkness. During the final moments the HERALD turned rapidly to starboard and was prevented from sinking totally because her port side took the ground in shallow water. The HERALD came to rest on a heading of 136° with her starboard side above the surface. The accident resulted in the deaths of 193 passengers and crew members. Many others were injured. The position in which the HERALD came to rest was less than 7 cables from the harbour entrance and was latitude 22° 28.5' North, longitude 3° 11' 26" East

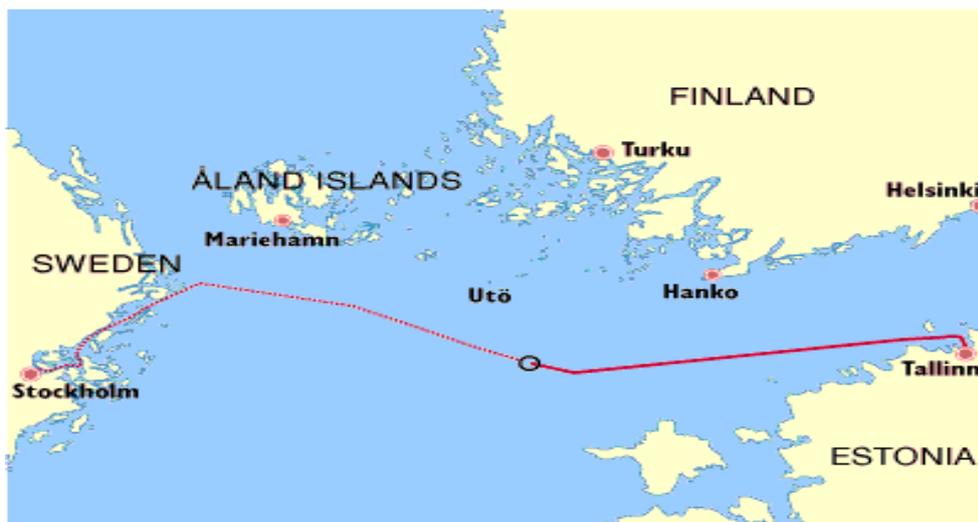
Picture 7

The voyage proceeded normally. Sea conditions along the Estonian coast were moderate, but became more rough when the ship left the sheltered waters. The ship had a slight starboard list due to a combination of athwartships weight disposition, cargo disposition and wind pressure on the port side. During his scheduled round on the car deck the seaman of the watch heard shortly before at 01:00 a metallic bang from the bow area as the vessel hit a heavy wave. The seaman of the watch informed the second officer about what he had heard and was ordered to try to find out what had caused the bang. The seaman did so by waiting at the ramp, listening and checking the indicator lamps for the visor and ramp locking devices. He reported that everything seemed to be normal. Further observations of unusual noise, starting at about 01:05, were made during the following 10 minutes by many passengers and some crew members who were off duty in their cabins. When the seaman of the watch returned from his round, soon after the change of watches, he caught up the master and entered the bridge just behind him. Shortly afterwards he was sent down to the car deck to find out the cause of the sounds reported by telephone to the bridge. He did not, however, manage to reach the car deck. At about 01:15 the visor separated from the bow and tilted over the stem. The ramp was pulled fully open, allowing large amounts of water to enter the car deck. Very rapidly the ship took on a heavy starboard list. She was turned to port and slowed down.

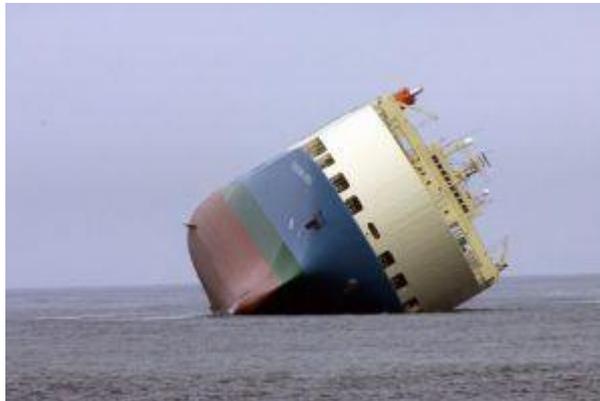
Picture 8

If a vessel maintains its stability at sea then it is safer to sail. However, the problem with the RO-RO ship is its design, which includes cargo in upper decks and accommodation at even higher levels. Even a minor shift of cargo in the ro-ro vessel can become a major threat to the stability of the ship. Similarly, hull failure leading to flooding can result in capsizing of the vessel in no time. The effects of wind and bad weather on high accommodation can also disturb the ship's stability.
