Service Experience 2014

MAN Diesel & Turbo

Service Experience

MAN B&W Two-Stroke Engines

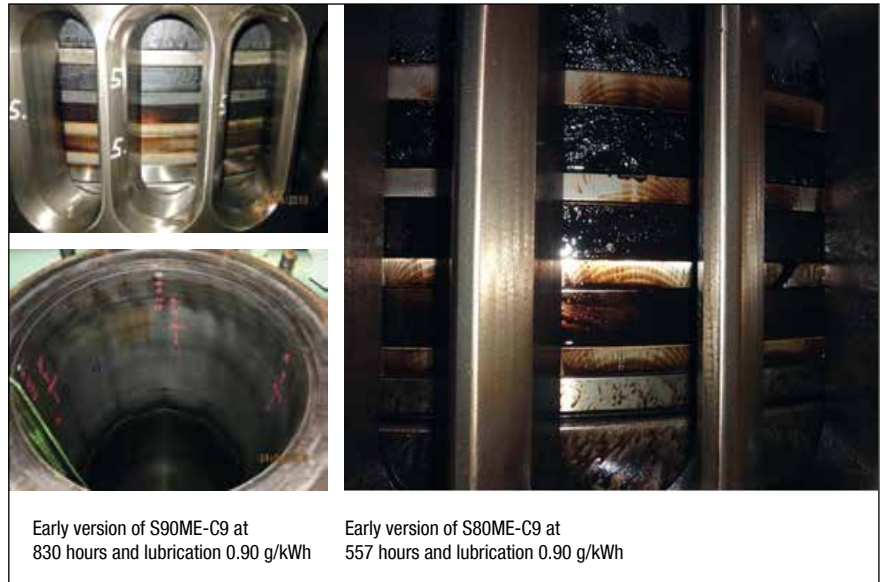
Recently, cold corrosion of cylinder liners has grown to become a major issue for the latest generation of MAN B&W two-stroke engines, see Fig. 1. This has called for measures to control/suppress the cold corrosion, leading MAN Diesel & Turbo to take the following initiatives:

Fig. 1: Poor cylinder condition – recent examples

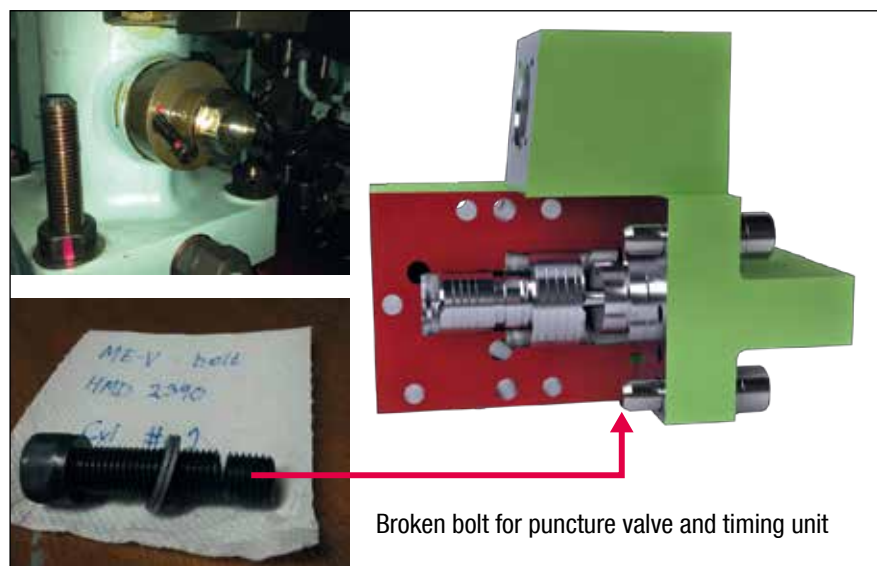
cylinder of the exhaust valve actuator. The high pressure resulted in a number of incidents with broken bolts on the puncture valve and a few cases of broken bolts on the timing unit end cover, see Fig. 24.

Fig. 24: ME-B dot 3 feedback from test bed

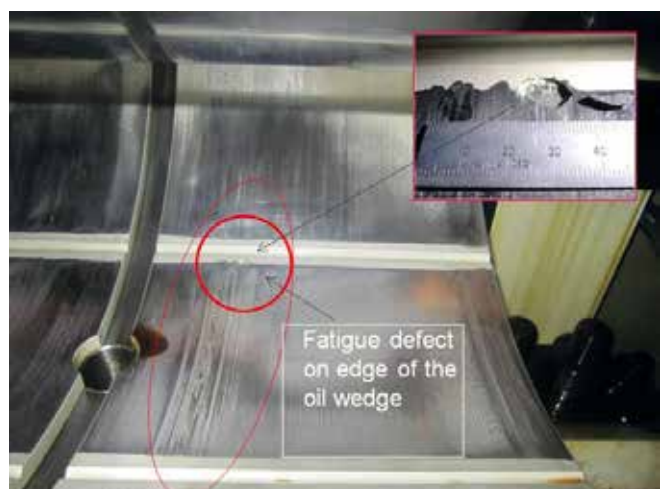
Due to the changed balance between inertia forces and gas forces, we will get an increased load on the crosshead bearing shells in T/C cut-out mode with the increased gas pressures at low rpm. On the K98 engine, this has resulted in minor slow-developing fatigue damage on the central pad in the lower crosshead bearing shell, see Fig. 29.

Fig. 29: K98 crosshead bearings and T/C cut-out, minor fatigue damage

Modified designs of crosshead bearing shells are currently being tested in service. However, these will not be concluded quickly as the development of fatigue damage typically takes two years. Fig. 30 shows elasto-hydro dynamic (EHD) bearing calculations of one of the

We have issued a Circular Letter to owners and operators about K98 engines with instructions on how to inspect and assess the crosshead bearing condition. We also assist owners in assessing bearing damage on a case-to-case basis.

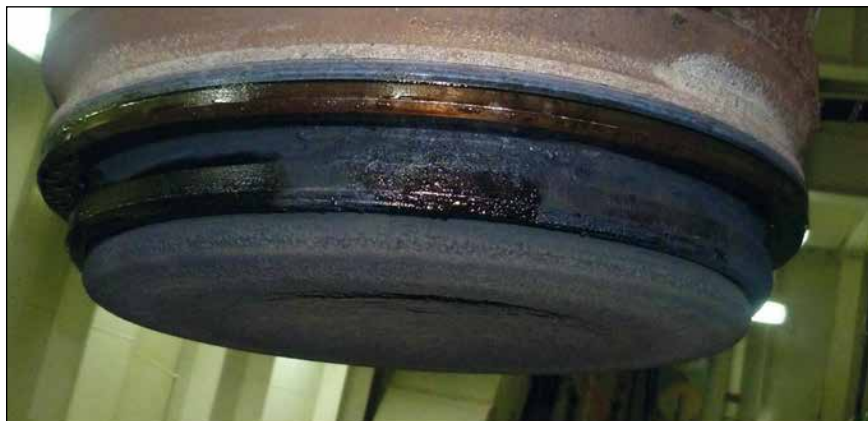
Fig. 32 shows an exhaust valve spindle disk from an S60MC-C8 operating at low load for a long time. The burn-away

level after 26,000 hours is 11 mm. This is above the maximum of 9 mm burn-away for reconditioning of the spindle. So in this case, earlier inspection of the exhaust valve could have made reconditioning possible.

S60MC-C8: Running hour 26,000
Burn away: >11 mm (max. 9 mm)

Fig. 32: Burn-away of spindle disc during low-load operation

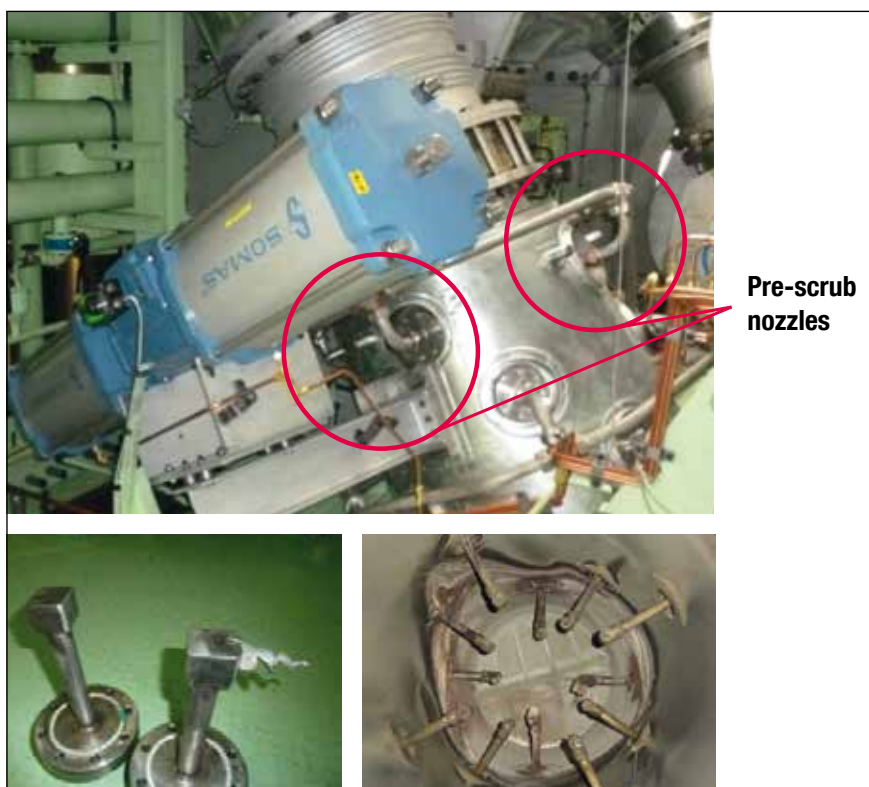
One item which has been observed is “turning” of the upper pre-scrubber nozzles, see Fig. 39. A new welded nozzle-flange design has been introduced to prevent the nozzles from “turning” during operation.

Fig. 39: Pre-scrubber nozzles

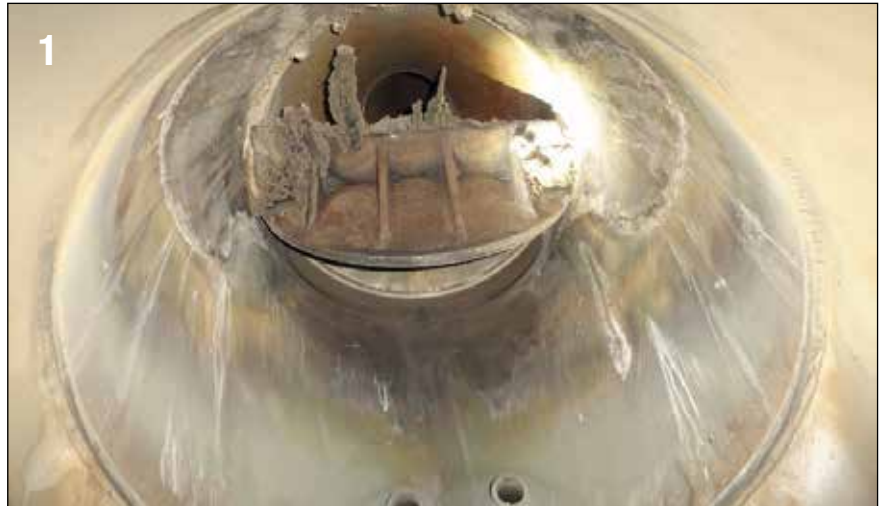
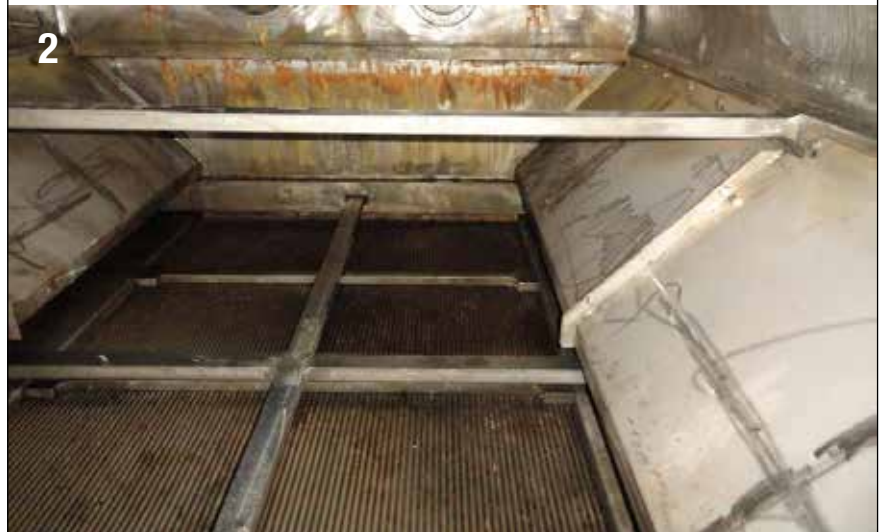
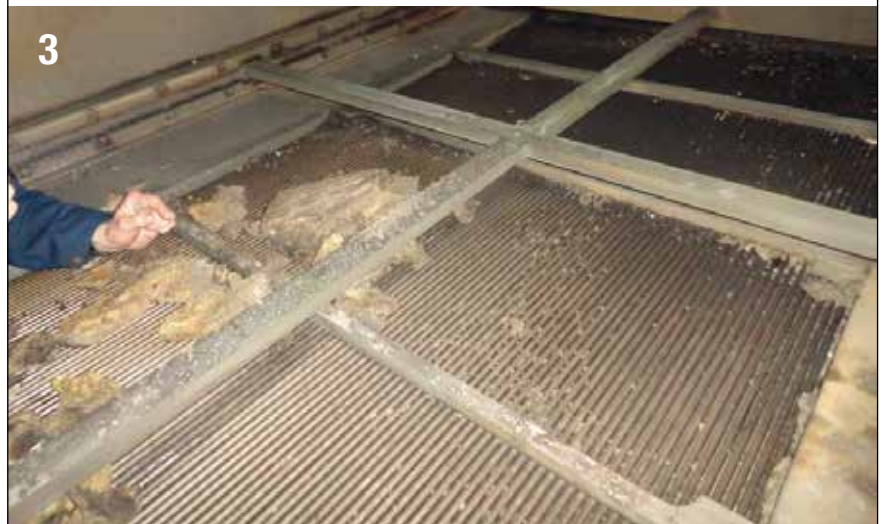
Another observation is the salty deposits (Na_2SO_4) created on the turbocharger cut-out valve during EGR operation. When starting non-EGR operation with open T/C cut-out valve, these deposits end on the top of the EGR cooler. When switching back to EGR operation, the deposits on the EGR cooler are dissolved by water. This sequence is illustrated in Fig. 40. In order to eliminate the formation of these salty deposits, we are presently working to change the flow at the T/C cut-out valve.

1: During EGR running, scrubber water hits the T/C cut out valve and forms salty deposits.

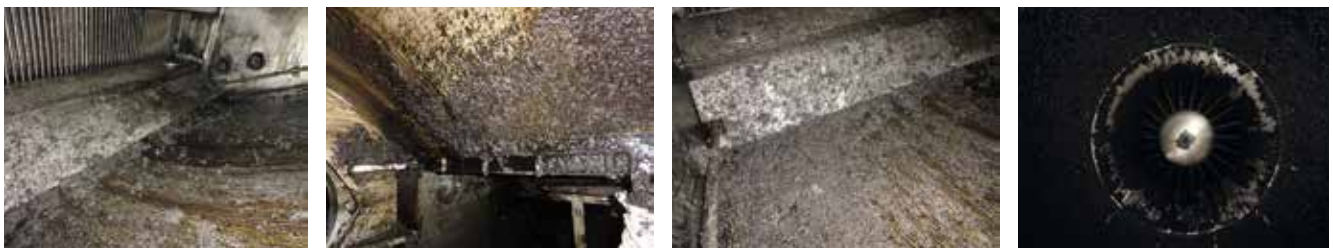
Fig. 41: EGR-blower suction chamber greasy oily soot lumps accumulated

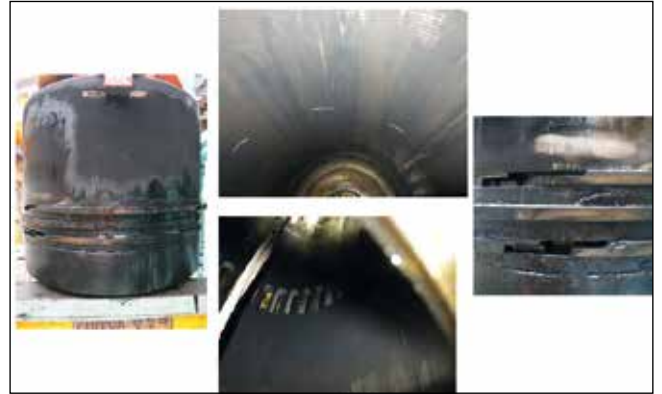
Fig. 45: T/C cut-out test and black carbon deposits

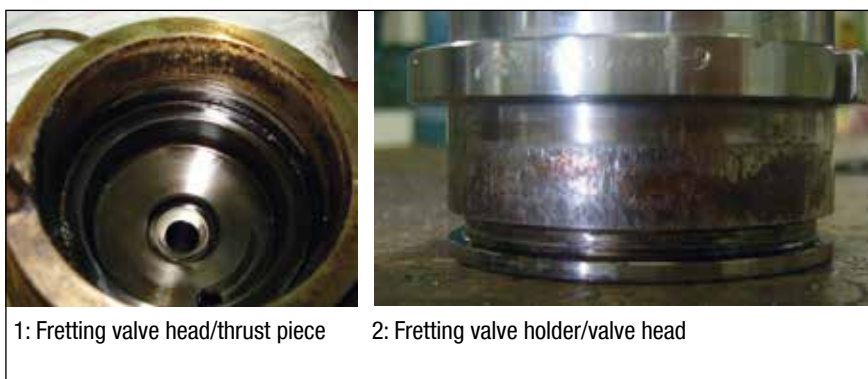
1: Fretting valve head/thrust piece 2: Fretting valve holder/valve head

However, especially on some large bore engines, we still see fretting occurring in the top of the fuel injectors, see Fig. 48. We are therefore testing various design modifications to eliminate this fretting. At the time of writing, the most promising test result comes from a fuel injector with guide rings in the top part of the injector, see Fig. 49. This design also involves application of stronger

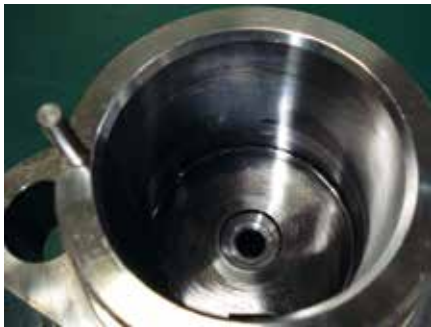
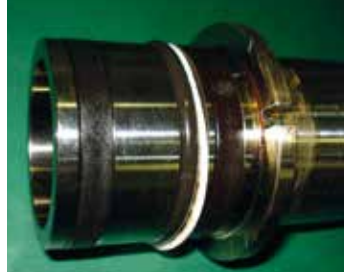
- No fretting
- O-ring in perfect condition
- Guide ring and back up ring in perfect condition

Fig. 50: Fuel valve with guide rings. Inspection after 2,000 hours in service on an S90ME-C9.2

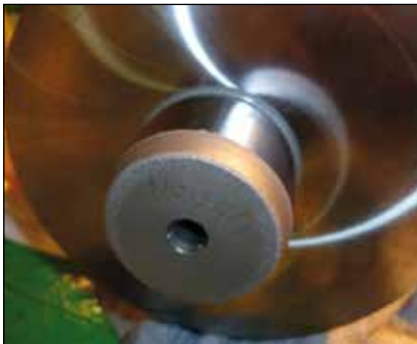
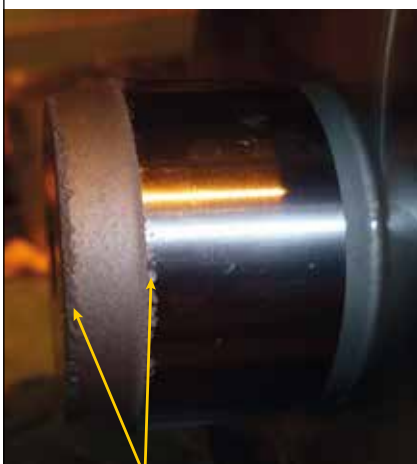
We have received reports of cavitation damage found in various areas in the standard 300-bar low force exhaust valve actuation system. At the time of writing, we are conducting tests to find a solution to this issue. Fig. 51 indicates the areas where cavitation has been found. The extent of cavitation on the thrust piece can be significantly reduced by using a new material. Cavitation has also been found around inlet holes, cooling bores and relief grooves in the actuator top cover, see Fig. 52. We are currently testing some modified actuator top covers, and Fig. 53 shows two alternative test executions where the inlet holes have been redesigned.

Heavy cavitation on opening damper (top of piston)

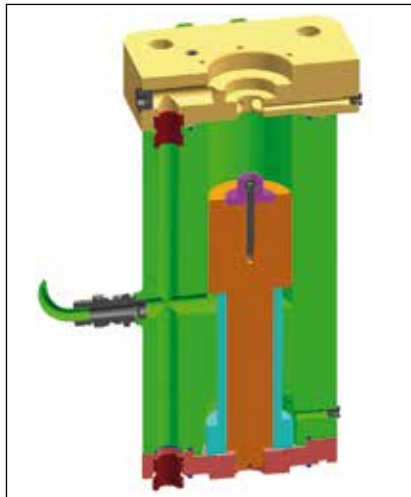
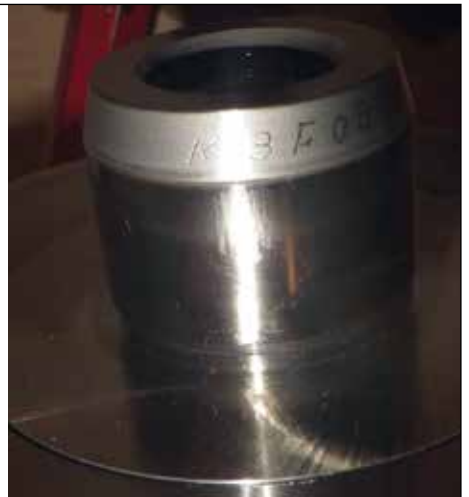
The actuator housing is in perfect running condition, and only minor cavitation has been found on the step-one piston landing surface at the lower base. On the other hand, on the step-two piston we have found rather heavy cavitation damage on the opening damper at the top of the piston, see Fig. 54. We have tested a piston with a bolted-on “damper-nose” consisting of a harder alternative damper material (S85W6Mo). As can be seen in Fig. 55, this solution has eliminated the cavitation on the damper. Both actuator pistons show excellent condition on the running surface. Fig. 56 shows a typical

Step-2 piston with loose damper nose of material S85W6Mo

No cavitations found directly on damper

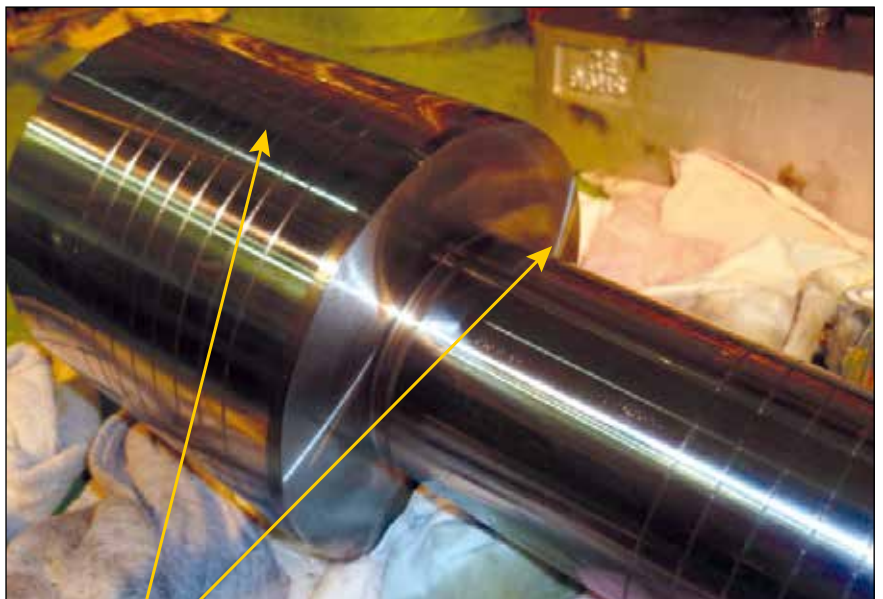
Perfect running surface, no cavitation found in grooves

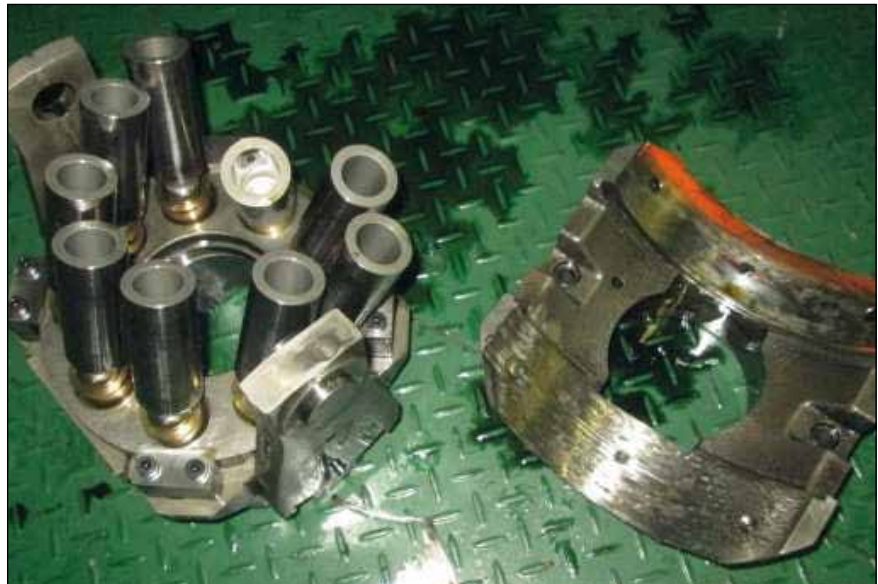
For the bearing shells of the original design, the use of steel shells with a thin layer of polymer has not resulted in sufficiently reliable service experience with satisfactory overhaul intervals. Fig. 57 shows an example of a damaged pump – the root cause of the damage is the steel bearing shells.

Fig. 57: ME engine Eaton main hydraulic pumps. Pump swash plate/piston assembly, bearings and holder damaged
