# Service Experience MAN B&W Two-stroke Engines

# **Service Experience**

MAN B&W Two-Stroke Engines

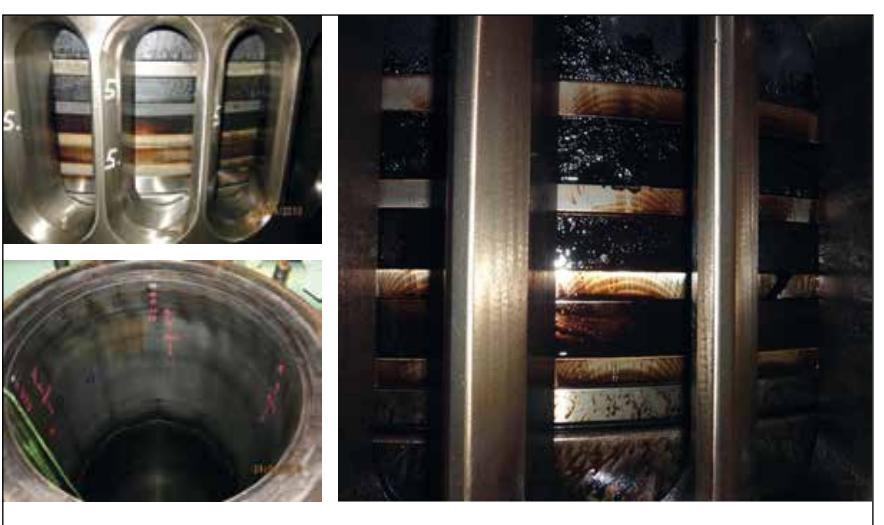
Fig. 1: Poor cylinder condition - recent examples

Recently, cold corrosion of cylinder liners has grown to become a major issue for the latest generation of MAN B&W two-stroke engines, see Fig. 1. This has called for measures to control/suppress the cold corrosion, leading MAN Diesel & Turbo to take the following initiatives:

Early version of S90ME-C9 at 830 hours and lubrication 0.90 g/kWh

Early version of S80ME-C9 at 557 hours and lubrication 0.90 g/kWh

- 1. Introduction of BN 100 cylinder oils
- 2. Increased jacket cooling water temperatures – various systems

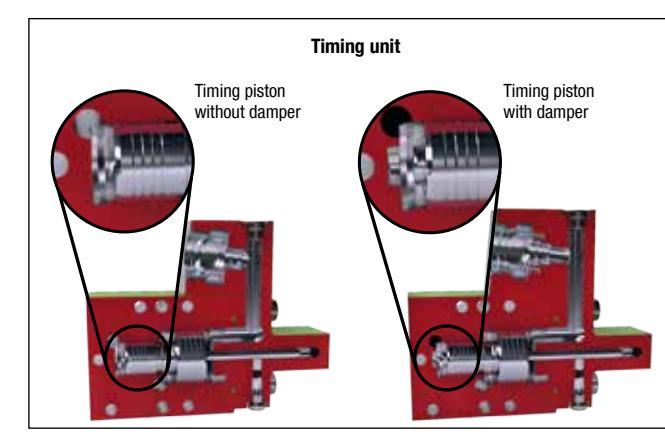
Fig. 25: ME-B dot 3 feedback from test bed

When the dot 3 technology was introduced, we experienced some difficulties with the timing unit system on a number of engines running on test bed, see Fig. 23. High-pressure peaks occurred in the timing unit and in the oil cylinder of the exhaust valve actuator. The high pressure resulted in a number of incidents with broken bolts on the puncture valve and a few cases of broken bolts on the timing unit end cover, see Fig. 24.

Measurements and simulations revealed that the timing piston had a high landing velocity on the return stroke when the timing unit is deactivated. A damper for the timing piston has been introduced as a countermeasure and the landing speed has been considerably reduced, see Fig. 25. Furthermore, this countermeasure reduces the maximum pressure to an acceptable level.

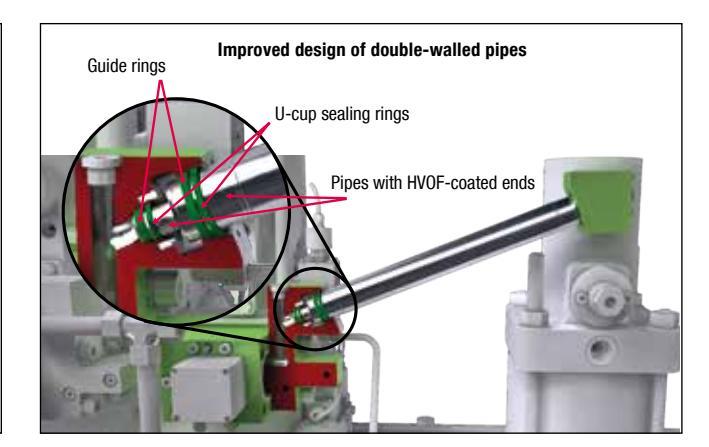
Fig. 26: ME-B dot 3 feedback from test bed

Fretting has been found on the double-walled pipe connecting the timing unit and exhaust valve actuator. The cause of the fretting is relative movements between the HCU with the timing unit and the exhaust valve actuator. To counteract the fretting and ensure good reliability for the sealing rings, the pipe system has been upgraded as described in the following. HVOF-coating, using the same spray powder as for the exhaust valve spindle, is added on the ends of the pipes together with a PTFE sliding ring and a PTFE U-cup sealing ring. Furthermore, a wiper ring is added on the outer pipe to minimise the risk of particles, or the like, entering the sealing area. Modifications are shown in Fig. 26.

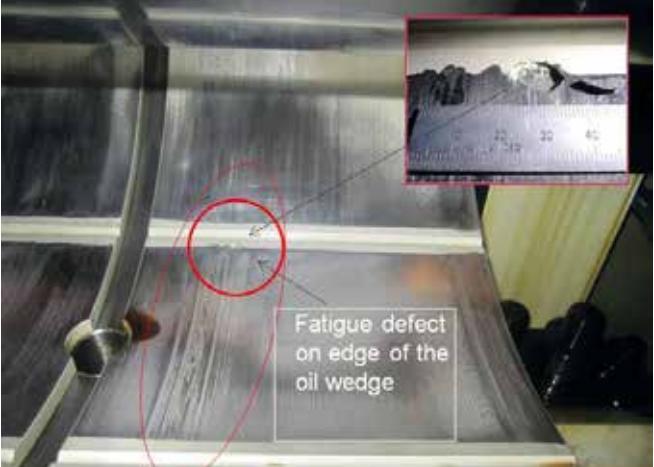
Fig. 29: K98 crosshead bearings and T/C cut-out, minor fatigue damage

Due to the changed balance between inertia forces and gas forces, we will get an increased load on the crosshead bearing shells in T/C cut-out mode with the increased gas pressures at low rpm. On the K98 engine, this has resulted in minor slow-developing fatigue damage on the central pad in the lower crosshead bearing shell, see Fig. 29.

Modified designs of crosshead bearing shells are currently being tested in service. However, these will not be concluded quickly as the development of fatigue damage typically takes two years. Fig. 30 shows elasto-hydro dynamic (EHD) bearing calculations of one of the

We have issued a Circular Letter to owners and operators about K98 engines with instructions on how to inspect and assess the crosshead bearing condition. We also assist owners in assessing bearing damage on a caseto-case basis. We definitely advise owners to continue low-load operation with T/C cut-out despite of the cases of minor fatigue damage on the crosshead bearing shells. A 12K98 engine operating, on average, at 40% load will save approx. 1,000,000 USD/year by using T/C cutout. This saving is so significant that we continue recommending the use of the T/C cut-out mode.

However, it is important to note that normal inspection for white metal in the crankcase should still be carefully observed. Also, we underline that extra open-up inspections of crosshead bearings are not recommendable. In general, crosshead bearings should only be opened if external signs of damage are found. To supplement normal inspections, we have instead developed a method to do additional inspections by an endoscopic method. We recommend using this method, for example before a scheduled dry docking of a vessel with K98 and T/C cut-out.

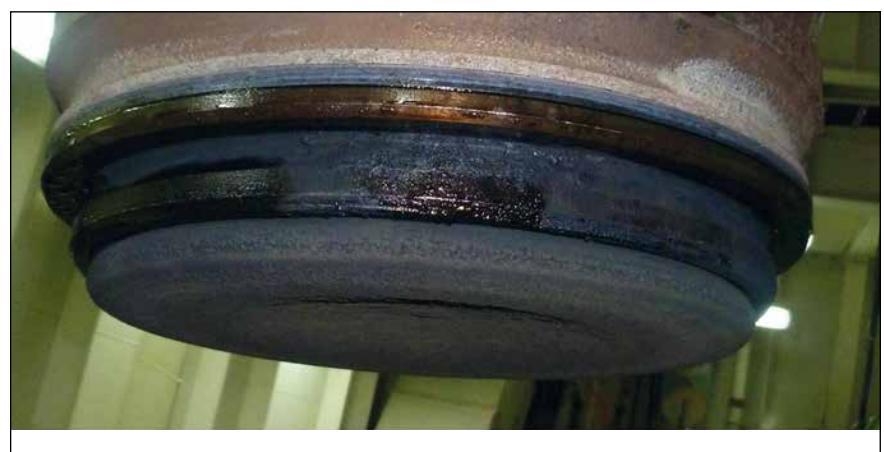
Fig. 32: Burn-away of spindle disc during low-load operation

Fig. 32 shows an exhaust valve spindle disk from an S60MC-C8 operating at low load for a long time. The burn-away level after 26,000 hours is 11 mm. This is above the maximum of 9 mm burnaway for reconditioning of the spindle. So in this case, earlier inspection of the exhaust valve could have made reconditioning possible.

S60MC-C8: Running hour 26,000 Burn away: >11 mm (max. 9 mm)

We have changed our max. burnaways, see Table 3.

With these new limits, three times (instead of two times) reconditioning and the new limit for burn-away, the spindle lifetimes illustrated in Table 2 will be as shown in Table 4.

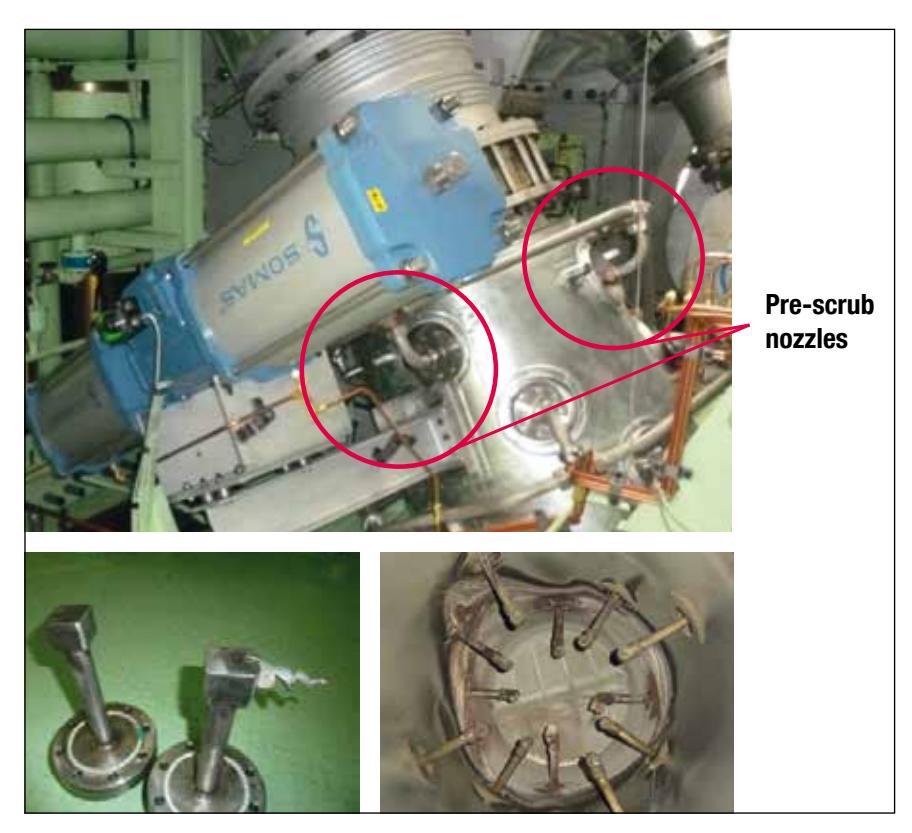
Fig. 39: Pre-scrubber nozzles

One item which has been observed is "turning" of the upper pre-scrubber nozzles, see Fig. 39. A new welded nozzle-flange design has been introduced to prevent the nozzles from "turning" during operation.

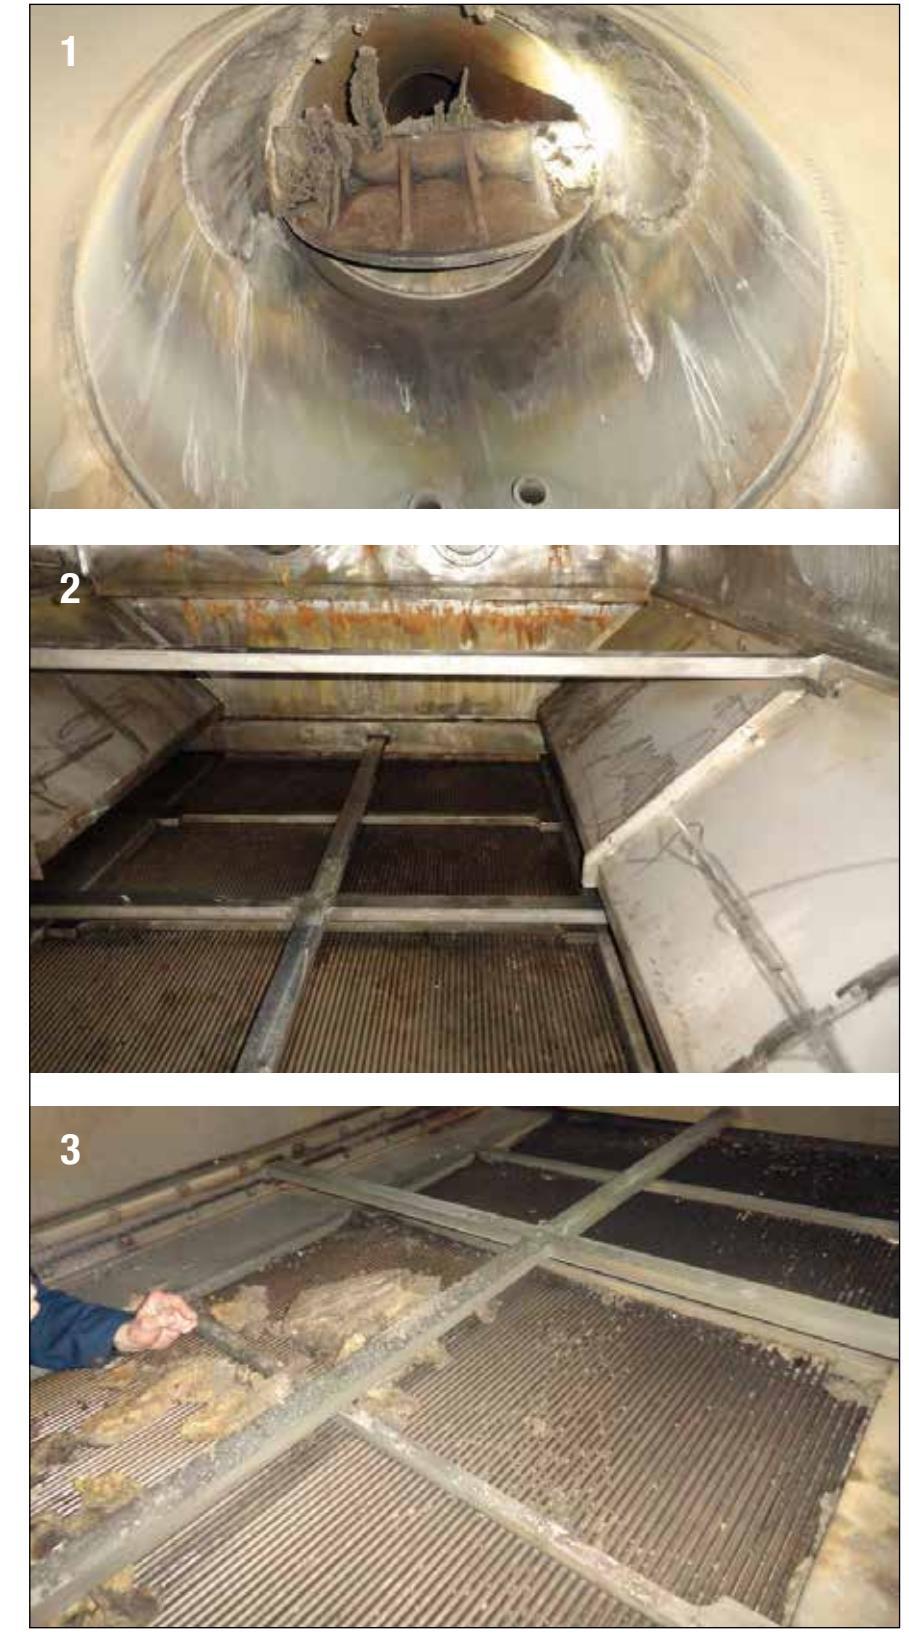
Fig. 40: EGR cooler and T/C cut-out valve

Another observation is the salty deposits ( $Na_2So_4$ ) created on the turbocharger cut-out valve during EGR operation. When starting non-EGR operation with open T/C cut-out valve, these deposits end on the top of the EGR cooler. When switching back to EGR operation, the deposits on the EGR cooler are dissolved by water. This sequence is illustrated in Fig. 40. In order to eliminate the formation of these salty deposits, we are presently working to change the flow at the T/C cut-out valve.

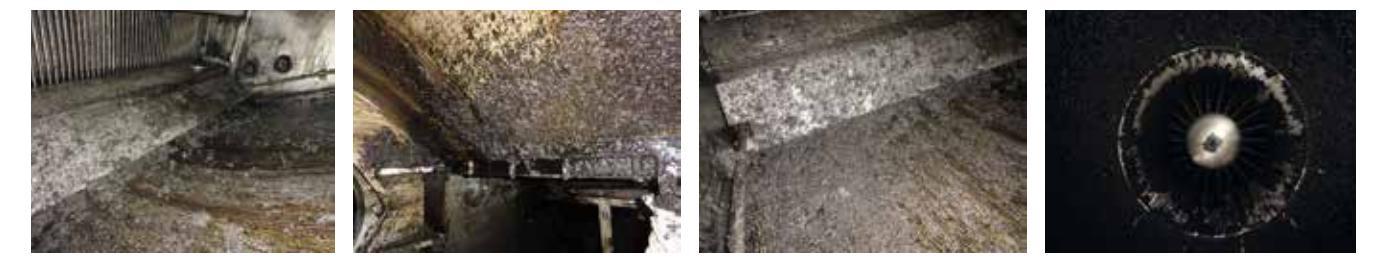
Fig. 41: EGR-blower suction chamber greasy oily sooth lumps accumulated

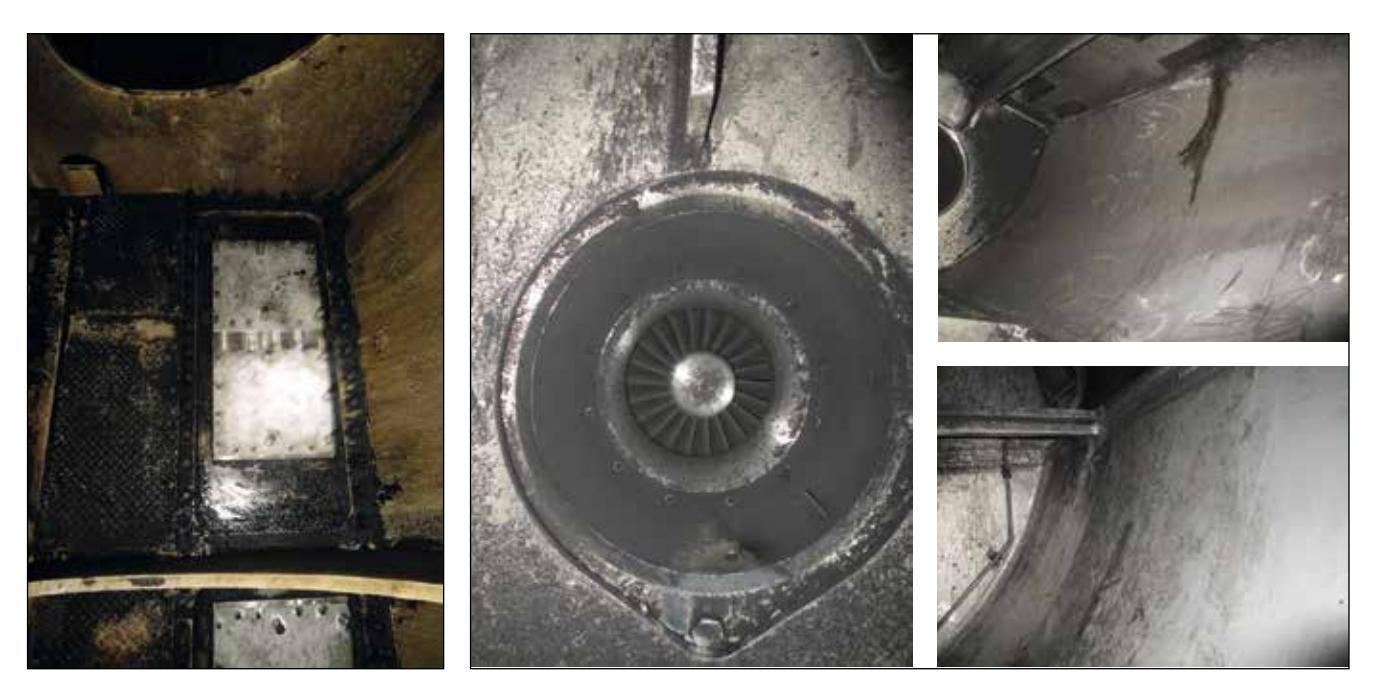
Fig. 42: Blanking of non-return-valves

Fig. 43: Suction chamber and blower inlet found in good condition

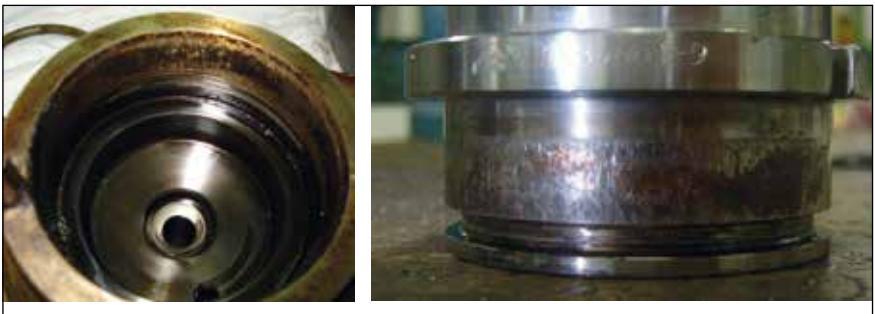
Fig. 48: Fuel valve service experience ME engines

1: Fretting valve head/thrust piece

2: Fretting valve holder/valve head

However, especially on some large bore engines, we still see fretting occurring in the top of the fuel injectors, see Fig. 48. We are therefore testing various design modifications to eliminate this fretting. At the time of writing, the most promising test result comes from a fuel injector with guide rings in the top part of the injector, see Fig. 49. This design also involves application of stronger

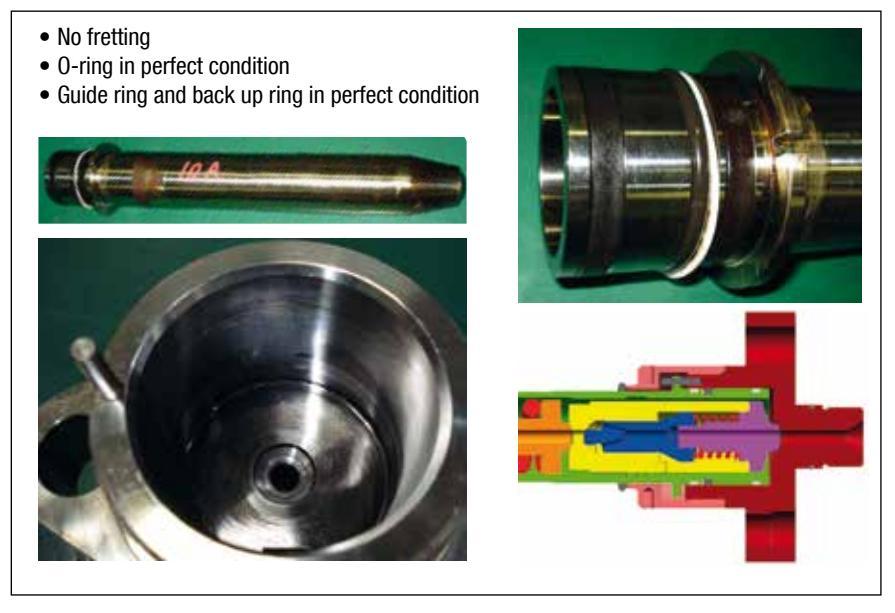
Fig. 50: Fuel valve with guide rings. Inspection after 2,000 hours in service on an S90ME-C9.2

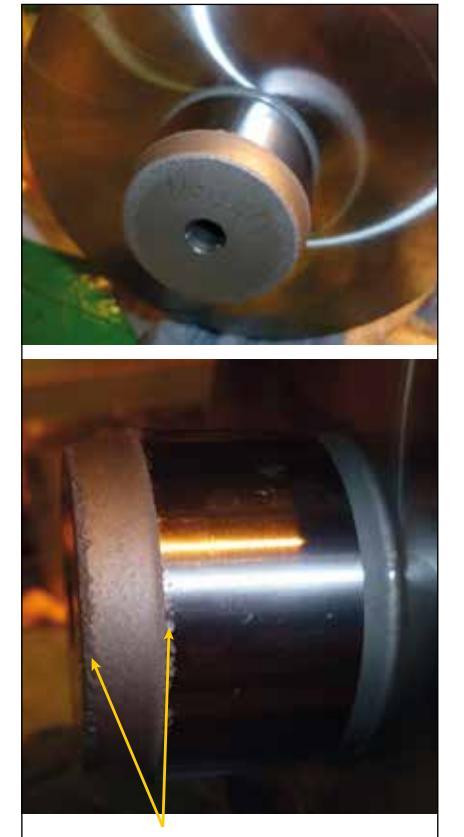
Heavy cavitation on opening damper (top of piston)

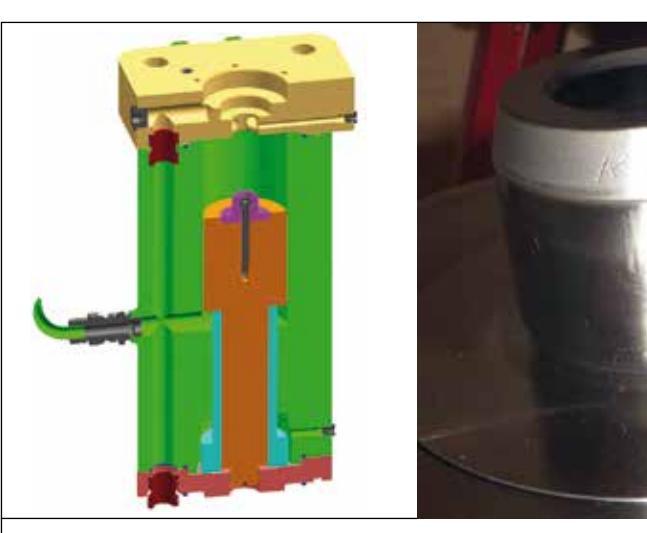
Step-2 piston with loose damper nose of material S85W6Mo

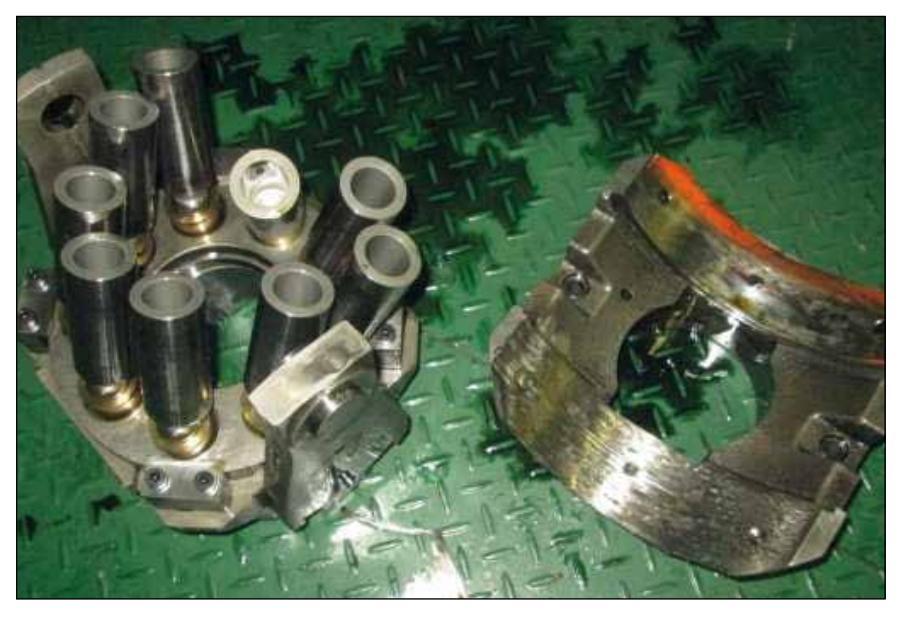
For the bearing shells of the original design, the use of steel shells with a thin layer of polymer has not resulted in sufficiently reliable service experience with satisfactory overhaul intervals. Fig. 57 shows an example of a damaged pump – the root cause of the damage is the steel bearing shells.

Fig. 57: ME engine Eaton main hydraulic pumps. Pump swash plate/piston assembly, bearings and holder damaged
