Work Card Page 1 (5)	Criteria for Replacement of Connecting Rod Big-end and Main Bearing Shells	506-01.16 Edition 04
-------------------------	---	---------------------------------

L27/38, L23/30H, L21/31, L21/31S, L23/30S, L27/38S

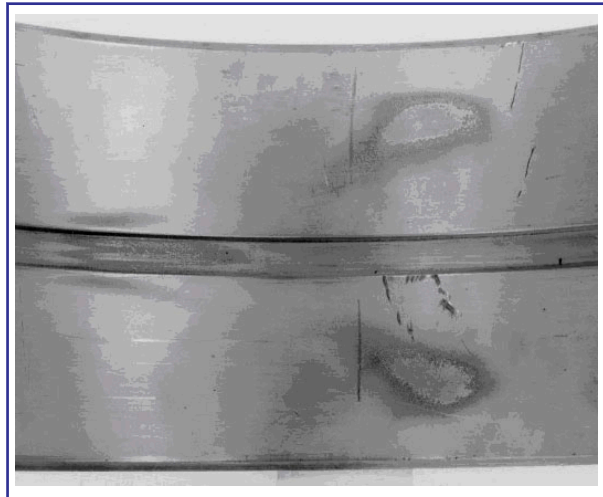
Although conventional wear will never change the properties of the surface of the lining, the resulting increase in clearance can have several effects. These will all limit the acceptable level of wear, regardless of the lining material. The oil flow requirement through the bearing will increase, and ultimately the capacity of the engine oil pump will be reached. Hydrodynamic oil film formation is also a function of clearance, very large values resulting in reduction of film thickness. Additionally, as clearance increases, all bearing materials become more prone to suction cavitation erosion.

Figure 1: Suction cavitation erosion due to high clearance.

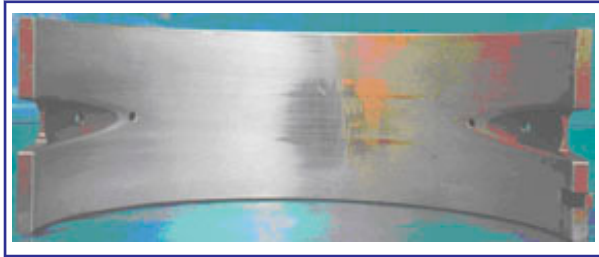
Figure 2: A104 bearing after 22.000 hours. **Can refit.**

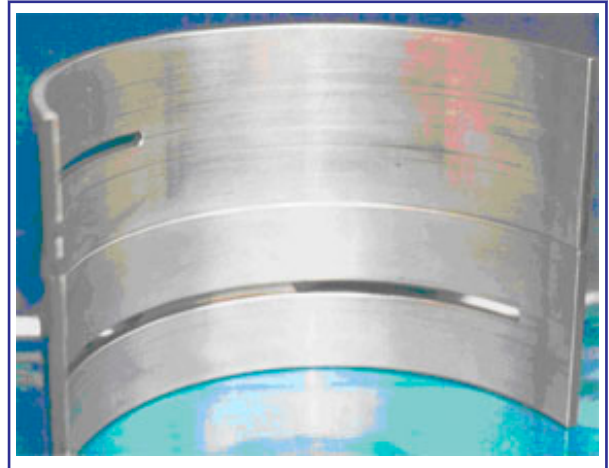
A significant rate of wear would only be anticipated under severe adverse conditions, most commonly where oil entrained hard debris is present. Fine debris would be evidenced by an abraded appearance of the bore surface, while coarse debris would produce deep scoring with raised edges, often polished and eventually bedded-in. Large debris may not become completely embedded in the lining material, and would also score the shaft. Severe scoring of the bearing could cause overheating, tin melt and eventually seizure. However, aluminium tin bearing materials, such as A20 and A104, are tolerant of a significant level of contaminant, and can absorb it without detriment, and such bearings can be refitted.

Figure 3: Acceptable level of contaminant. **Can refit.**

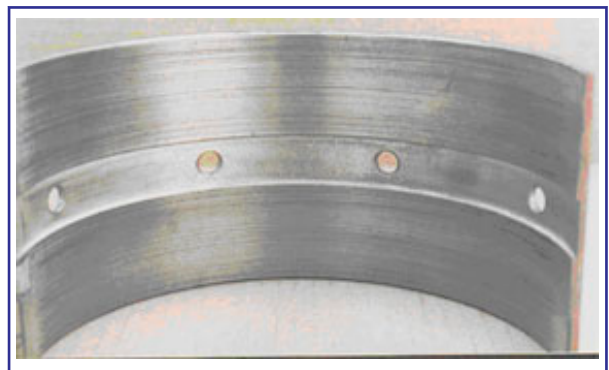
Figure 4: Multiple scoring due to excessive fine debris. **Do not refit.**

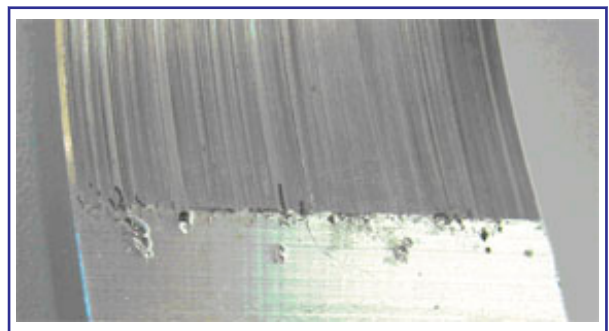
Figure 5: Large embedded debris. **Do not refit.**

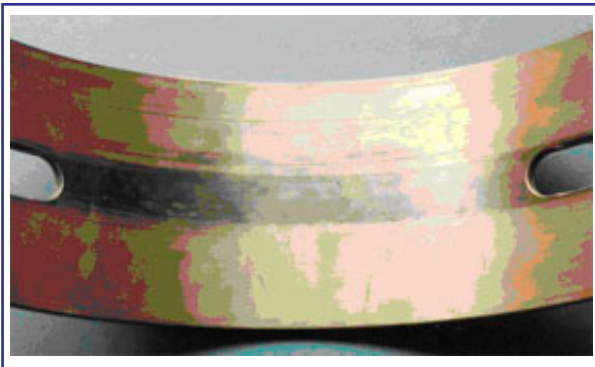
Figure 6: Cam wear. **Do not refit.**

If significant debris has been present in the oil, over a long time interval, differential wear of the crank surface may have occurred. This is termed cam wear and is characterised by wear or wiping of the bearing surface between the ends of partial grooves. If this is evident, the bearings should be replaced, and the differential wear of the crank surface eliminated.

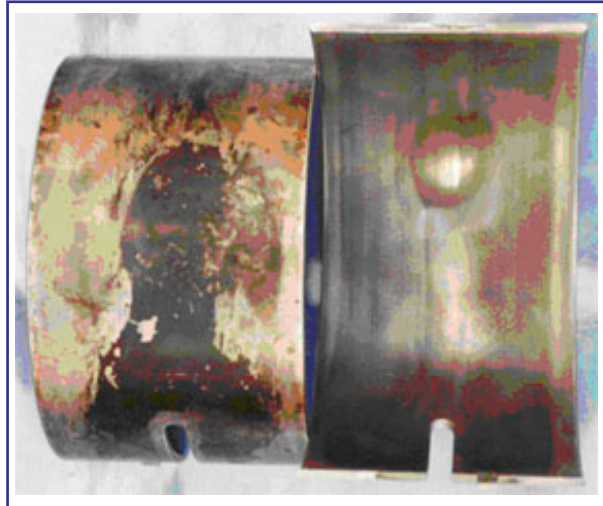
Any indication of loss of lining is an obvious reason not to refit the bearings. However, the cause for such damage should be investigated, and corrected where possible. The two most likely causes are fatigue and cavitation erosion. Provided the engine has been running at its design rating, fatigue should not occur unless some introduced defect is present. Possibilities include oil or debris trapped between the bearing and its housing, mechanical damage to the housing bore, the bearing back or bearing bore, or lack of support behind the bearing.

Figure 7: Carbonised oil behind bearing, causing overloading. **Do not refit.**

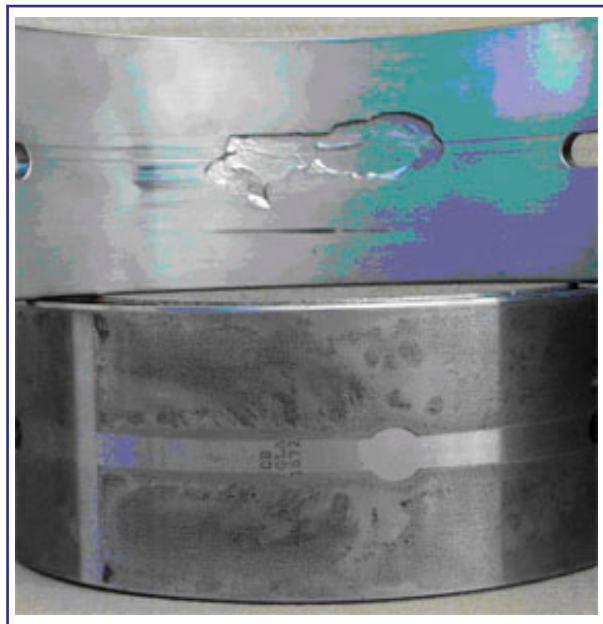
Figure 8: Lack of support behind bearing back results in fatigue in the bore. **Do not refit.**

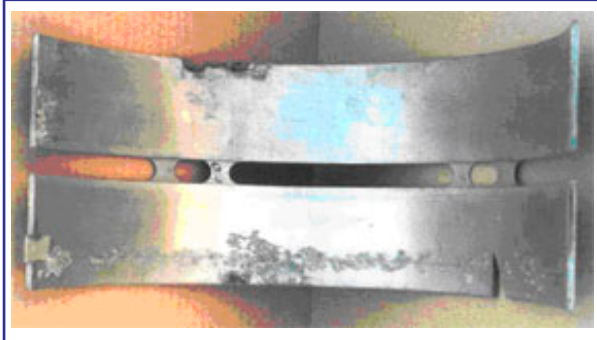
Aluminium tin bearings are resistant to corrosion in a normal engine environment, but can suffer damage due to water if the engine has been shut down for a long time. If all the oil has drained away, the bore surface and bond lines can oxidise. Such bearings should not be refitted.

Figure 9: Corrosion due to water (in this case, outside the engine). **Do not refit.**

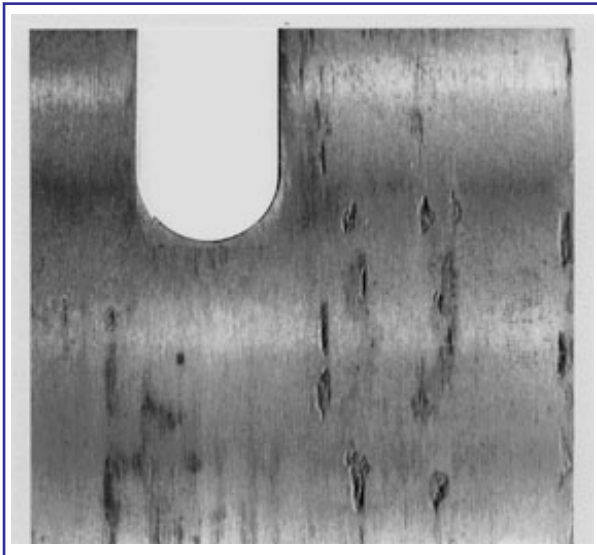
Figure 10: Fretting pits on bearing back. **Do not refit.**

As with any bearing material, if the interface between the bearing back and the housing bore shows signs of fretting, the bearing should be renewed, and any damage to the housing rectified. Even if the bearing bore surface has not been damaged, refitting in such a condition may still result in later damage.
