L28/32-L23/30H Piston, Connecting Rod and Cylinder Liner

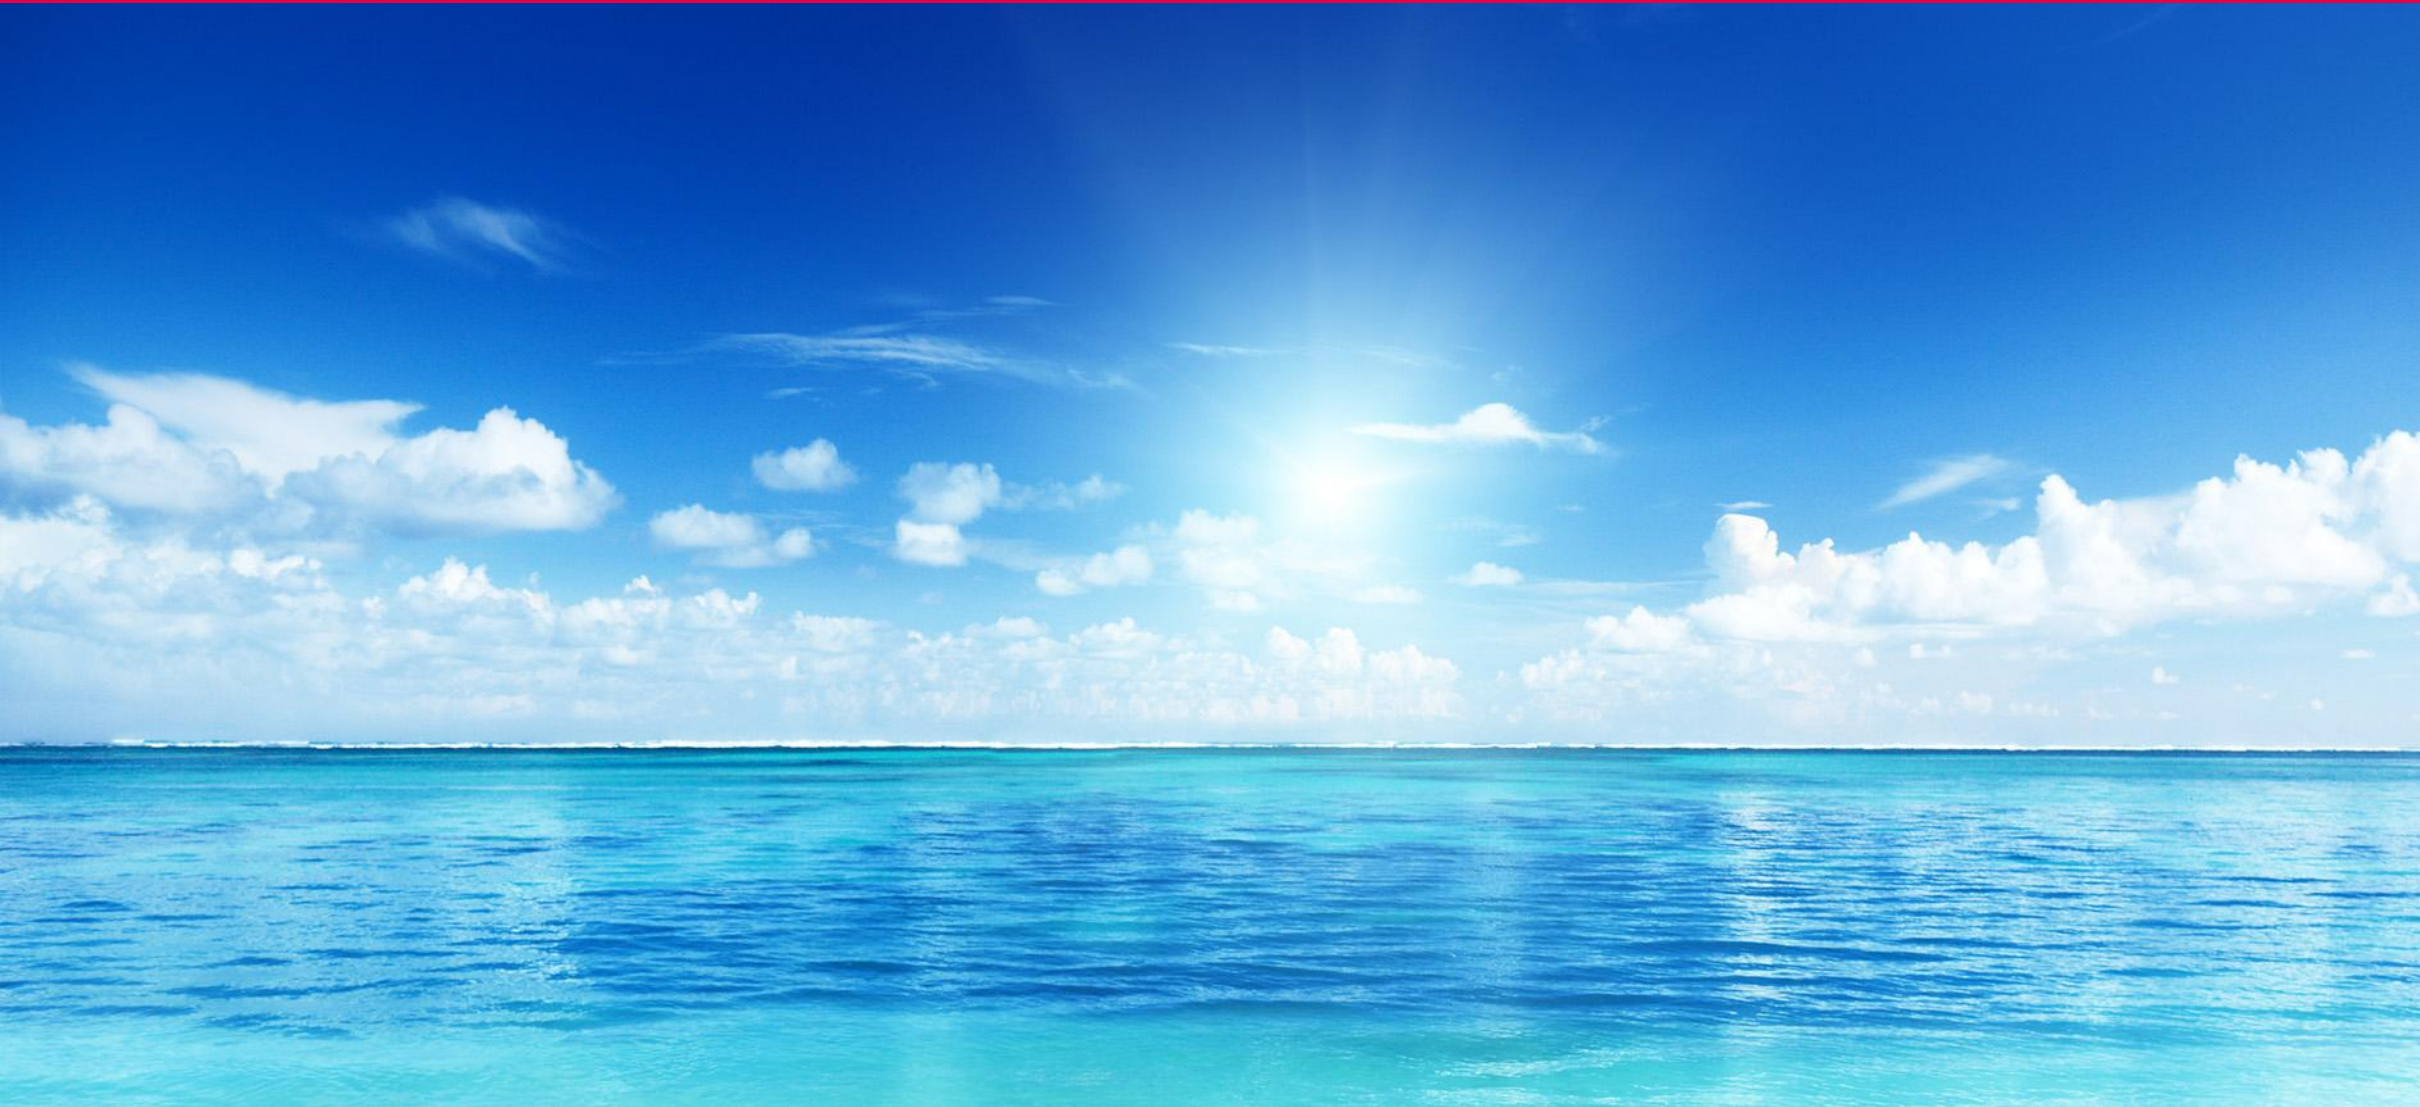
Piston:

The piston, which is oil-cooled and of the mono bloc type made of nodular cast iron, is equipped with 3 compression rings and 1 scraper ring.

Piston Pin:

The piston pin is fully floating which means that it can turn freely in the pin bosses of the piston as well as in the connecting rod bush, kept in place by two circlip.

Connecting rod:

The connecting rod is die-forged.

Cylinder liner:

The cylinder liner is made of fine-grained, pearlite cast iron and is fitted in a bore in the engine frame.

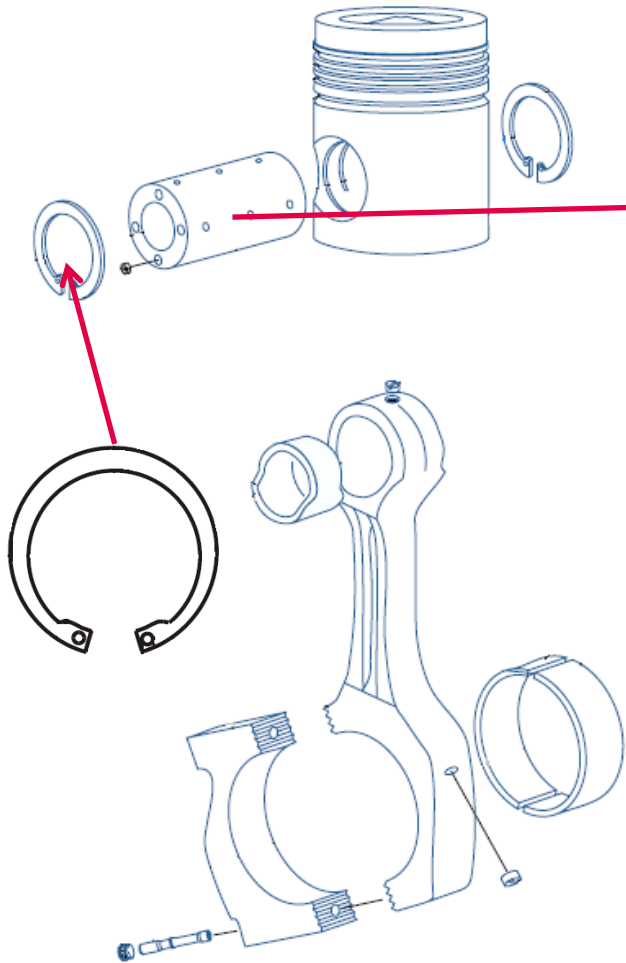
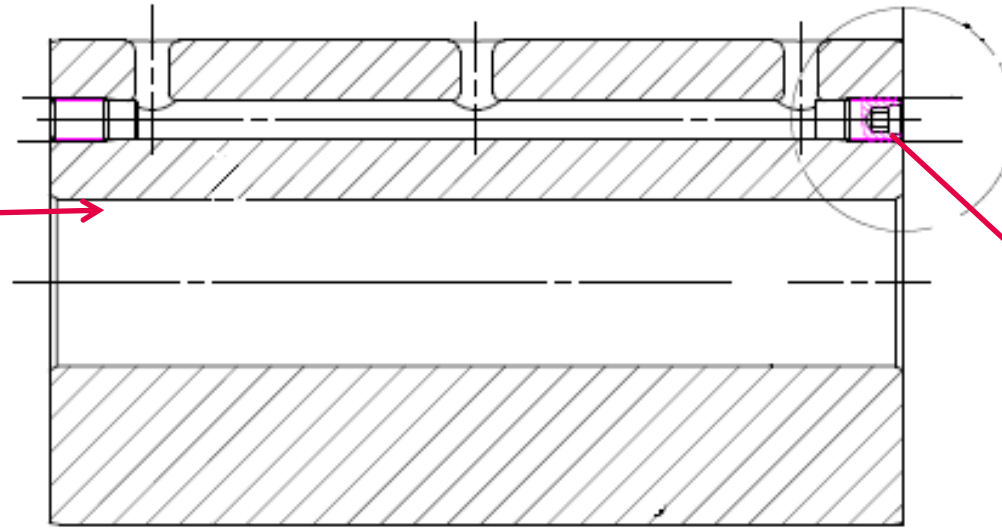
L28/32-L23/30H Piston, Connecting Rod

The surface is carbonized

Threads in the piston pin and screw plugs degreased.
Screw plugs screwed in with Loctite 648
and caulked with special tool not later than 10 minutes after.
After a hardening time of at least 6 hours checked for tight fit.
Test moment = 40 Nm.

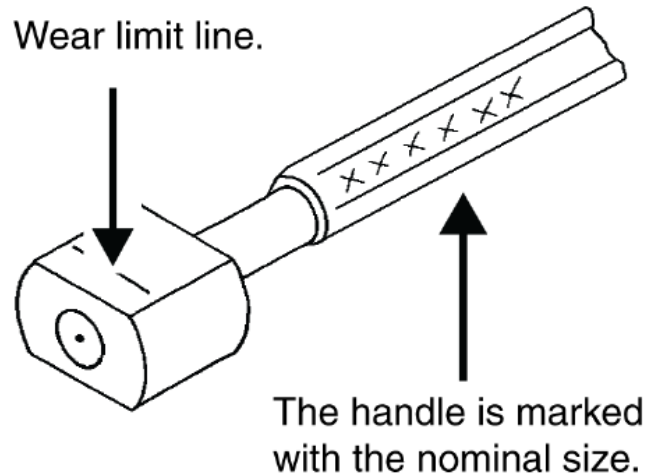
A) Testing Mandrel for Ring Grooves

If the wear limit (2 mm mark) on the testing mandrel is exceeded, the specified max. wear limits are exceeded, and the piston must be scrapped.

B) Clearance Ring/Groove

- 1) Remove the piston and scraper rings.
- 2) Clean and examine the piston rings to determine if reuse is acceptable.
- 3) Clean the piston outside and inside.
- 4) Inspect the piston ring and scraper ring grooves for wear.

The piston has to be scrapped if:

- A) The wear limit on the testing mandrel is exceeded, or
- B) The clearance between the new piston/scraper ring and ring groove is exceeded.

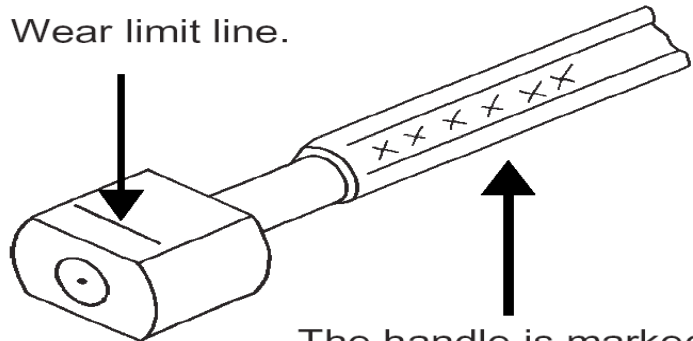
A) Testing Mandrel for Ring Grooves

If the wear limit (2 mm mark) on the testing mandrel is exceeded, the specified max. wear limits are exceeded, and the piston must be scrapped.

Wear limit line.

The handle is marked with the nominal size.

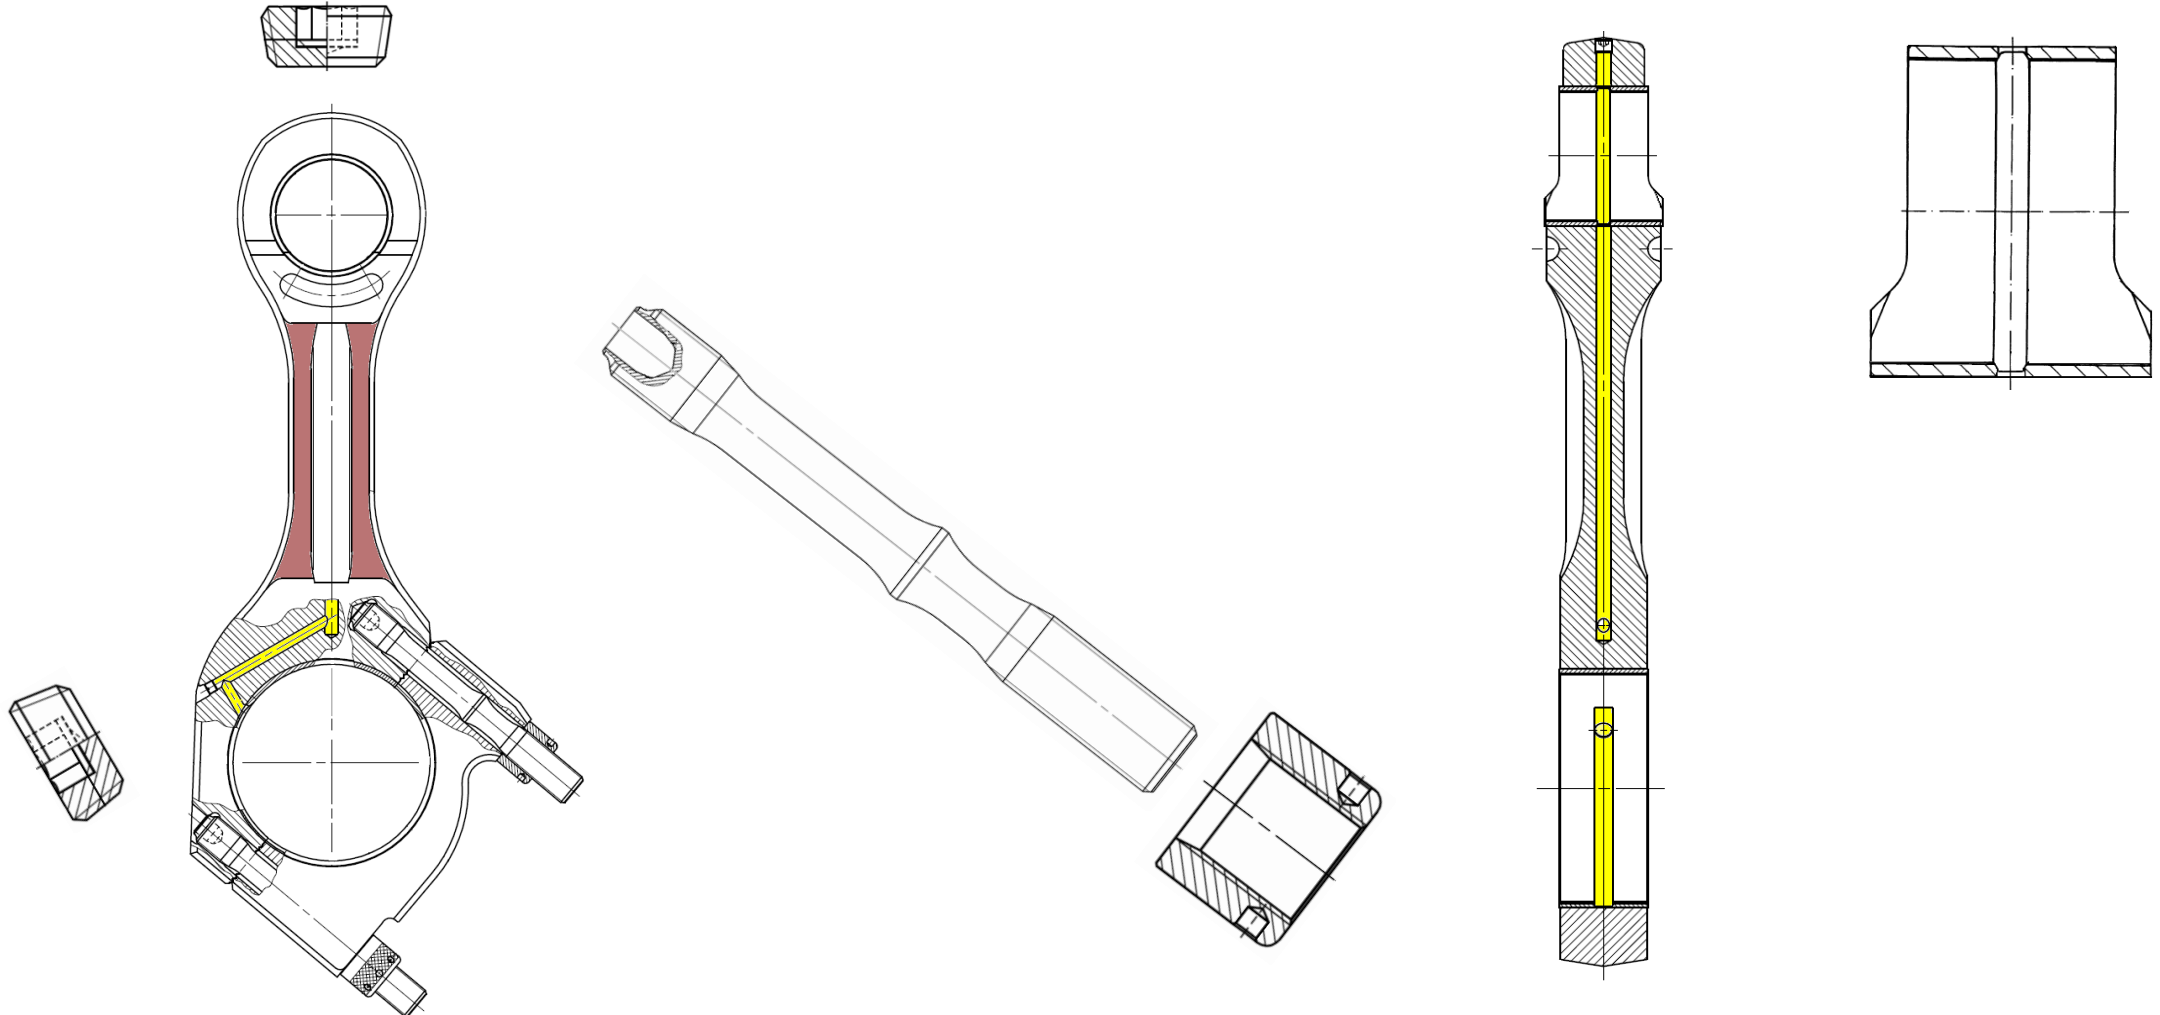
L28/32-L23/30H Connecting rod

The connecting rod is die-forged. The big-end has an inclined joint in order to facilitate the piston and connecting rod assembly to be withdrawn up through the cylinder liner. The joint faces on connecting rod and bearing cap are serrated to ensure precise location and to prevent relative movement of the parts.

The connecting rod has bored channels for supply of oil from the big-end to the small-end eye.

The big-end bearing is of the trimetal type coated with a running layer.

The bearing shells are of the precision type and are therefore to be fitted without scraping or any other kind of adaption.

The small-end bearing is of trimetal type and is pressed into the connecting rod. The bush is quipped with an inner circumferential groove, and a pocket for distribution of oil in the bush itself and for supply of oil to the pin bosses.

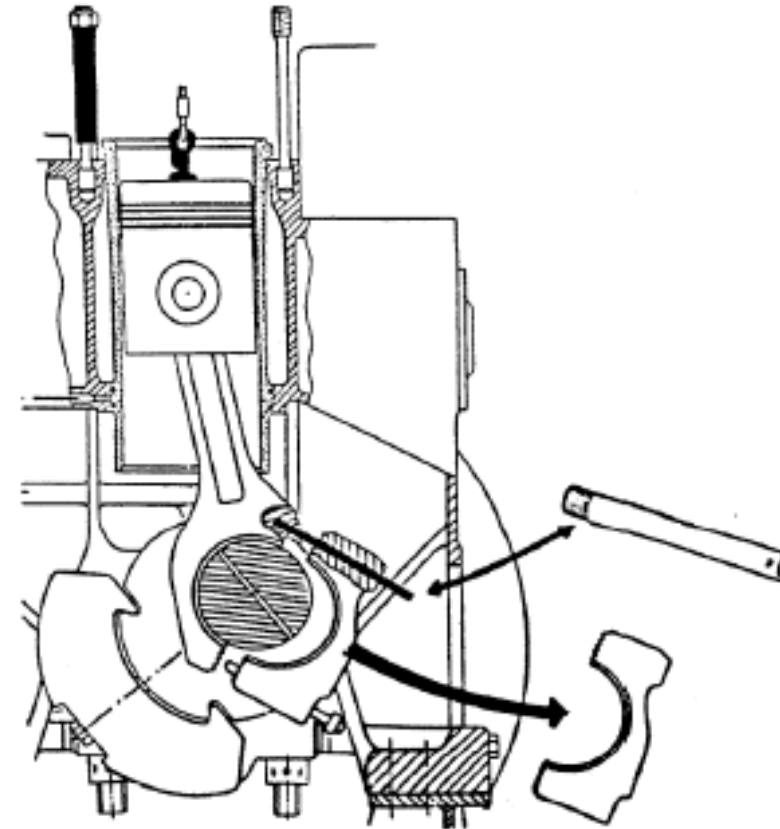
Mounting of tools

Removal of bearing cap

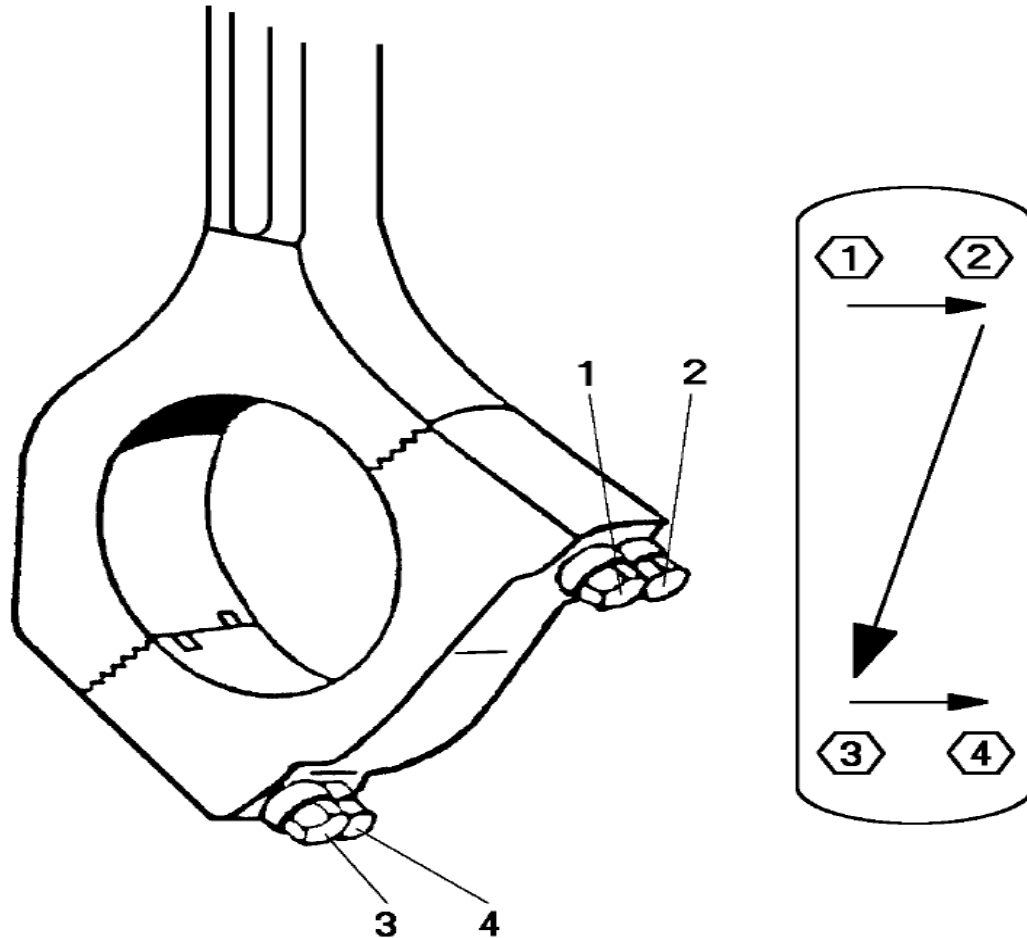
Tightening order

Tightening the screws in tightening order as illustrated in fig. 1 using an initial torque of 400 Nm.

The tightening condition is checked with a torque of 700 Nm executed in prescribed screw tightening order, see fig. 1.

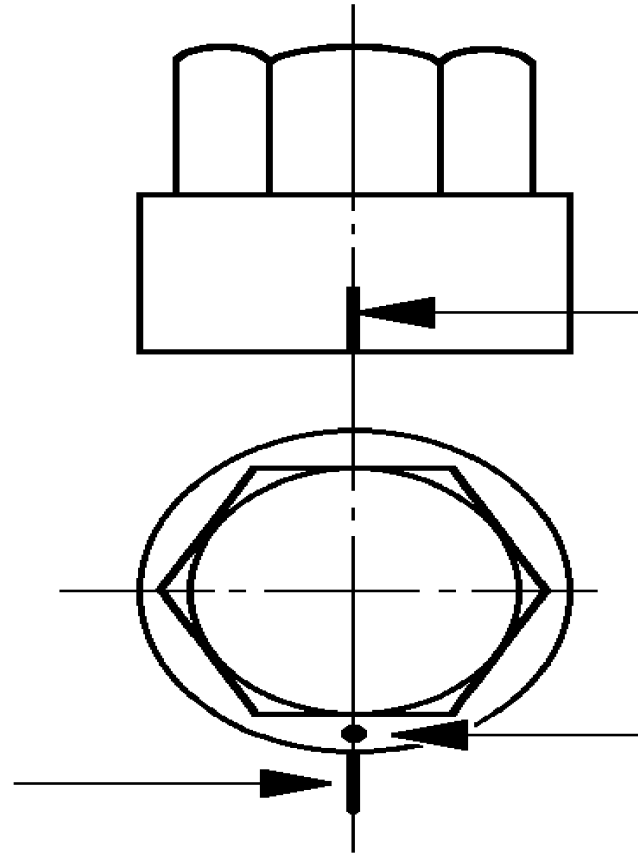
Coinciding
mark on
bearing cap

Mark on
screw collar

Mark the four screws and the bearing cap felt-tippen as illustrated in fig. 2.

Tightening order by turning through a $60^\circ \pm 2^\circ$ angle i.e. until the marks on screws collar and connecting rod coincide radially.

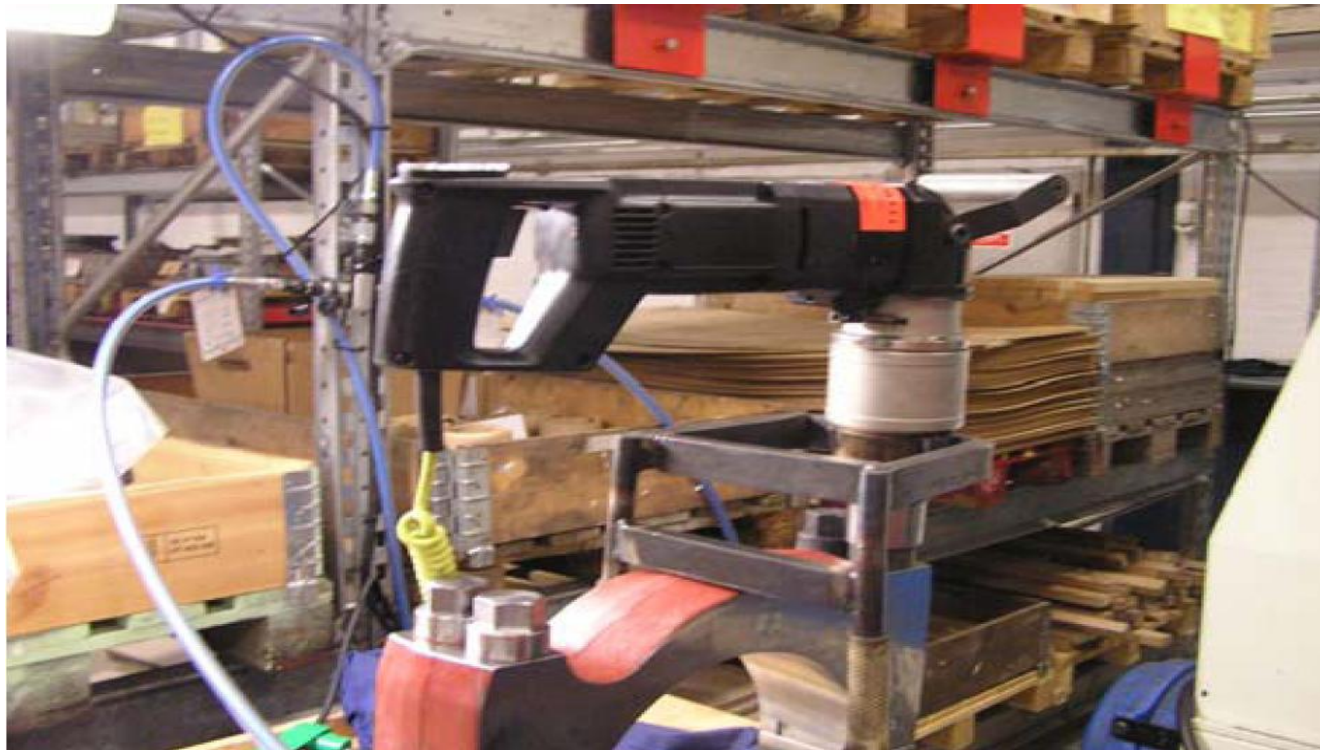
Tightening according to procedure
400 Nm
60 deg

Check of Connecting Rod Screws, Tightening Condition:

Check of the tightening condition of connecting rod screws has to be executed within a short running period after remounting/mounting of the connecting rod.

Proper tightening condition is present if the screws are not turning further during the test.

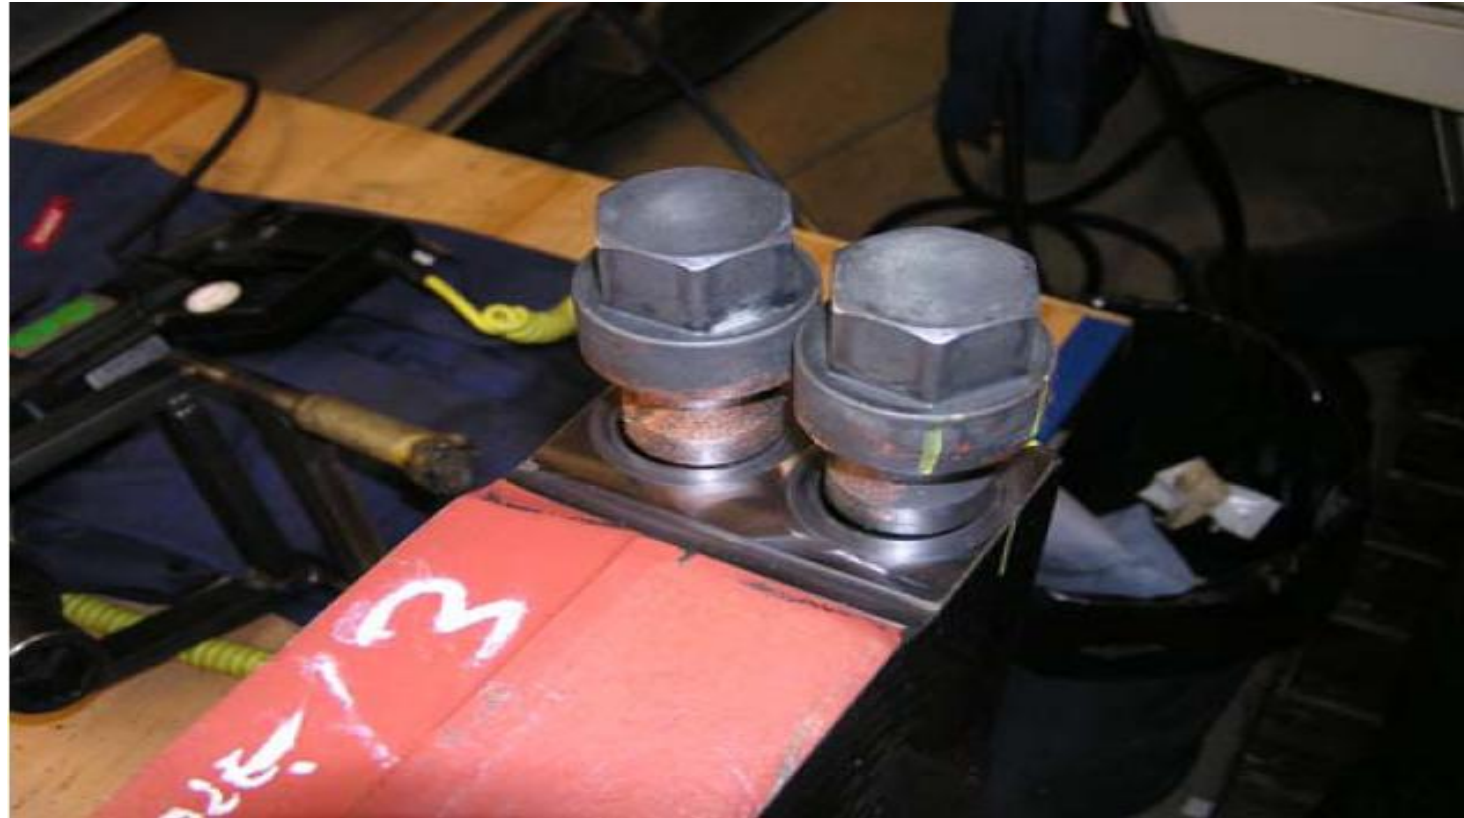
No seizure on the heads of the screw nor on the cap

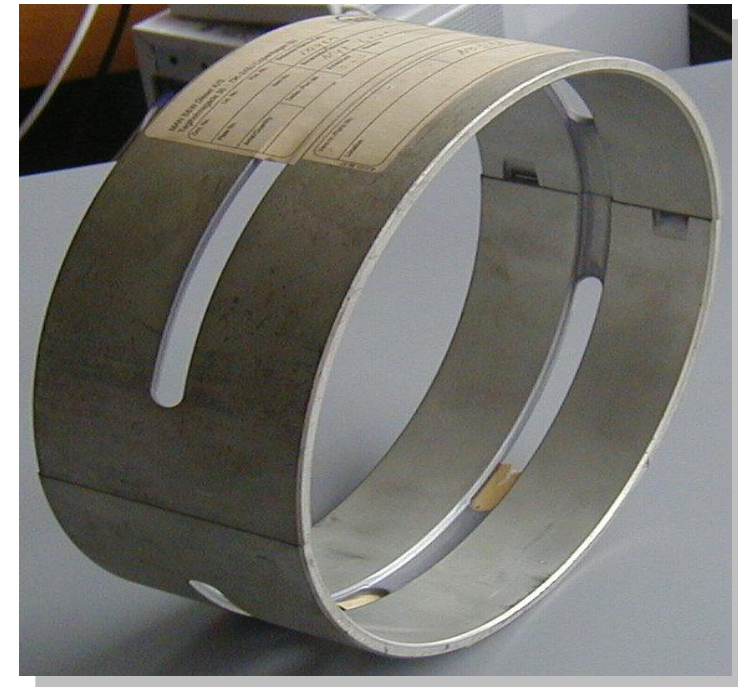
Bearing System no. 1

Condition: The slot geometry corresponds to a new bearing shell. The overlay in the slots is fully preserved, Dark spots are mainly oil coke remains.
Valuation: The ratio between light-alloy metal and overlay is 75 % to 25 %.
Re-use!

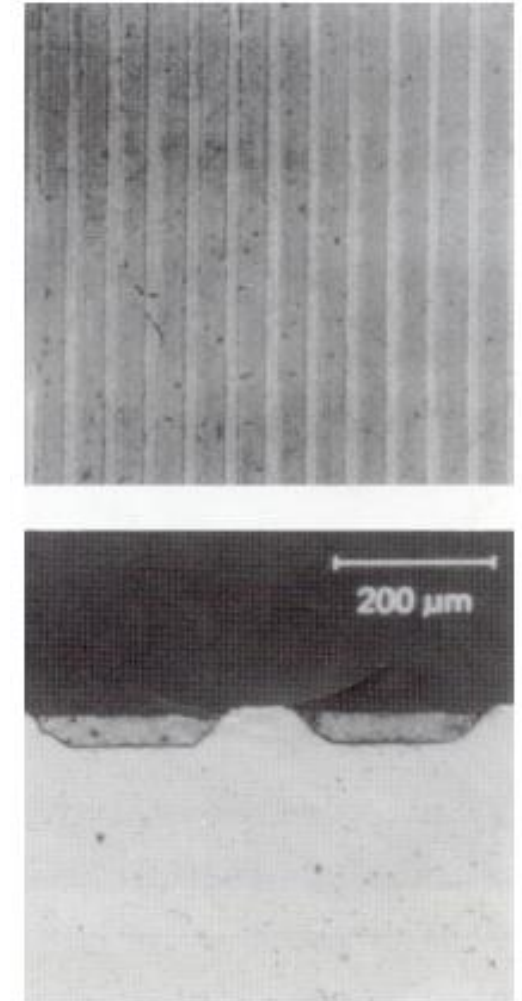
Condition: The overlay is equally worn, approx. 0.005 mm in the slots. The light-alloy strips show no wear, see fig. 3. Dark spots are mainly oil coke remains.
Valuation: Due to worn running surface the light alloy strips are slightly widened. Re-use

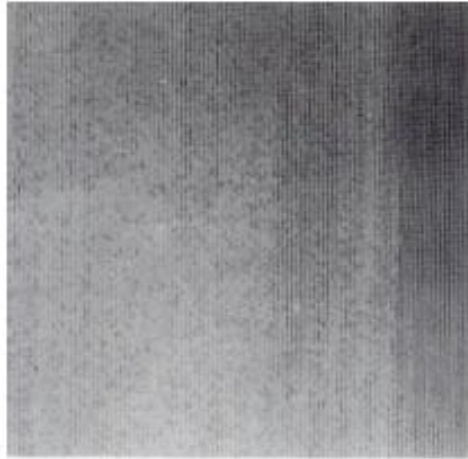
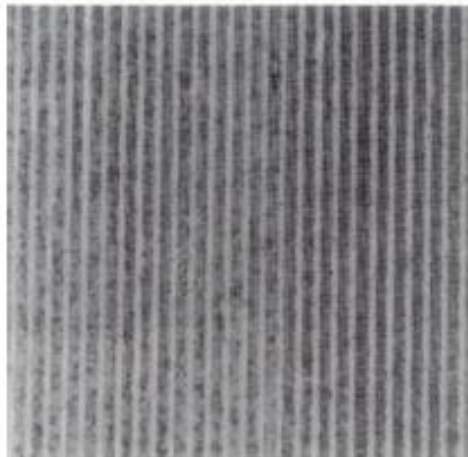
Condition: Small particles all over the overlay. The light- alloy metal shows no changes of importance,
Valuation: Re-use of the shell, as the particles are wedged in the slots.

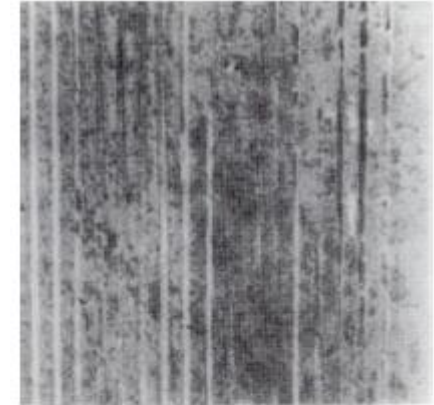
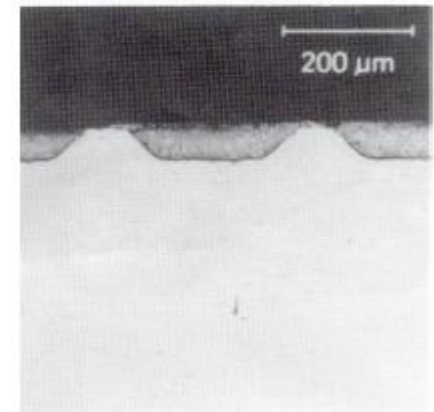
Condition: The overlay has been dragged and smudged over the light- alloy metal. These are only partly visible.
Valuation: Re-use of the shell.

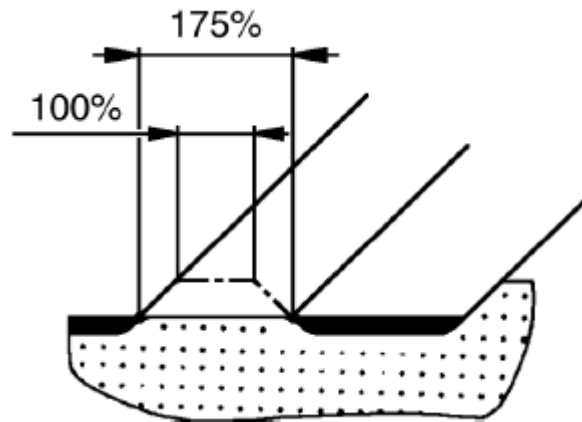
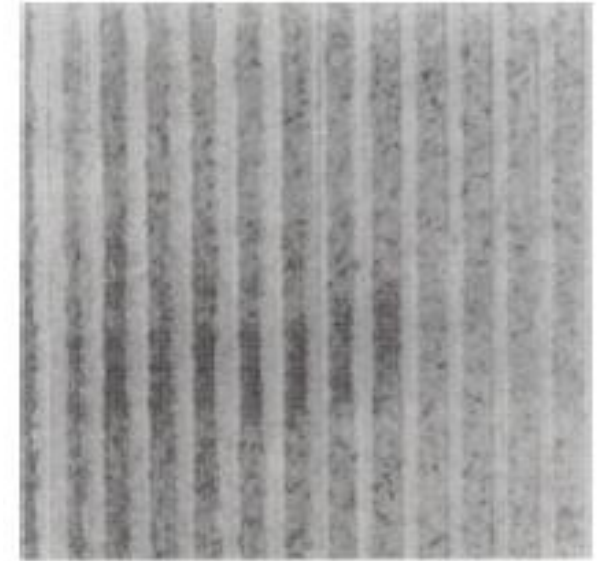
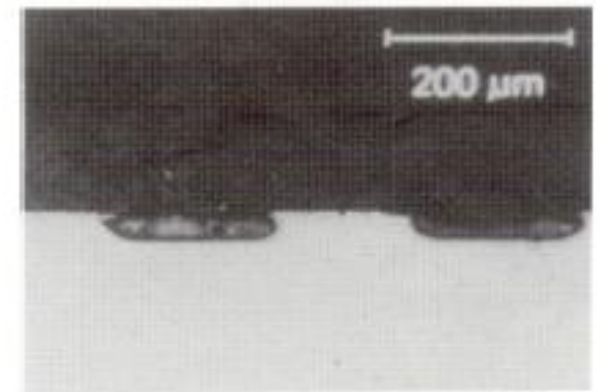
Condition: The bearing shell is locally so worn, that the ratio between the light-alloy metal and the overlay is 1:1. The width of the light-alloy metal has increased from 100 % (new bearing shell) up to 175 %. In the slots some overlay is still left,

Valuation: The bearing can operate with wear of the below listed size, see fig. 8 og 9. If the wear limits are exceeded the bearing shells must be exchanged due to safety precautions.

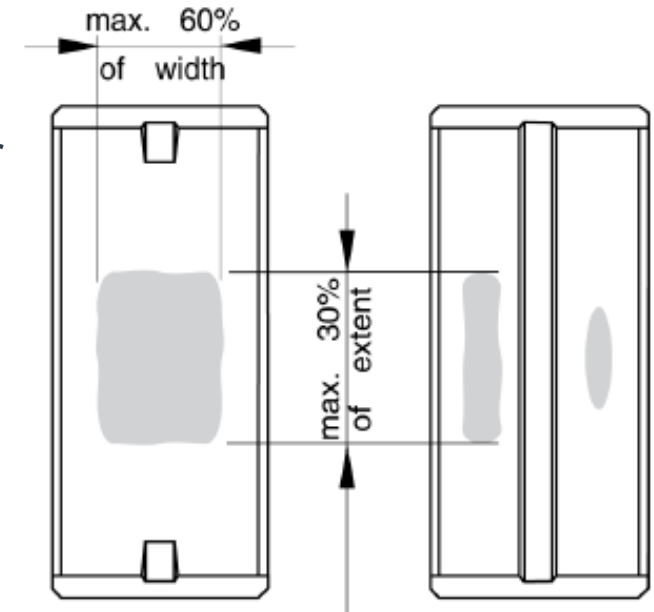
Valuation: The bearing can operate with wear of the shown size. If the wear limits are exceeded the bearing shells must be exchanged due to safety precautions.

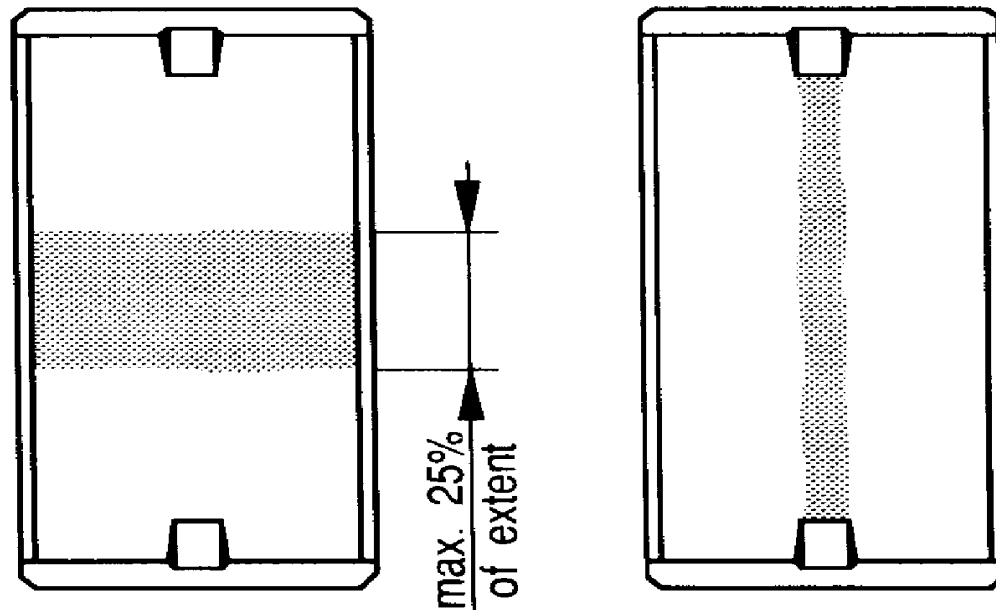
The bearing can operate with wear of the below listed size. If the wear limits are exceeded the bearing shells must be exchanged due to safety precautions.

max. 10% of width or
max. 5 mm

max. 10% of width

max. 5%
of extent

If the limits shown above are exceeded the bearing shells must be exchanged.

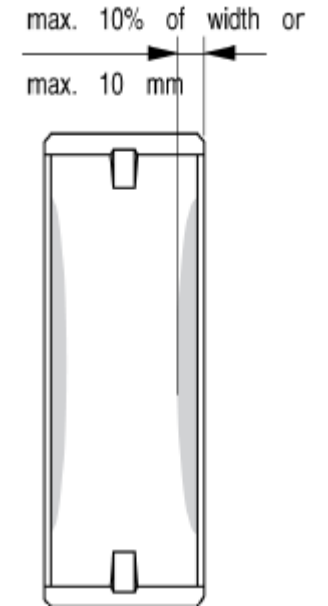
Condition: Breakage in the overlay due to local overload, as shown.
Valuation: If the limits as shown are exceeded with totally or partially empty slots, the bearing shells must be exchanged.

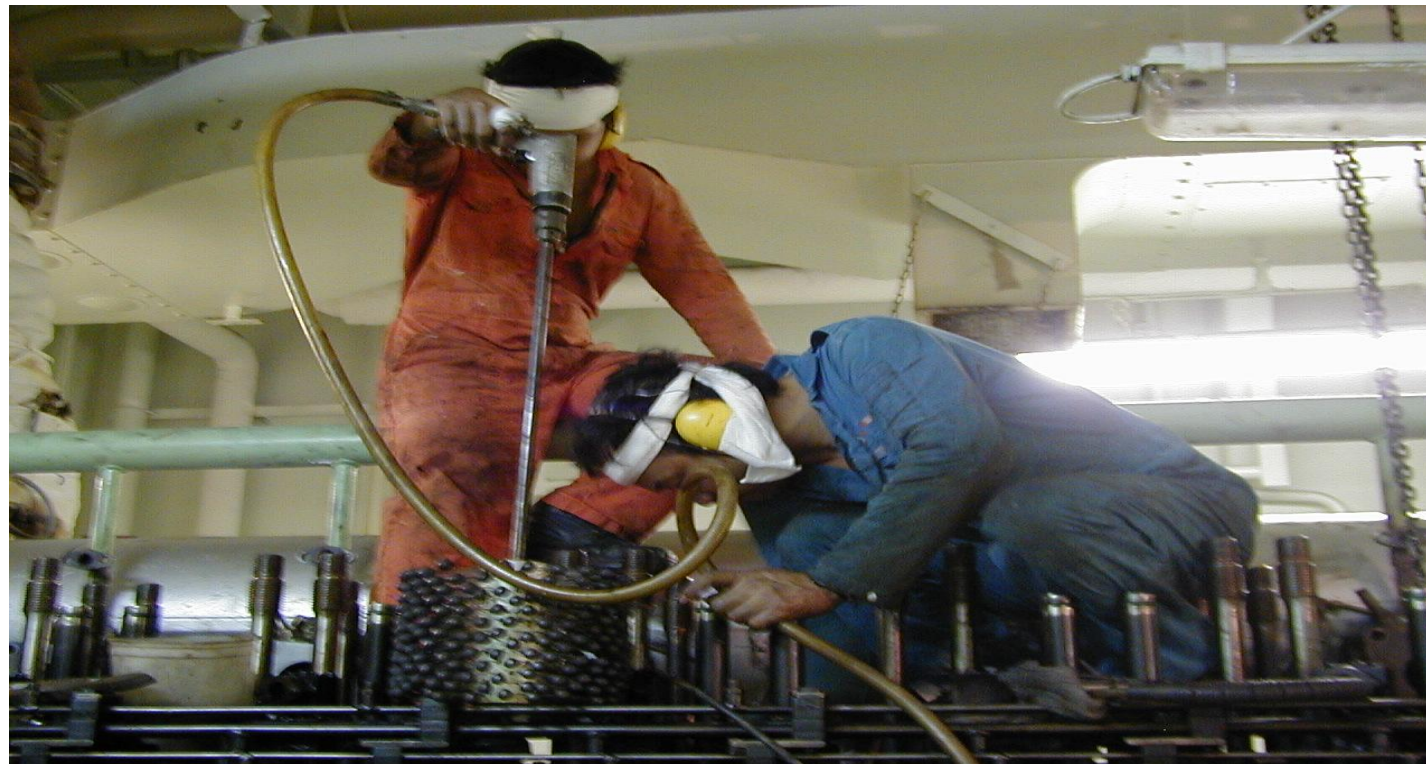
Honing brush for cleaning & rough up only
Pockets as in previous slide can not be restored by brush!

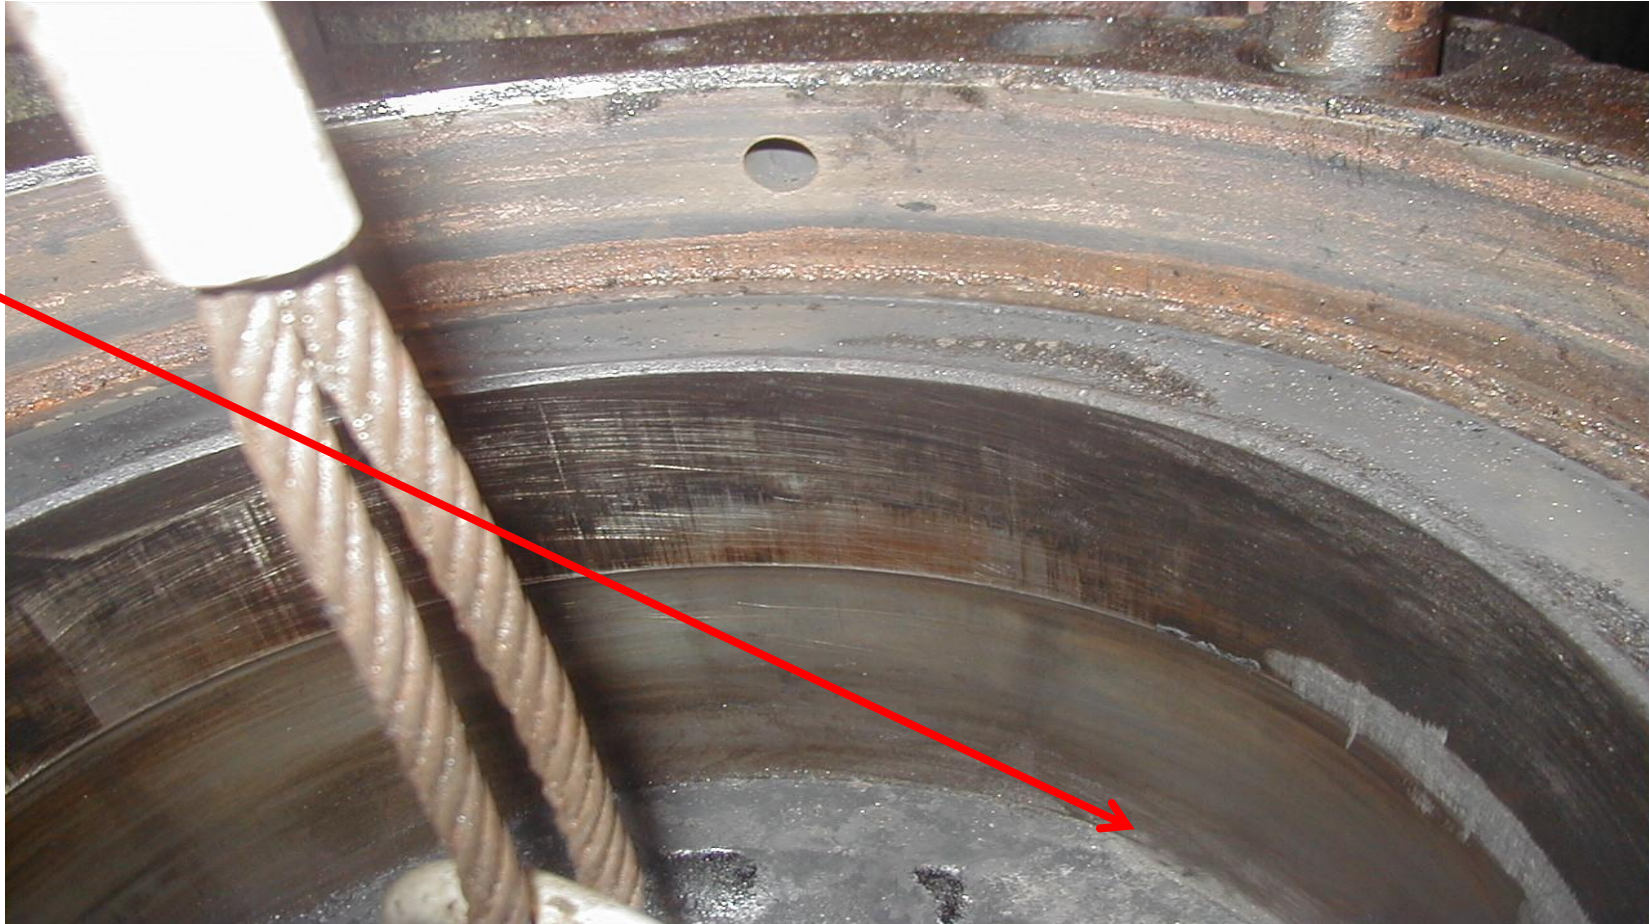
In order to lift
flame ring –
use old piston
ring on top of
piston

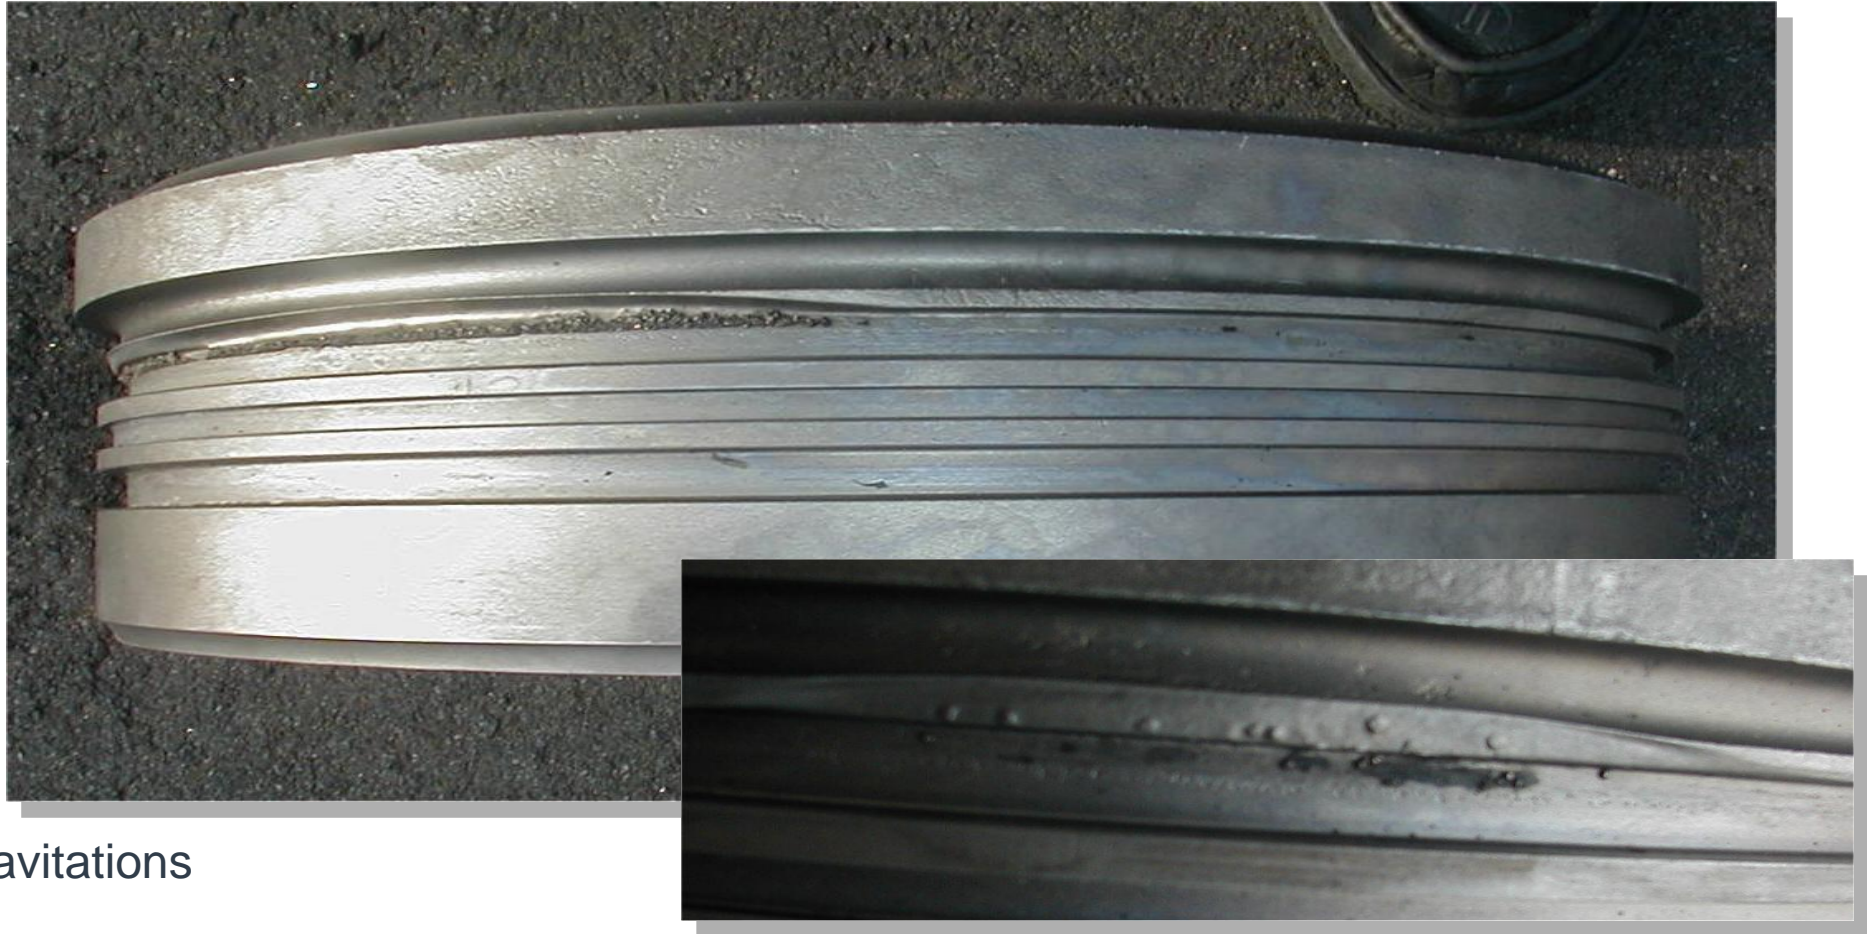
Example of cavitations
