| Work Card Page 1 (5) | Criteria for Replacement of Connecting Rod Big-end and Main Bearing Shells | 506-01.16 Edition 02 |

L27/38, L23/30H, L21/31, L16/24, L16/24S, L21/31S, L23/30S, L27/38S

This paper gives information about the evaluation of the connecting rod big-end and main bearing shells when wear appears on the running surface under normal operating conditions.

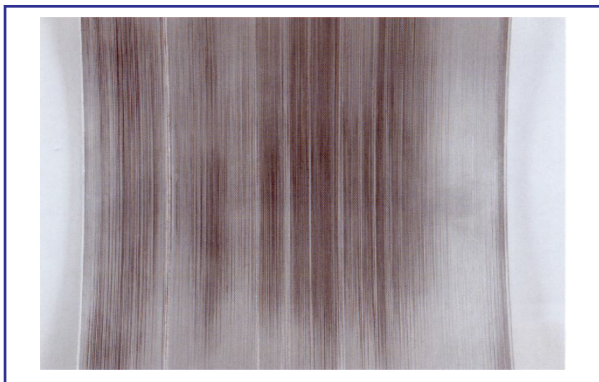
Figure 2: Reusable

1) **Normal wear**

Slightly polished zones and symmetrical running pattern in the most loaded zone of the bearing. Minor scoring. See fig 2.

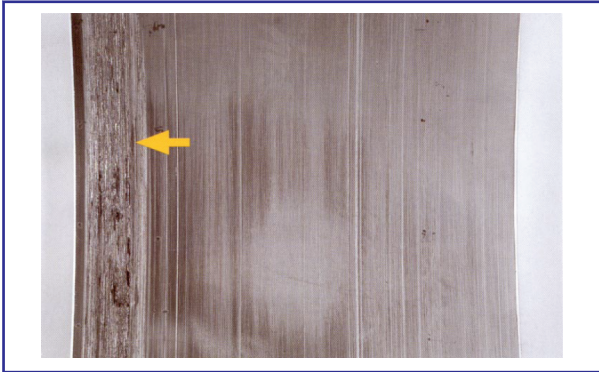
Figure 6: **Replace**

- 1) **Localized heavy smearing of lining material** due to local disturbance of the oil film. See fig 6.

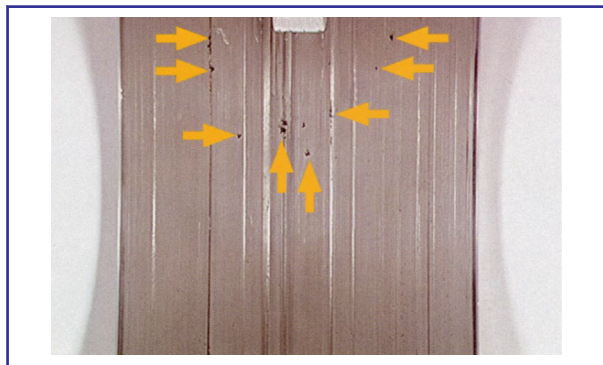
Figure 10: **Replace**

- 4) **Deep punctual cavitation**
In severe cases the cavitation extends to the steel shell, spreads along the interface between steel shell and lining material, and undermines the AlSn20 lining. See fig 10.

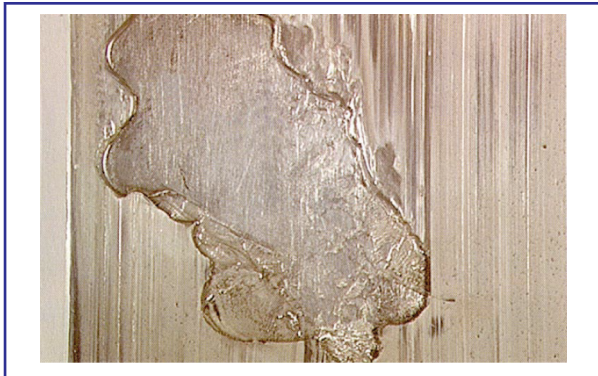
Figure 12: Fatigue rupture

6) Fatigue rupture of the lining material

- Development of fine cracks in the lining material
- Network of cracks (crazing)
- Parts of the lining material break out
