MAN Diesel & Turbo MAN PrimeServ Academy Holeby L23/30H Cylinder head 0 ② ⑤ ⑤ 2015 < 1 >

L23/30H Cylinder head - Check of Rocker arms

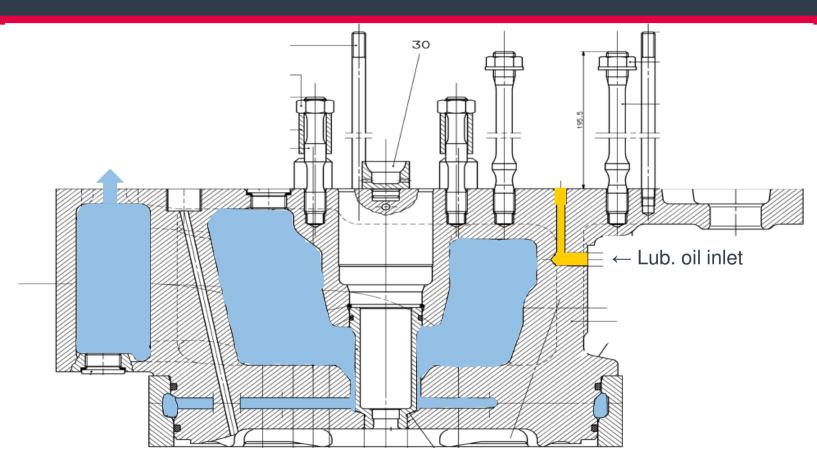
- Cross section

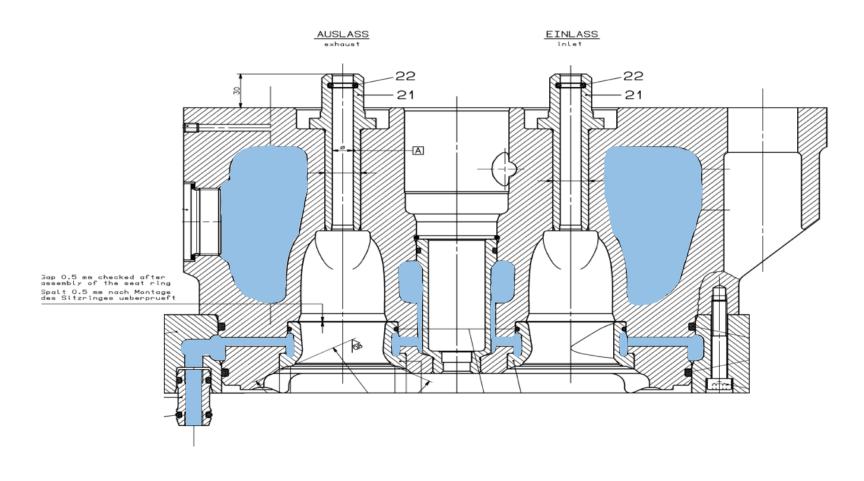
- Cross section

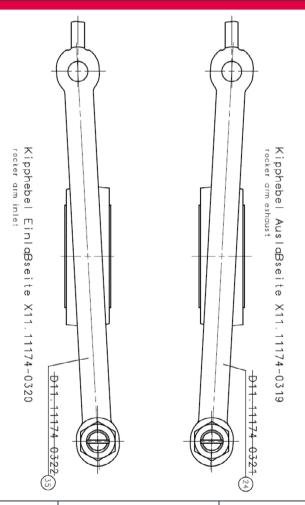
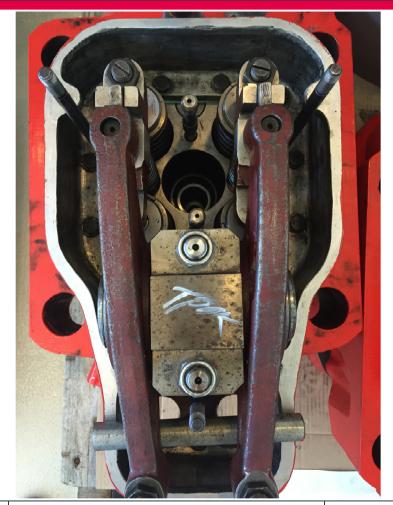
- Rocker arms

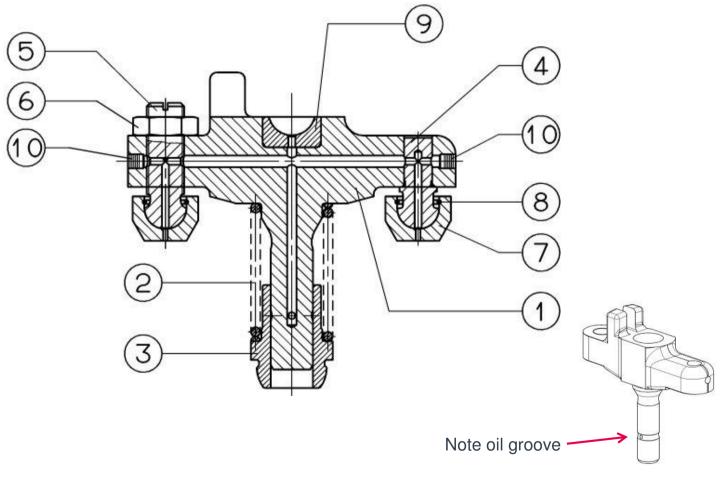
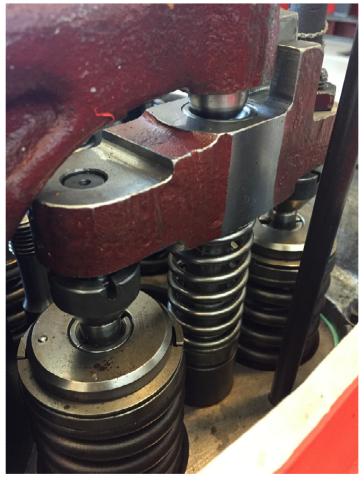
- Valve bridge

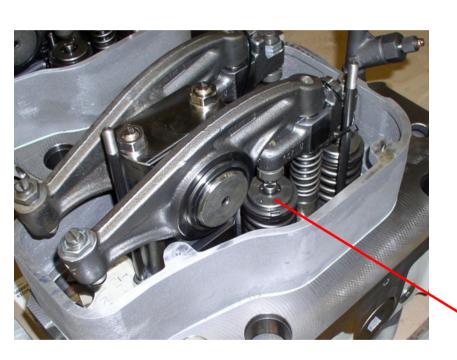
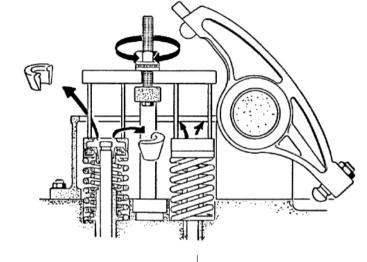
L23/30H Cylinder head Dismantle of valves, Valve rotator

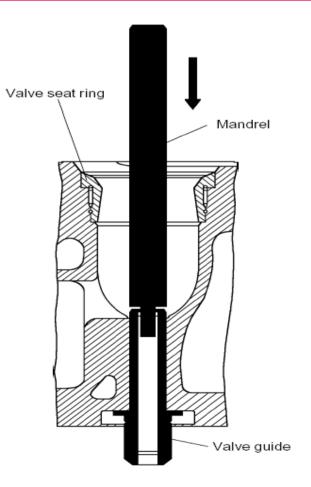
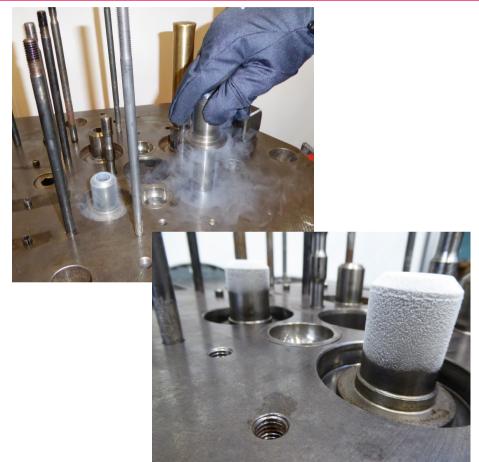
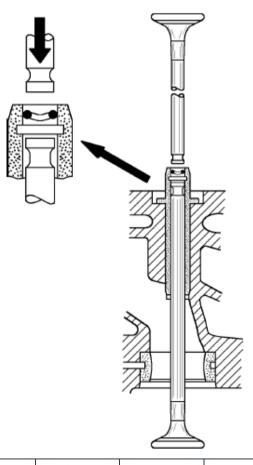
- Replacement of Valve guide / O-ring

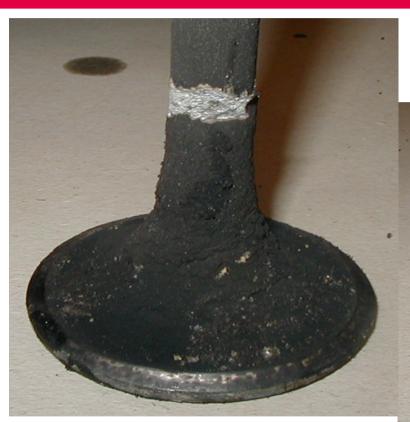
- Overhaul of valve

After cleaning and grinding

As received

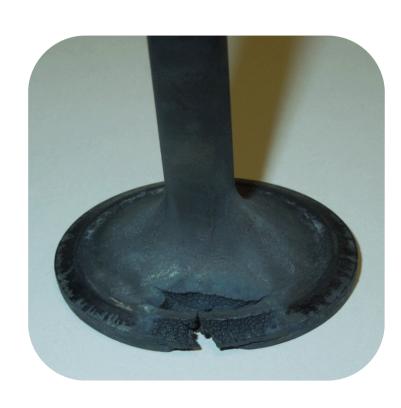
L23/30H Cylinder head - How to Avoid Burned Valves

Reasons for burned valves:

- 1. Valve rotator
- 2. Seat angles/geometry
- 3. High exhaust temperatures
- 4. Material properties
- 5. Sticking valves/poor combustions
- 6. Worn valve guide

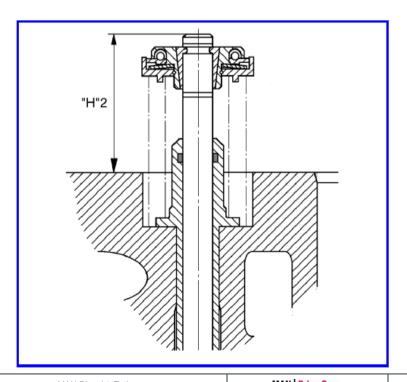
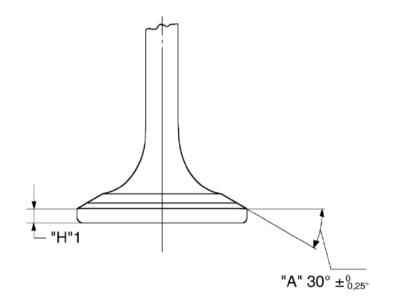
- Important measurement afterwards

After assembling the valves, check - on account of the valve motion - that distance "H"2 between the upper edge of the cylinder head and the upper edge of the valve spindle does not exceed the maximum value, see page 500.35.

Section	Description	mm. / bar
505	Maximum inner diameter, valve guide For grinding of valve spindle and valve seat ring (see also working card 505-01.10) Minimum height of valve head, inlet valve and exhaust valve, "H" 1 Maximum height of spindle above cylinder head, "H" 2	14.25 mm 5.0 mm 83.3 mm

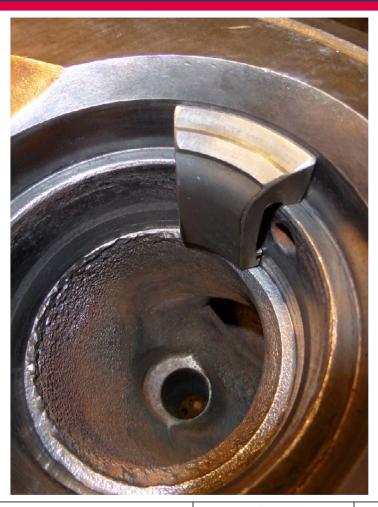
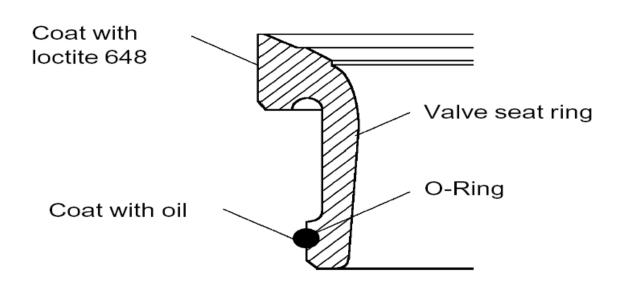
- Replacement of valve seats

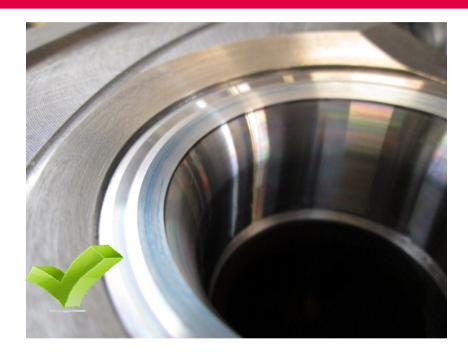
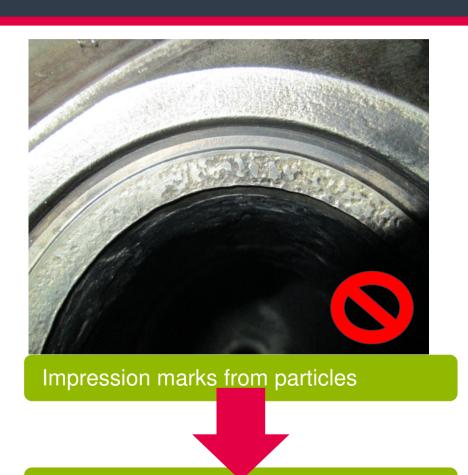
- Exhaust Valve Seat

New seat

Increasing exhaust temperatures

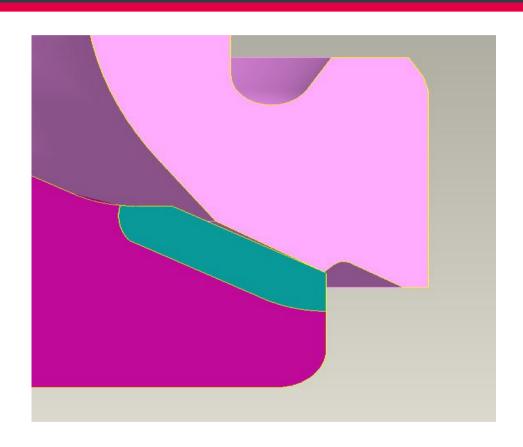
- Valve seat angle

- After grinding of valve seat, the angle between seat and valve cone is correct.
- During operation, the valve cone will be deformed and the contact area between seat and valve cone will be complete.

CORRECT

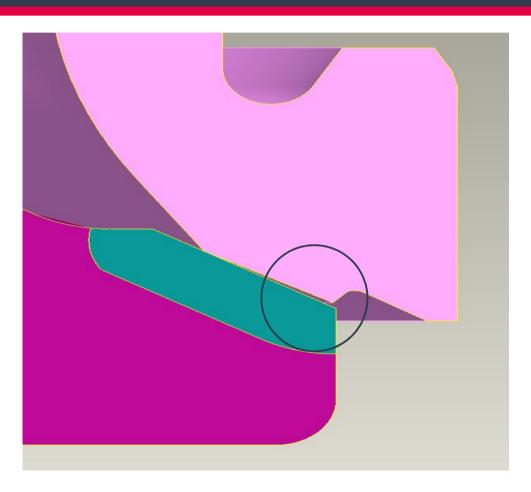
- Valve seat angle

- Not correct angle of valve seat. During operation, the valve cone will be deformed and the gab in the outer diameter will be bigger.
- Bigger gab will cause deposits on the seat and insufficient cooling of the valve cone.
- Insufficient cooling will cause burned valves and burning marks on the seat.
- INCORRECT!
