# Four-stroke Small bore GenSet Service Experience

# Small bore HFO gensets

# Service Experience

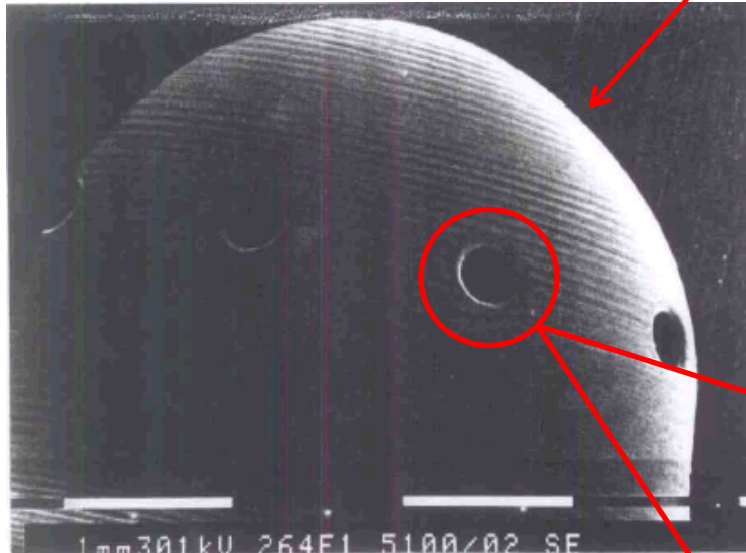
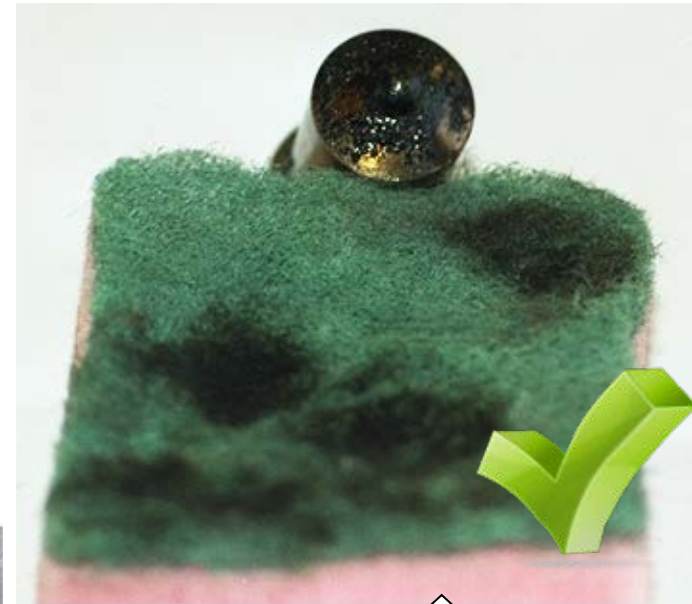
Damage from rotating steel brush

Use 'Scotch Brite' and diesel for cleaning

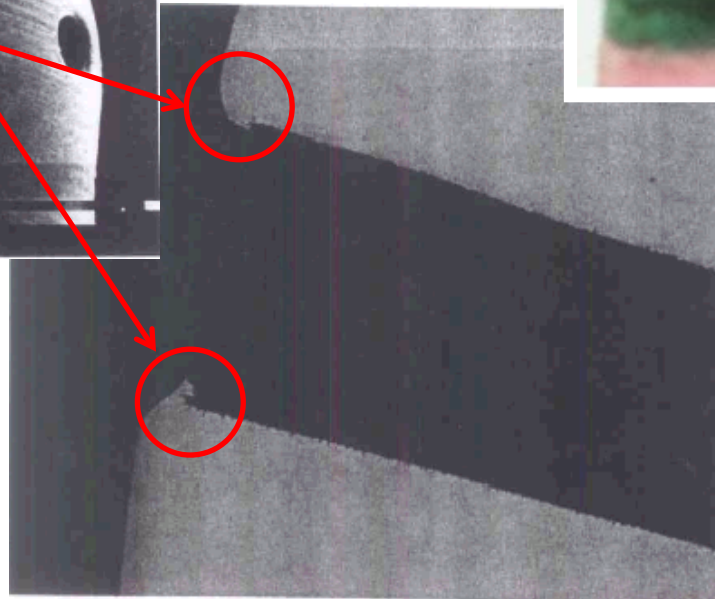
...cause poor combustion

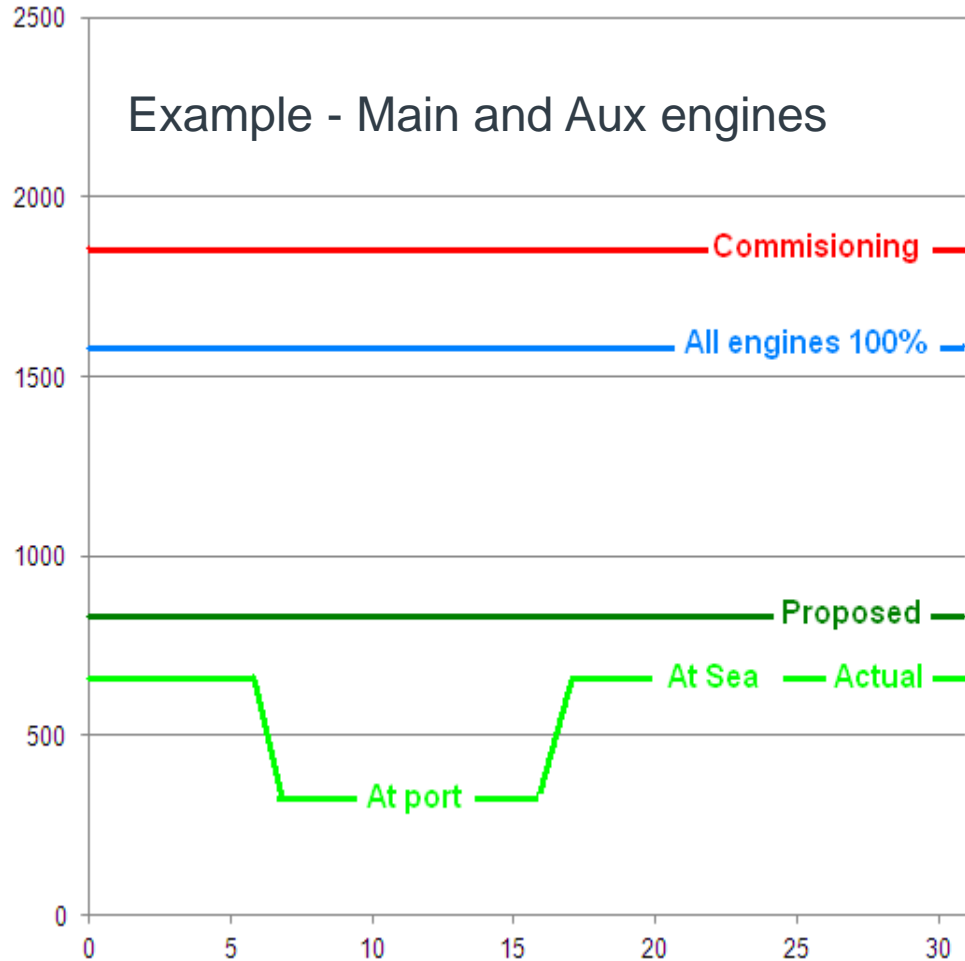
Separator flow

## Flow according to actual trade (slow steaming)

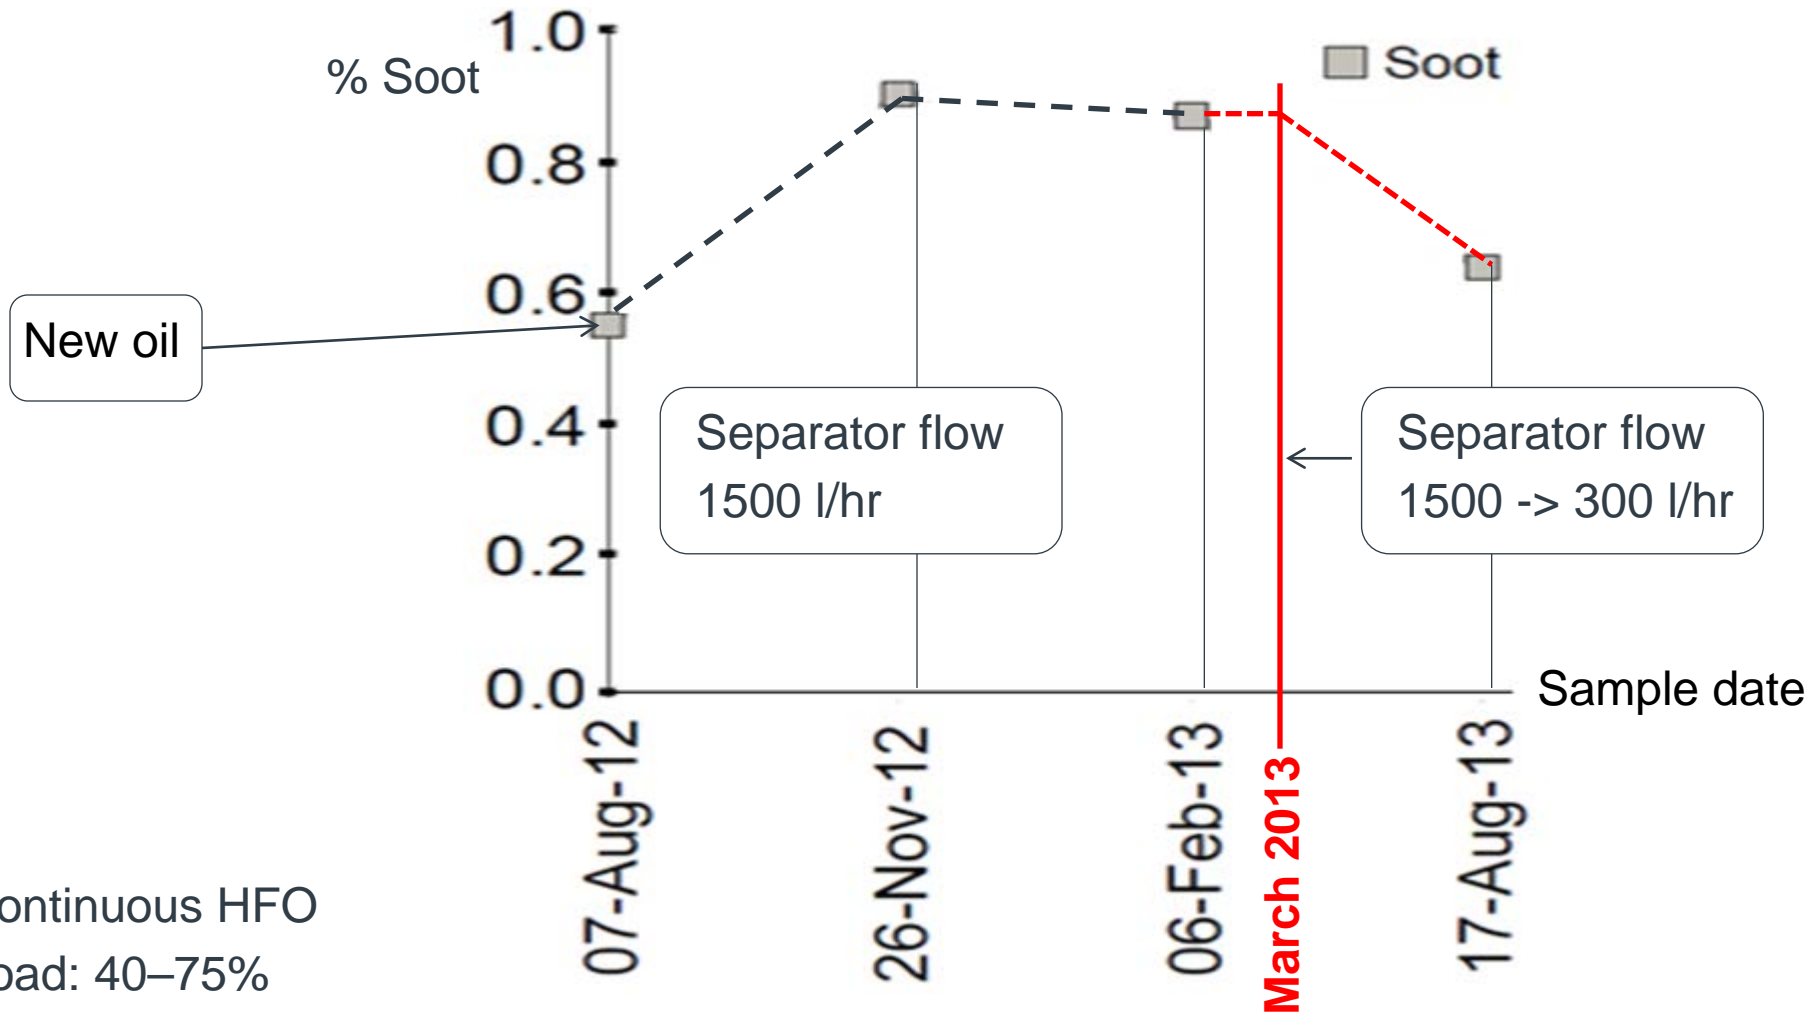
## Field test results

Continuous HFO  
Load: 40–75%

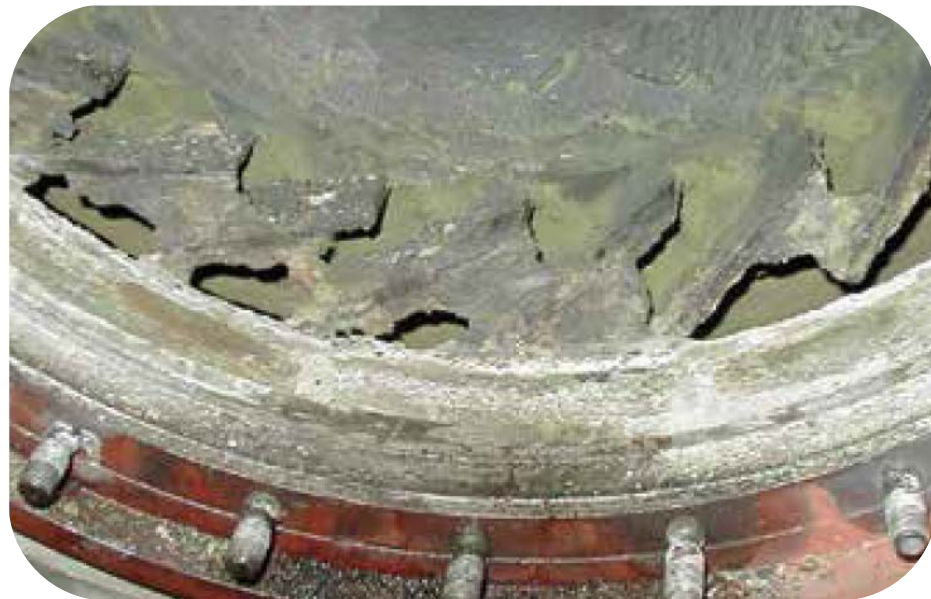
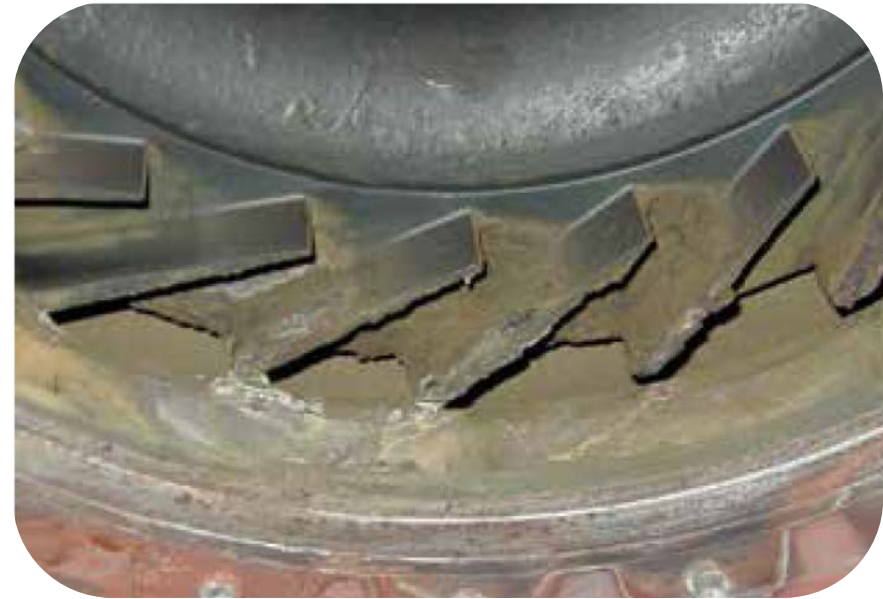
Engine Type	Nozzle Ring Area mm <sup>2</sup>	Fouling mm	Reduction mm <sup>2</sup>	Area reduction %
5L16/24	125	1.0	40.7	32.6
9L27/38	625	1.0	96.0	15.4

**Size Matters!**

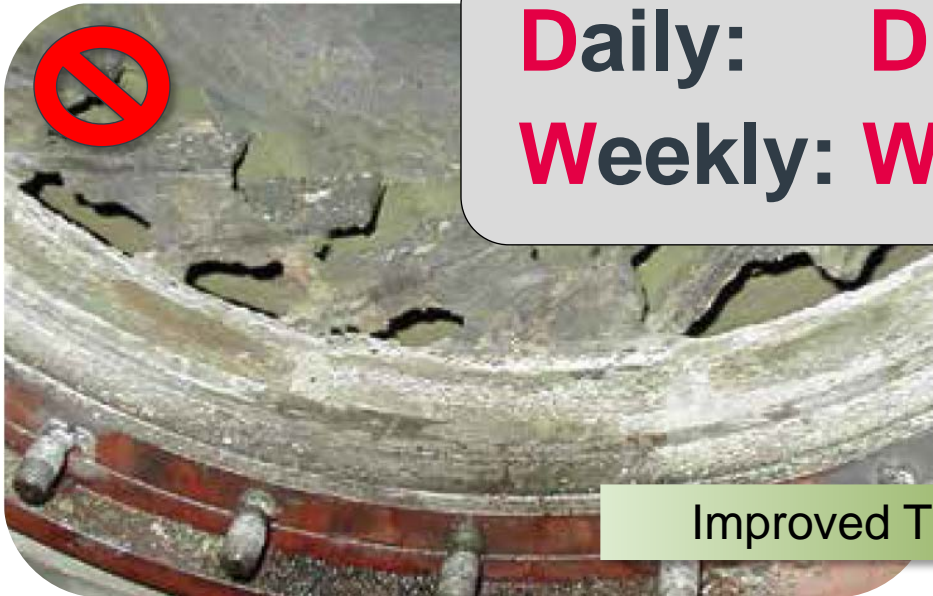
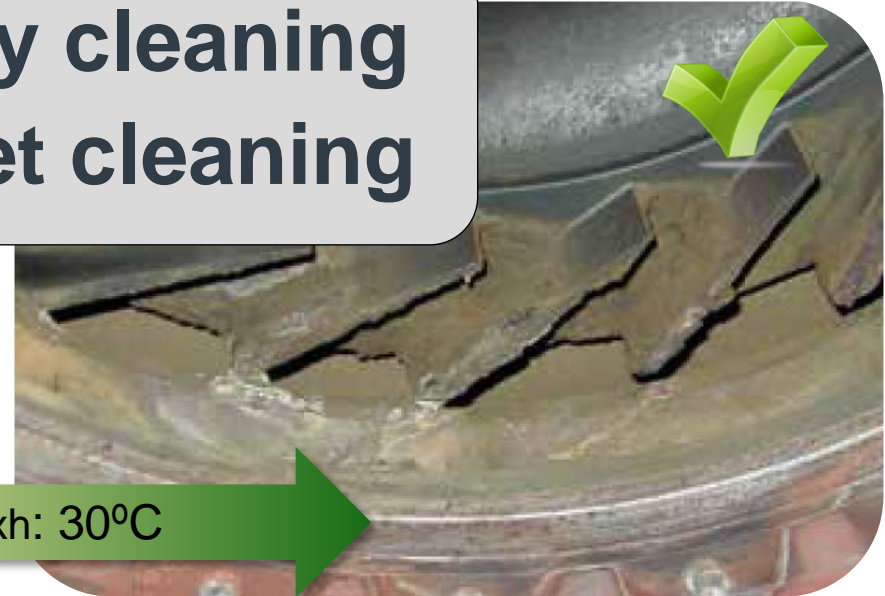
→ Fouling turbine (coke deposit).

→ Lower turbocharger performance.

→ Lower air-flow/-pressure through the engine

→ Increasing exhaust gas temperatures.

**Daily: Dry cleaning**  
**Weekly: Wet cleaning**

Improved Texh: 30°C

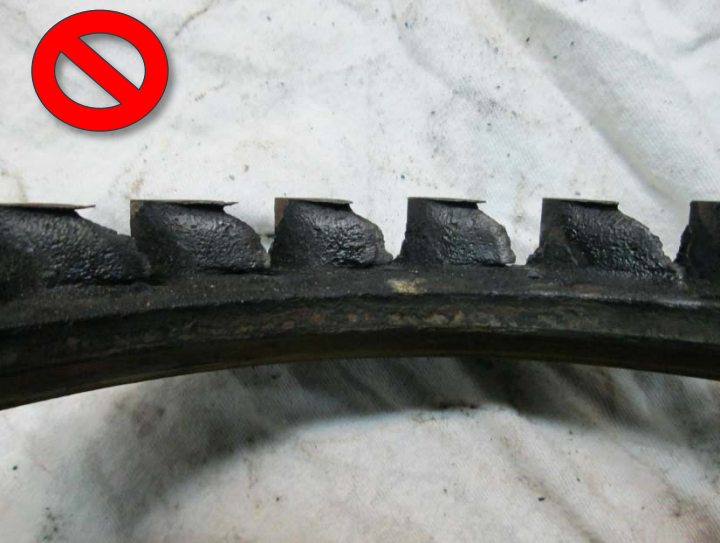
2,000 running hours  
No cleaning of TC,  
neither by water nor by dry means

Worn out

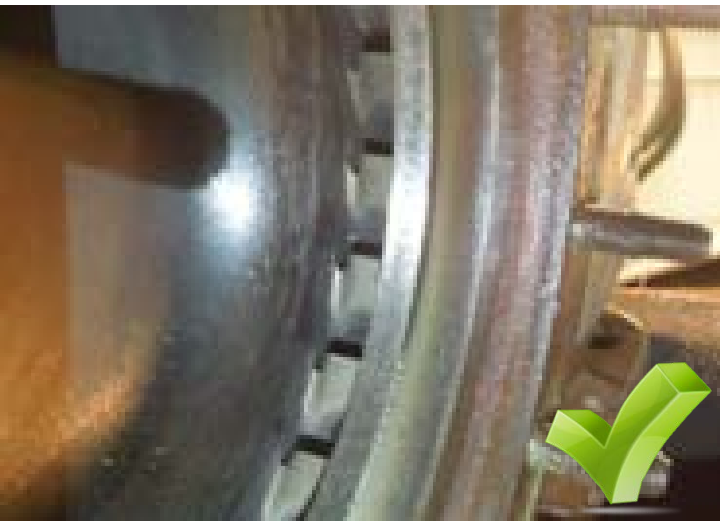
6,000+ running hours  
Daily dry cleaning, weekly water washing  
Surface-coated nozzle ring  
**Good fuel treatment**

Expected lifetime – 16,000+ hrs.

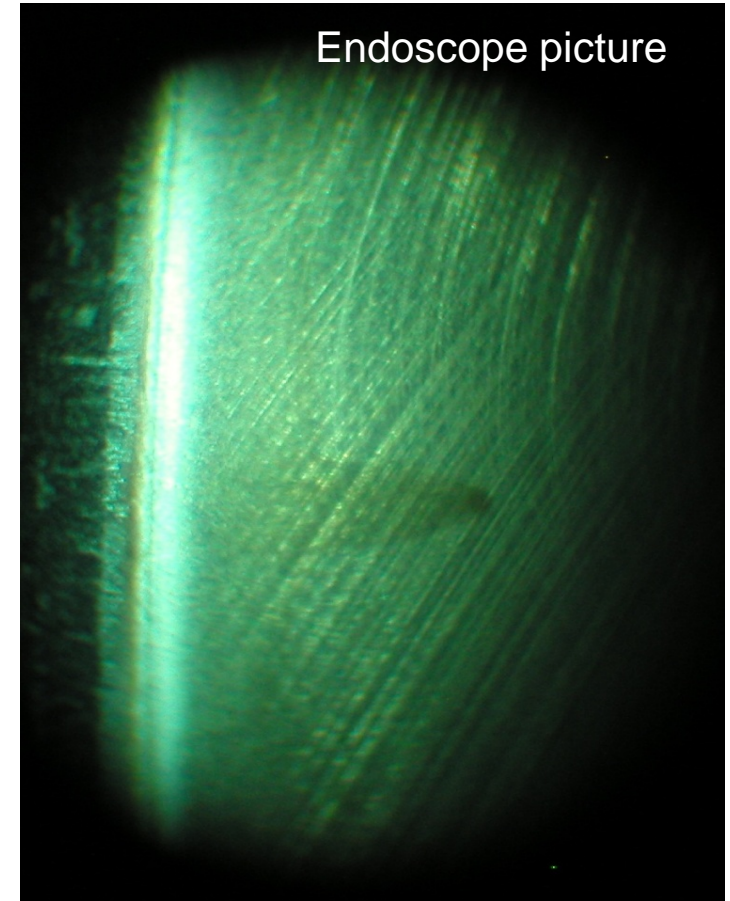
L23/30 Liner condition after 32000 hrs

1. Water carry-over - condensate
2. Cat-fines – coming in by HFO

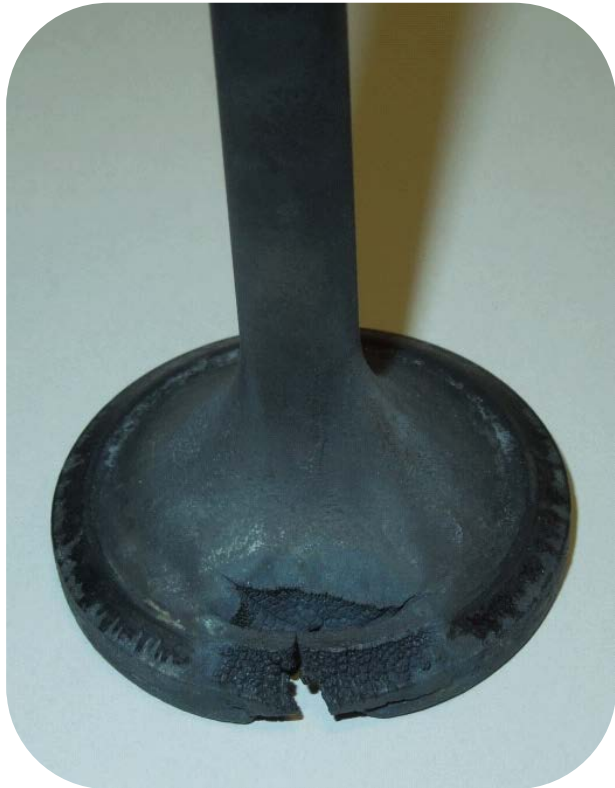
1. Valve rotator
2. Seat angles
3. Worn valve guide
4. High temperatures
5. Material properties

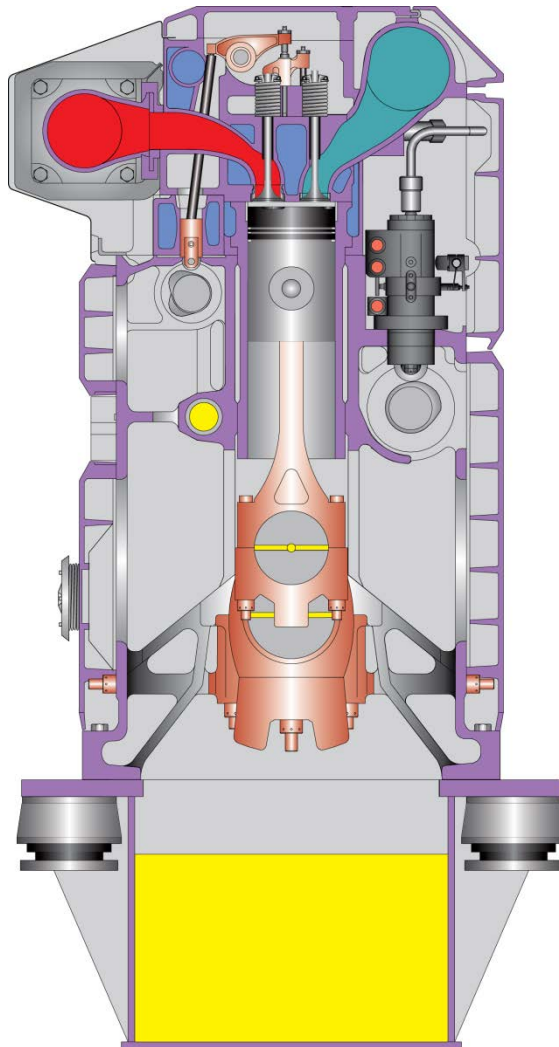
# L16/24 - 2015

Bore	160 mm
Stroke	240 mm
No. of cyl.	5-6-7-8-9
Speed	1000 / 1200 rpm
Output / cyl.	90 / 110 kW

5 cyl. engine	22.4 / 20.7 bar
6, 7, 8, 9 cyl. engines	23.6 / 22.8 bar
Mean piston speed	8 / 9.6 m/s
Combustion pressure	170 bar
HFO	700 cSt

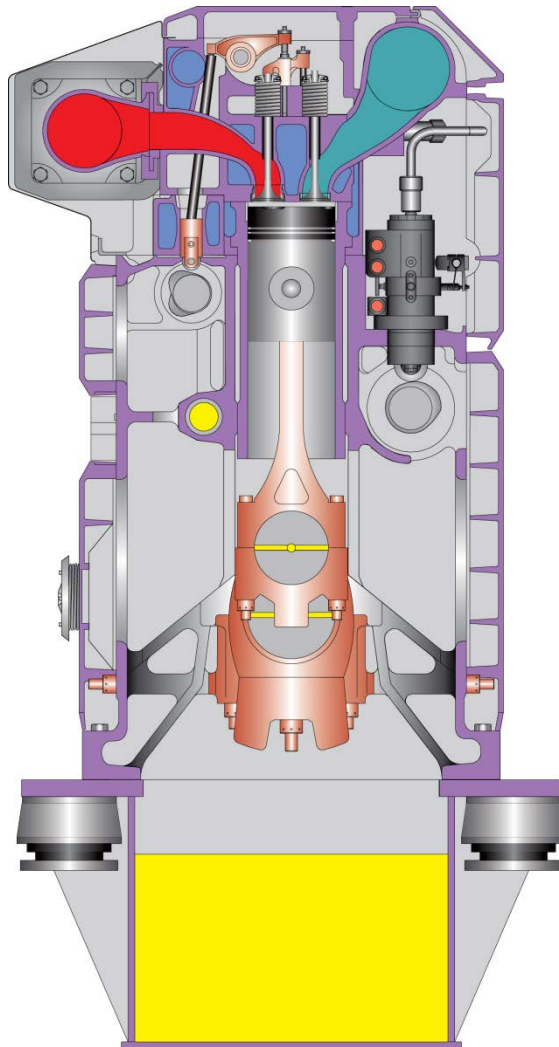
# L16/24 – Release January 2016

- Part load optimised
- 3-point installation

- Valve, exhaust DuraSpindle or Top Premium (Nimonic81 + Crystal coat)
- New piston ring pack

- TCR10 (5L)

- Heat insulation on top FEB
