# Service Experience MAN B&W Two-stroke Engines

# **Service Experience**

MAN B&W Two-Stroke Engines

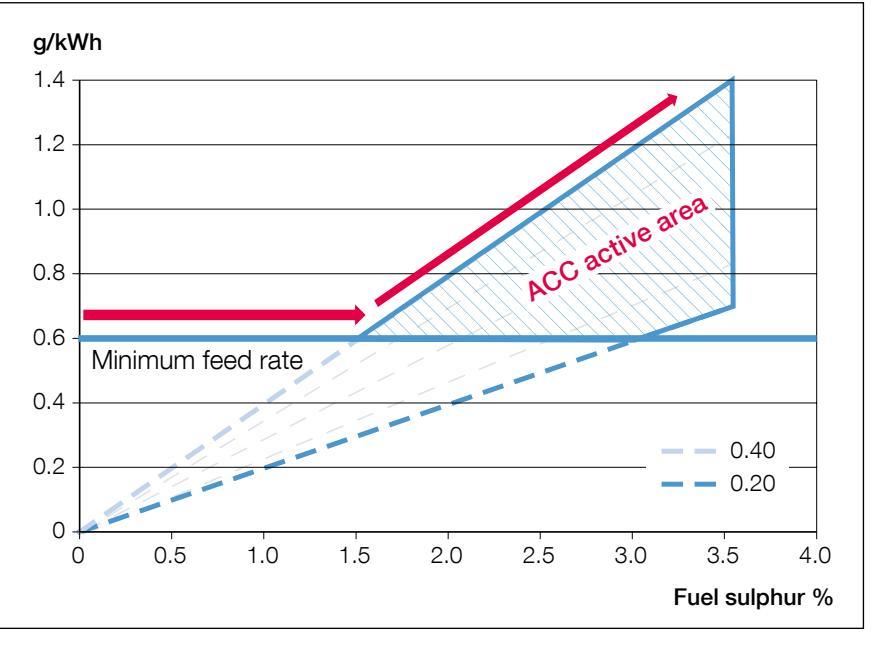
Fig. 2: BN 100 ACC range for Mark 8-8.1 and newer engines

This is illustrated by our feed rate guide, which sets the minimum feed rate to the level needed to keep the parts moving within a safe margin. However, so as to ensure the necessary lubrication effect, an increased formation of acid would call for a higher BN level than specified at the minimum feed rate. This is compensated for by calculating a feed rate based on an ACC factor within the guide shown in Fig. 2.

However, the ACC factor can only be assessed when the fuel sulphur level has been high enough to ensure that the lubrication has been in the ACC active area (the blue area marked in Fig. 2). At lower fuel sulphur levels, the engine is excessively protected against corrosion because of the active minimum feed rate. The acceptable wear rates must be in line with our recommendations on overhaul intervals and expected lifetime of the components. Liner wear rates are normally below 0.1 mm/1,000 running hours.

The best way to establish the optimum ACC factor is to measure the cylinder liner and piston ring wear. If the wear rate of the liner and piston rings is too high, because of corrosion, the ACC factor must be increased to reduce the wear.

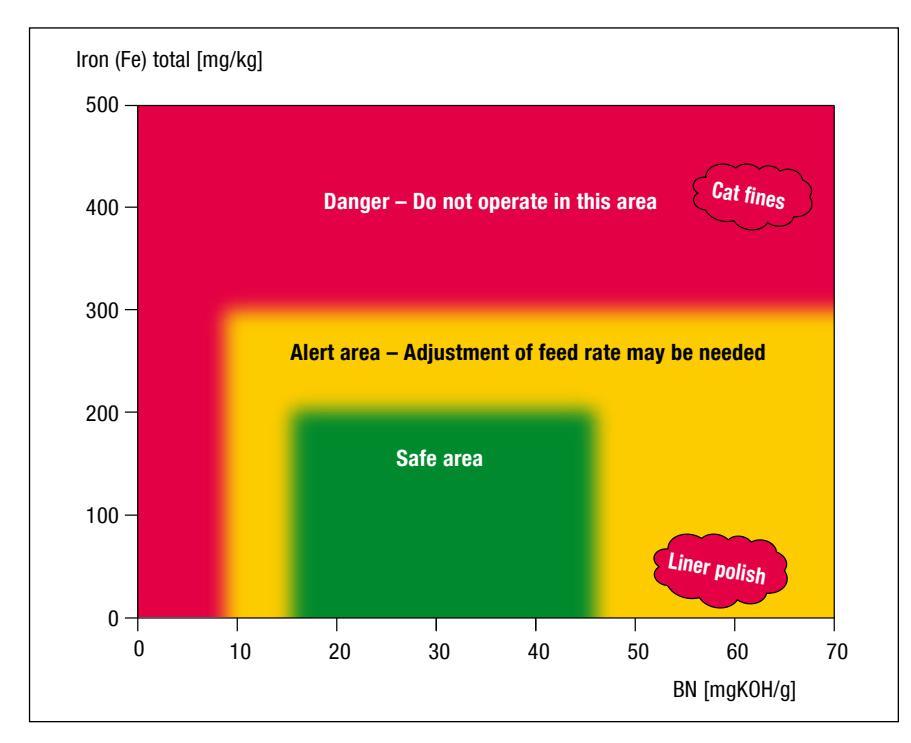
Fig. 3: Scavenge drain oil result

The piston ring wear must also be kept under observation, and it must be assured that the controlled leakage (CL) groove on the piston rings is not worn below the acceptable minimum and that the POP-ring groove does not exceed its maximum allowable wear. POP-rings are designed with gas leakage grooves on the bottom surface of the piston ring. A drain oil analysis is also a strong tool for judging the engine wear condition. Drain oil samples taken in active ACC operation will show if the oil feed rate can be optimised while keeping the BN between 10-25 mgKOH/kg and the iron (Fe) content below 200-300 mg/kg in the drain oil, see Fig. 3.

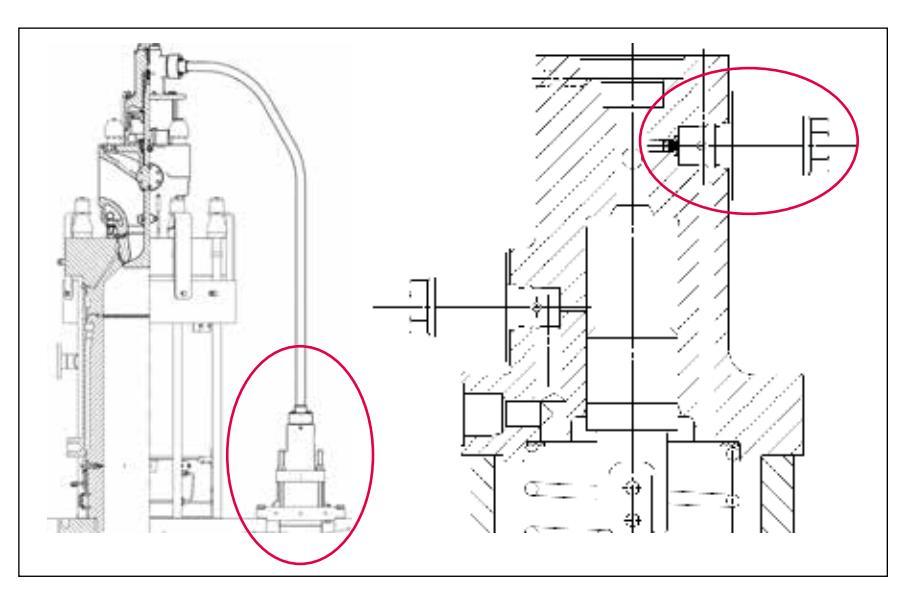
Fig. 18: ME-B/ME-C engine acceleration problems

The root cause has been identified to be a low excess air ratio (air for combustion) at low load and heavy running especially during the acceleration phase. This is due to the application of two-stroke Miller timing with late closing of the exhaust valve.

The countermeasure introduced by MDT has been the installation of a controllable orifice in the exhaust valve oil push rod, see Fig. 18, to facilitate earlier closing of the exhaust valve during low engine speed running. This solution will increase the air excess ratio in the cylinder.

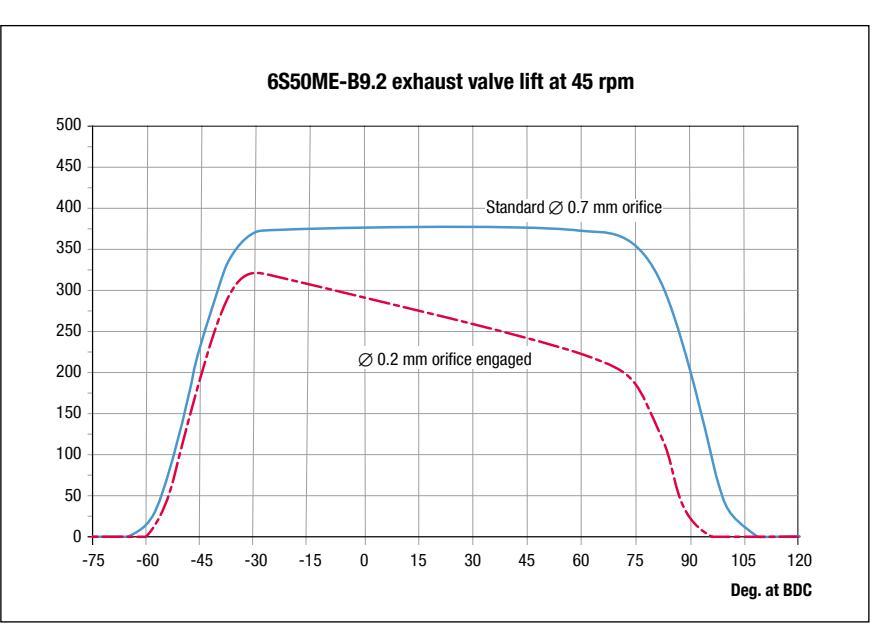
Fig. 19: ME-B9.2 engine acceleration problems

Fig. 19 shows the influence of the controllable orifice on the opening/closing timing of the exhaust valve.

On ME-B dot 3 and ME-C type engines, the exhaust valve closing and, accordingly,  $p_{comp}/p_{scav}$  ratio can be varied by means of the ECS parameter settings. This means that no hardware changes are needed.

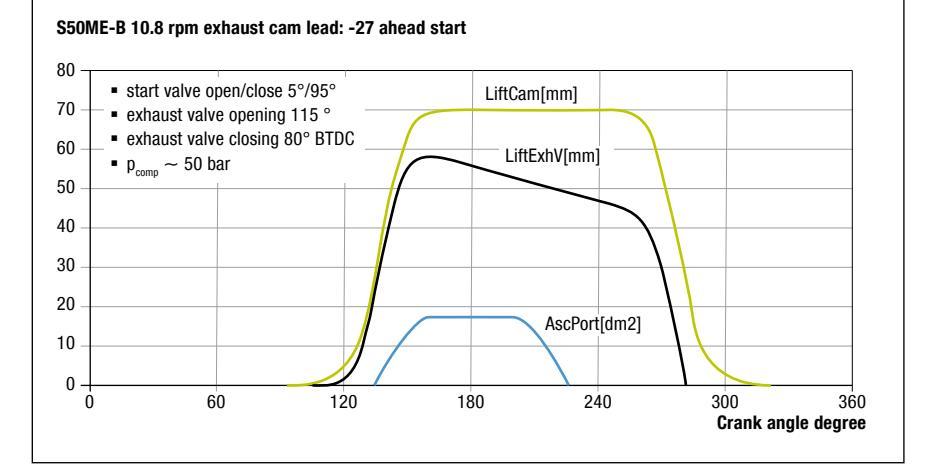
Fig. 20: ME-B9.2 astern start problems

For ahead start, the standard starting air interval of 5-95 deg does not conflict with the opening of the exhaust valve at 115 deg ahead of TDC. The exhaust valve closes at 80 deg before TDC, resulting in a compression pressure of approximately 50 bar. Fig. 20 indicates the timing during ahead start.

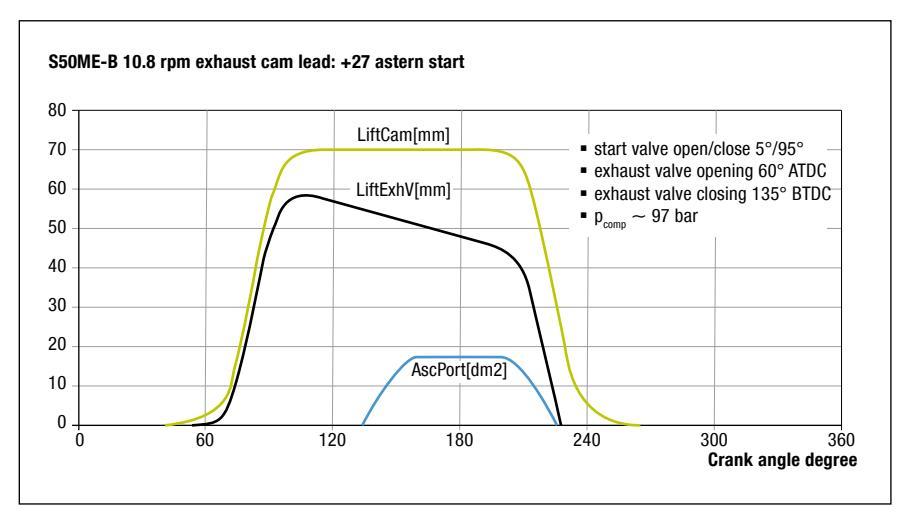
Fig. 21: ME-B9.2 astern start problems

As a result, at astern start, the exhaust valve opens already at 60 deg ahead of TDC, which leads to loss of starting air when applying the standard starting air timing (5-95 deg). Furthermore, the exhaust valve closes at 135 deg before TDC resulting in a compression pressure of approximately 95 bar. Fig. 21 illustrates the timing during astern start. The power of the "air engine" is decreased and the work needed has increased.

- In astern direction, the starting air timing is changed to 5-82 deg for five-cylinder engines and to 5-75 deg for six to nine-cylinder engines. This limits the loss of starting air.
- A throttle valve delays the exhaust valve closing to 110 deg before TDC, see Fig. 22, resulting in a considerably reduced compression pressure.

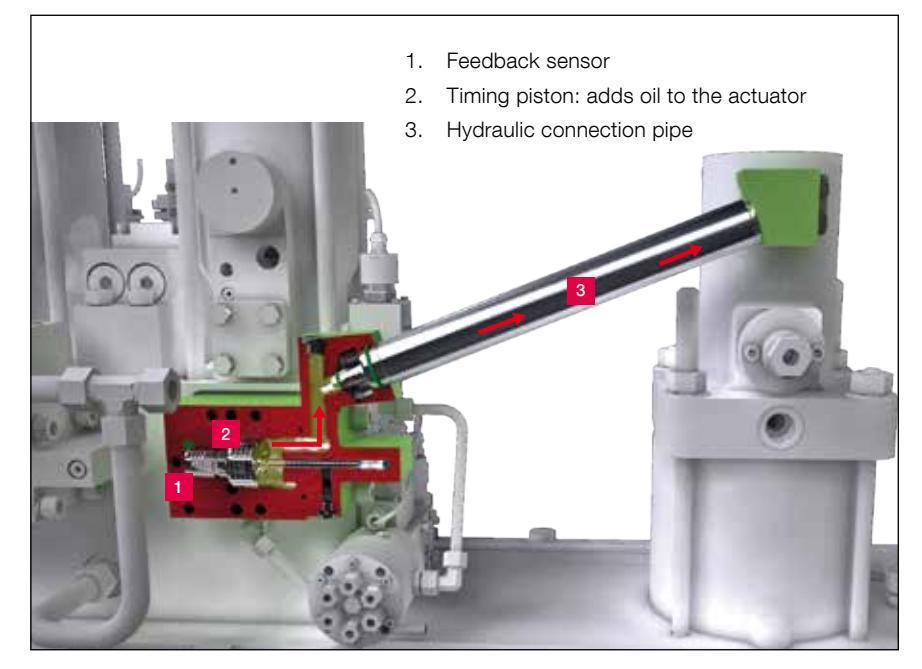
Fig. 23: Variable exhaust valve timing for ME-B

When the dot 3 technology was introduced, we experienced some difficulties with the timing unit system on a number of engines running on test bed, see Fig. 23. High-pressure peaks occurred in the timing unit and in the oil cylinder of the exhaust valve actuator. The high pressure resulted in a number of incidents with broken bolts on the puncture valve and a few cases of broken bolts on the timing unit end cover, see Fig. 24.

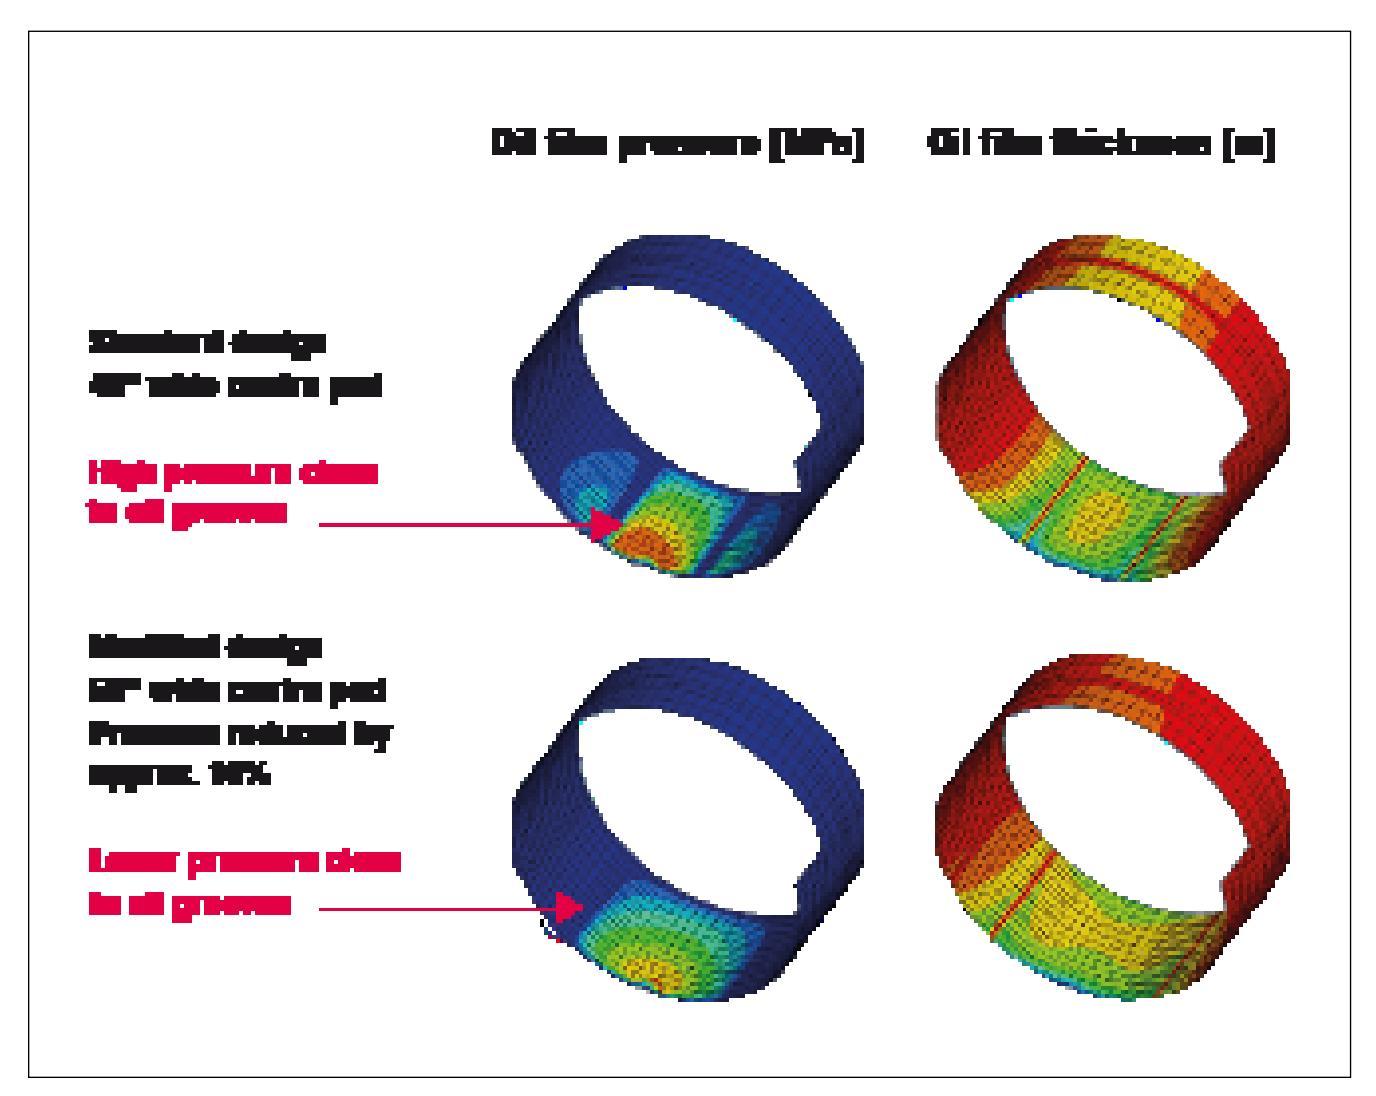
Fig. 30: K98 crosshead bearings and T/C cut-out: modified bearing shell design

Due to the changed balance between inertia forces and gas forces, we will get an increased load on the crosshead bearing shells in T/C cut-out mode with the increased gas pressures at low rpm. On the K98 engine, this has resulted in minor slow-developing fatigue damage on the central pad in the lower crosshead bearing shell, see Fig. 29.

Modified designs of crosshead bearing shells are currently being tested in service. However, these will not be concluded quickly as the development of fatigue damage typically takes two years. Fig. 30 shows elasto-hydro dynamic (EHD) bearing calculations of one of the

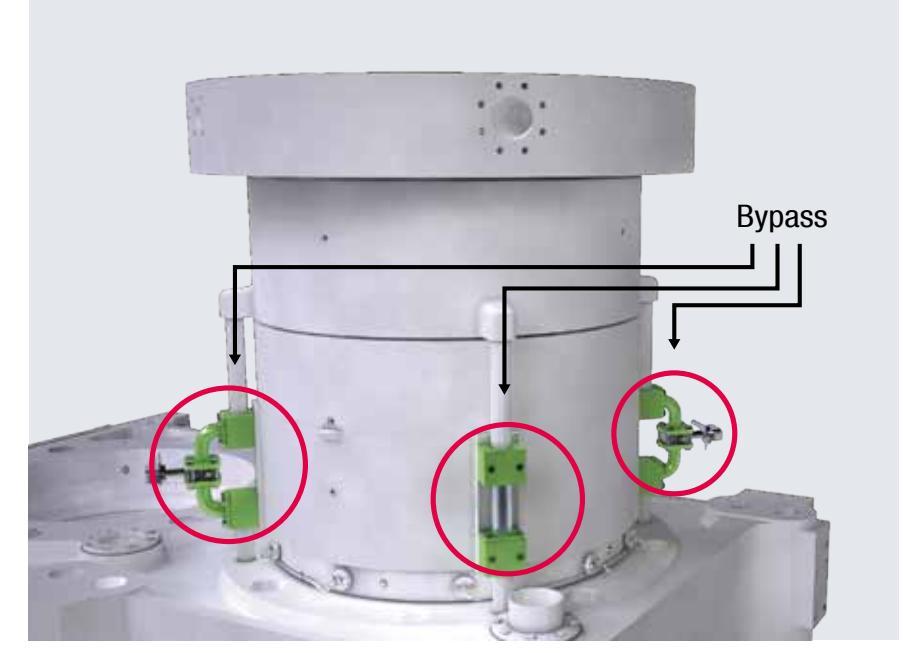
Fig. 31: Jacket cooling water bypass on a K98 engine

We have, in a few cases, seen excessive cold corrosion in the top of cylinder liners when operating at low load in T/C cut-out mode. This has been seen especially in cases where one of two turbochargers have been cut out. In such a case, a large scavenge air pressure increase is obtained at low load, resulting in rather high pressures and low temperature exposure for the cylinder liner top.

As a countermeasure, the jacket cooling water bypass was introduced, as described in the section of this paper related to cold corrosion in general. On K98 engines, the cooling water bypass can be arranged as shown in Fig. 31.

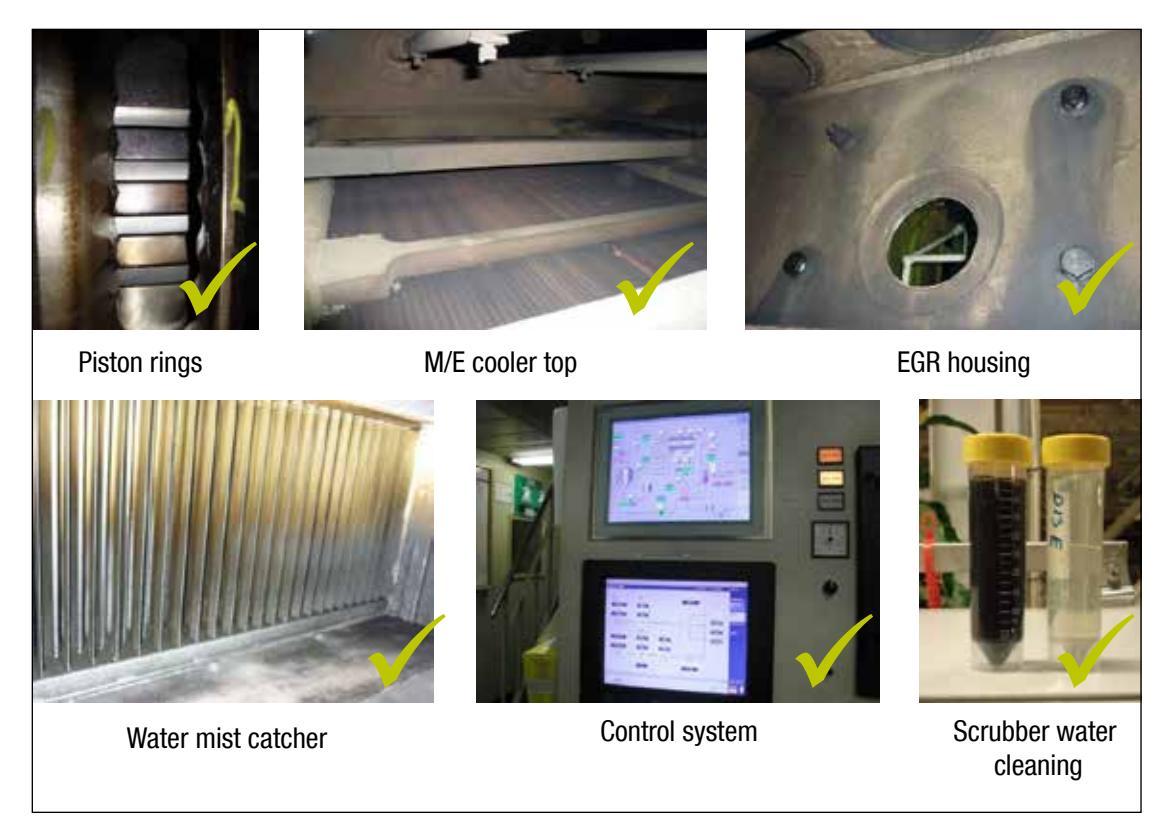
Fig. 37: EGR service test on Alexander Maersk with 3% sulphur HFO

tioning that the tests were actually interrupted for a three-month period during which *Alexander Maersk* was used as the main scene for the Hollywood movie "Captain Phillips" starring Tom Hanks. During the testing period on *Alexander Maersk*, we confirmed the expected  $NO_x$  reduction of 60%, see Fig. 36. Furthermore, after a number of modifications, good and stable operation was confirmed for the various subsystems of the EGR and the WTS. Fig. 37 illustrates some of the areas where satisfactory condition was obtained:

- Good (unchanged) cylinder condition
- Good performance of the main engine cooler
- Good condition for the EGR housing
- Well-performing water mist catcher
- EGR control system verified
- Water treatment system delivering clean water for bleed off.

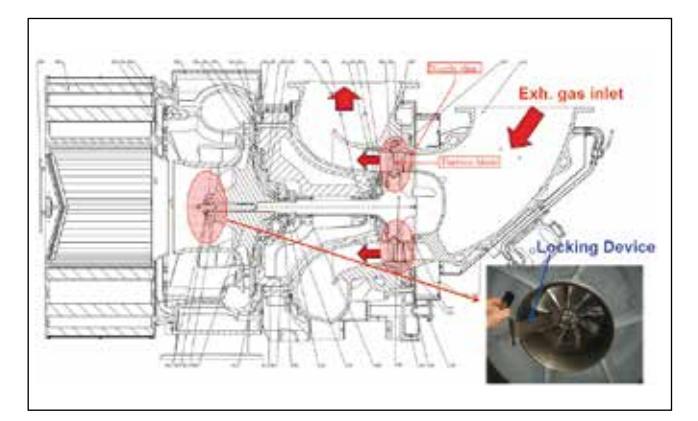
Fig. 45: T/C cut-out test and black carbon deposits

The attempt to run the 6G70ME-C9.2 engine in the emergency running mode without turbocharger resulted in a lot of black smoke and a large amount of black carbon deposits in the combustion chamber, both as a result of the engine trying to reach the required power by "over-fuelling", see Fig. 45.

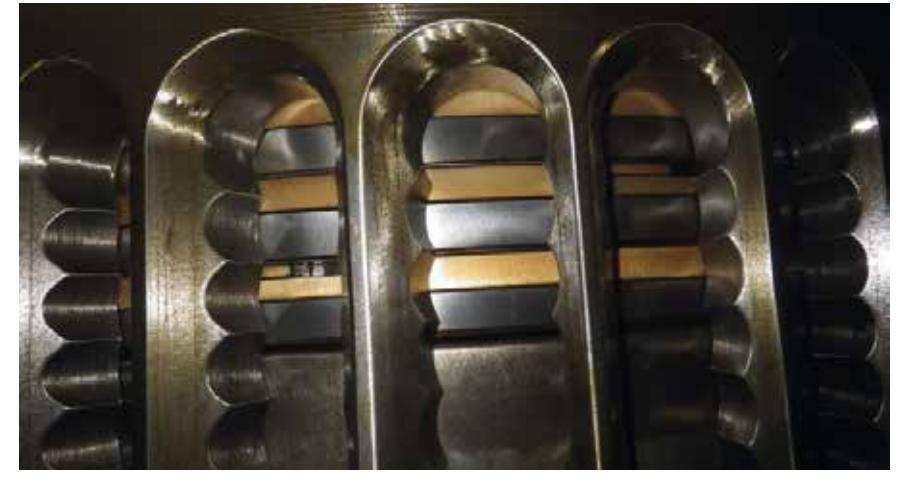
Fig. 47: T/C cut-out test with emergency bypass installed. No black carbon deposits visible.

that black carbon deposits are avoided in the combustion chamber, see Fig. 47.

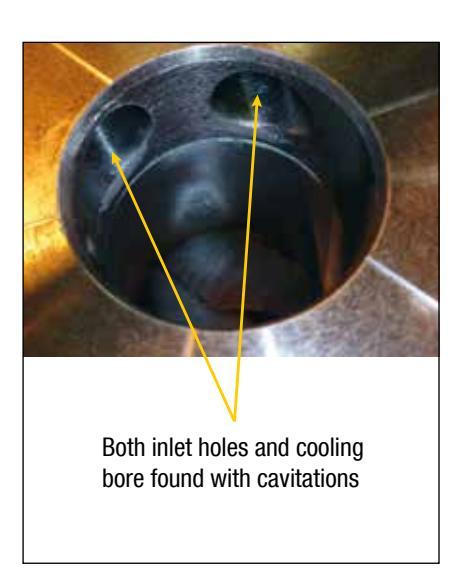
Fig. 52: Exhaust actuator - low-force top cover

We have received reports of cavitation damage found in various areas in the standard 300-bar low force exhaust valve actuation system. At the time of writing, we are conducting tests to find a solution to this issue. Fig. 51 indicates the areas where cavitation has been found. The extent of cavitation on the thrust piece can be significantly reduced by using a new material. Cavitation has also been found around inlet holes, cooling bores and relief grooves in the actuator top cover, see Fig. 52. We are currently testing some modified actuator top covers, and Fig. 53 shows two alternative test executions where the inlet holes have been redesigned.

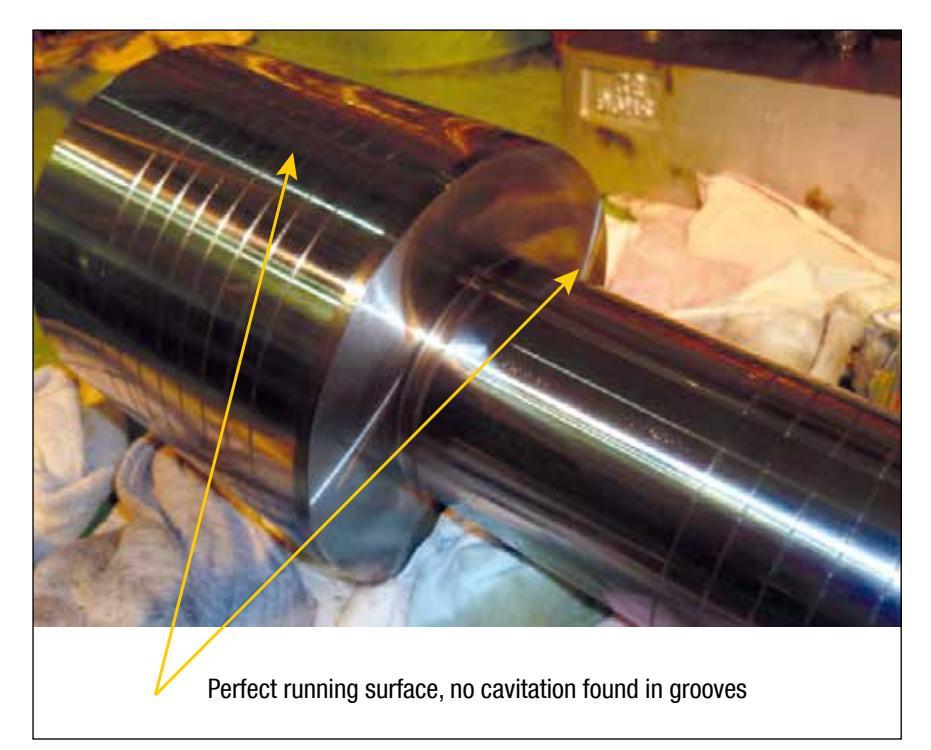
Fig. 56: Exhaust actuator - low-force step-two piston

The actuator housing is in perfect running condition, and only minor cavitation has been found on the step-one piston landing surface at the lower base. On the other hand, on the steptwo piston we have found rather heavy cavitation damage on the opening damper at the top of the piston, see Fig. 54. We have tested a piston with a bolted-on "damper-nose" consisting of a harder alternative damper material (S85W6Mo). As can be seen in Fig. 55, this solution has eliminated the cavitation on the damper. Both actuator pistons show excellent condition on the running surface. Fig. 56 shows a typical

condition for the running surface of the step-two piston.
