Service Experience 2014

MAN Diesel & Turbo

Service Experience

MAN B&W Two-Stroke Engines

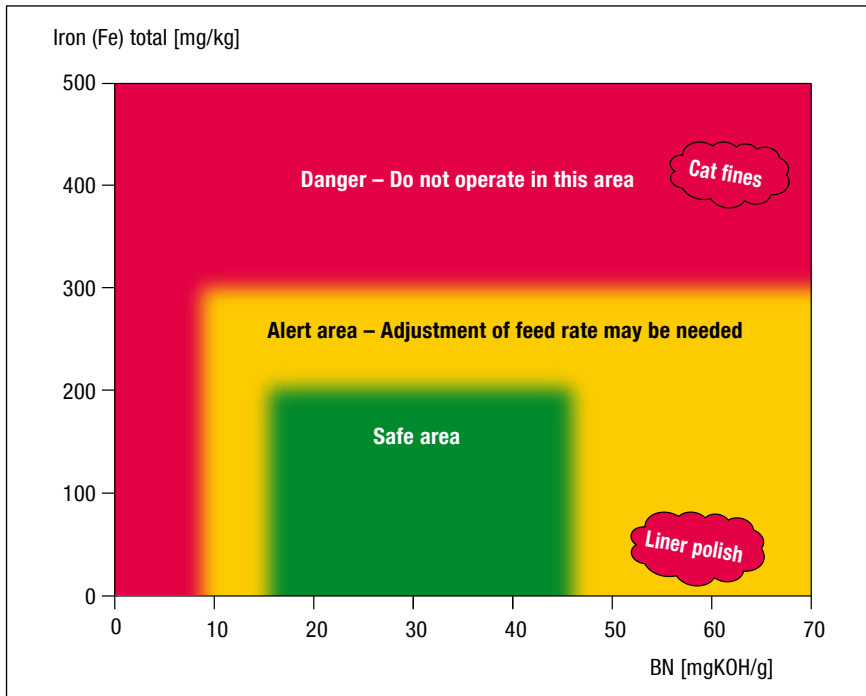
Fig. 3: Scavenge drain oil result

A drain oil analysis is also a strong tool for judging the engine wear condition. Drain oil samples taken in active ACC operation will show if the oil feed rate can be optimised while keeping the BN between 10-25 mgKOH/kg and the iron (Fe) content below 200-300 mg/kg in the drain oil, see Fig. 3.

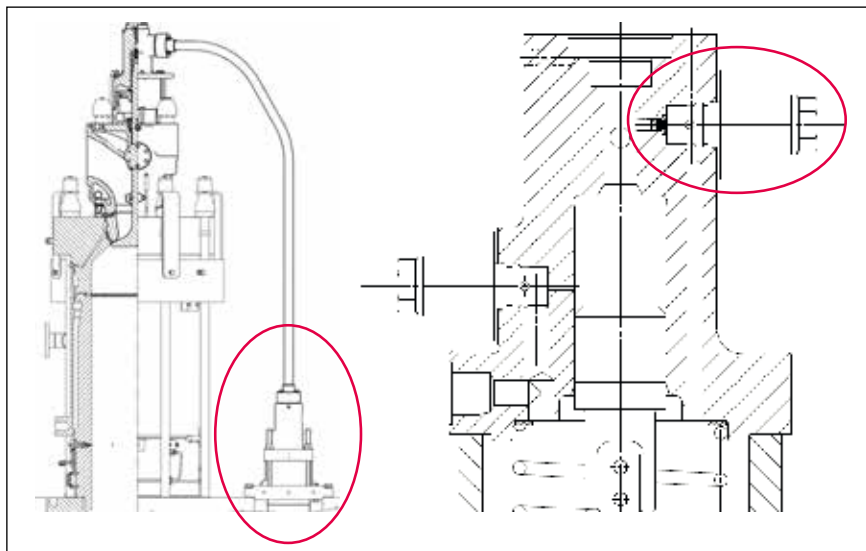
Fig. 18: ME-B/ME-C engine acceleration problems

The root cause has been identified to be a low excess air ratio (air for combustion) at low load and heavy running especially during the acceleration phase. This is due to the application of two-stroke Miller timing with late closing of the exhaust valve.

The countermeasure introduced by MDT has been the installation of a controllable orifice in the exhaust valve oil push rod, see Fig. 18, to facilitate earlier closing of the exhaust valve during low engine speed running. This solution will increase the air excess ratio in the cylinder.

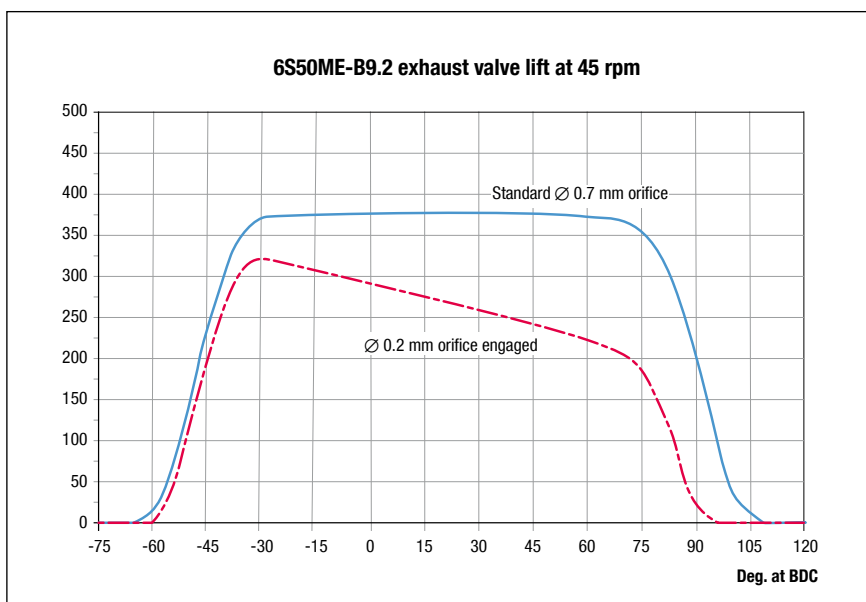
Fig. 19: ME-B9.2 engine acceleration problems

Fig. 19 shows the influence of the controllable orifice on the opening/closing timing of the exhaust valve.

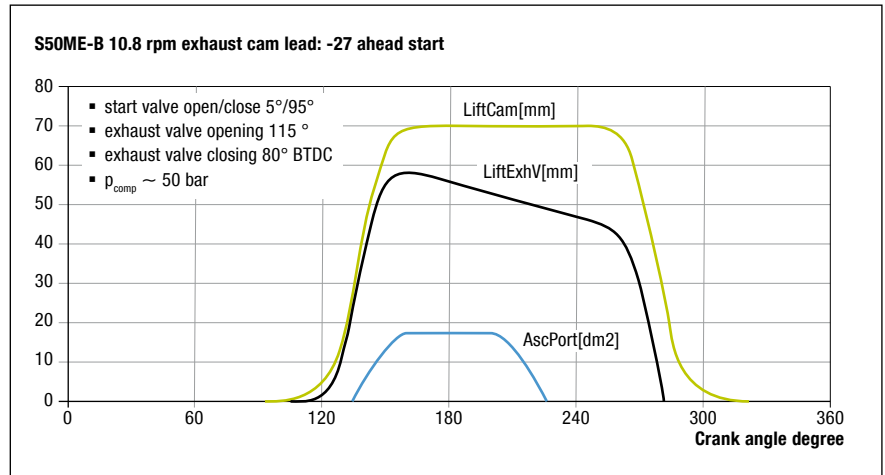
Fig. 20: ME-B9.2 astern start problems

For ahead start, the standard starting air interval of 5-95 deg does not conflict with the opening of the exhaust valve at 115 deg ahead of TDC. The exhaust valve closes at 80 deg before TDC, resulting in a compression pressure of approximately 50 bar. Fig. 20 indicates the timing during ahead start.

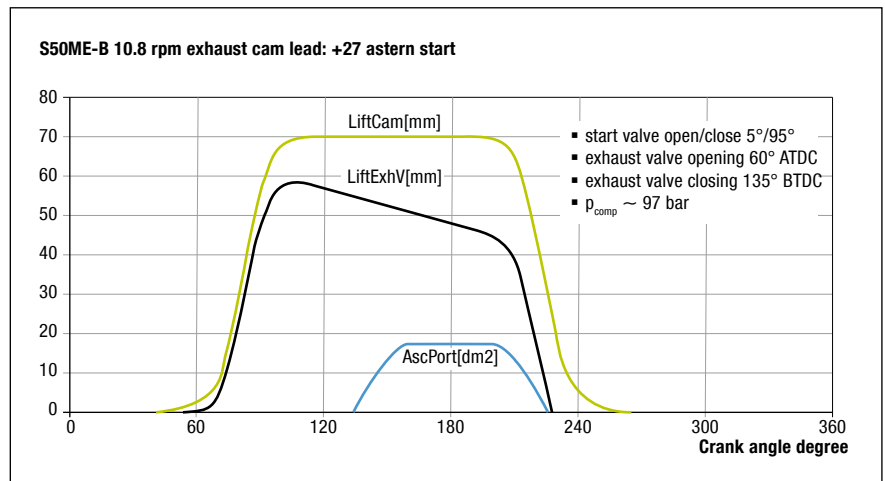
Fig. 21: ME-B9.2 astern start problems

As a result, at astern start, the exhaust valve opens already at 60 deg ahead of TDC, which leads to loss of starting air when applying the standard starting air timing (5-95 deg). Furthermore, the exhaust valve closes at 135 deg before TDC resulting in a compression pressure of approximately 97 bar. Fig. 21 illustrates the timing during astern start. The power of the “air engine” is decreased and the work needed has increased.

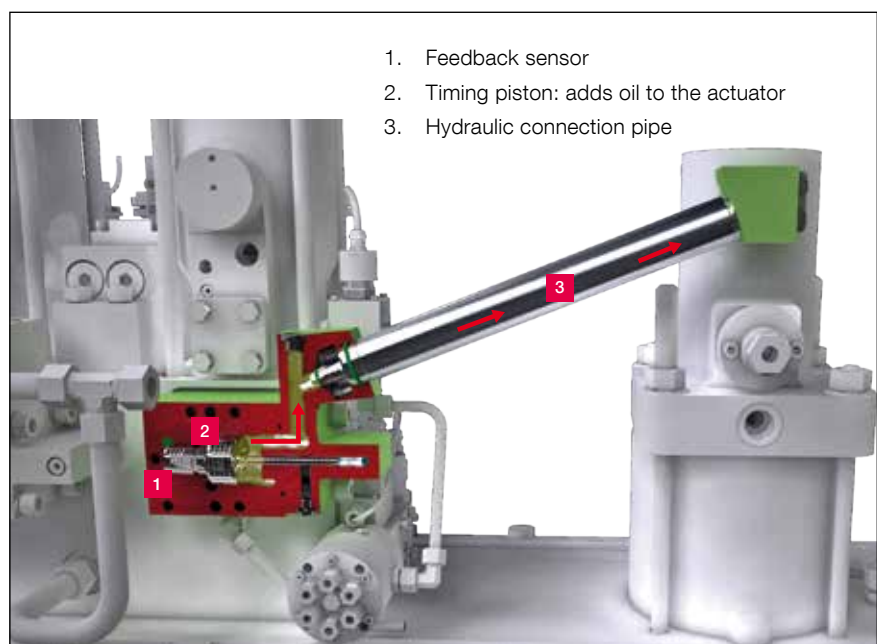
Fig. 23: Variable exhaust valve timing for ME-B

When the dot 3 technology was introduced, we experienced some difficulties with the timing unit system on a number of engines running on test bed, see Fig. 23. High-pressure peaks occurred in the timing unit and in the oil

cylinder of the exhaust valve actuator. The high pressure resulted in a number of incidents with broken bolts on the puncture valve and a few cases of broken bolts on the timing unit end cover, see Fig. 24.

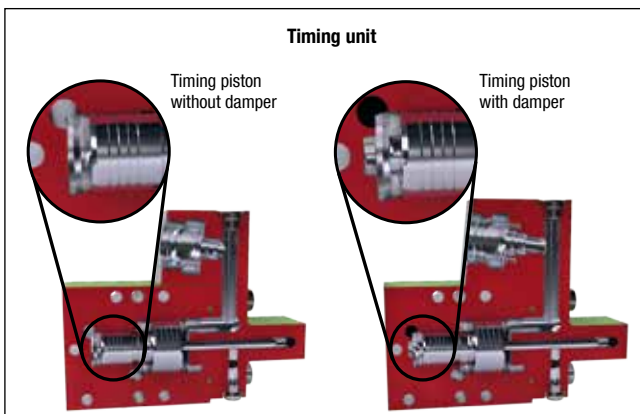
Fig. 25: ME-B dot 3 feedback from test bed

Measurements and simulations revealed that the timing piston had a high landing velocity on the return stroke when the timing unit is deactivated. A damper for the timing piston has been introduced as a countermeasure and the landing speed has been considerably reduced, see Fig. 25. Furthermore, this countermeasure reduces the maximum pressure to an acceptable level.

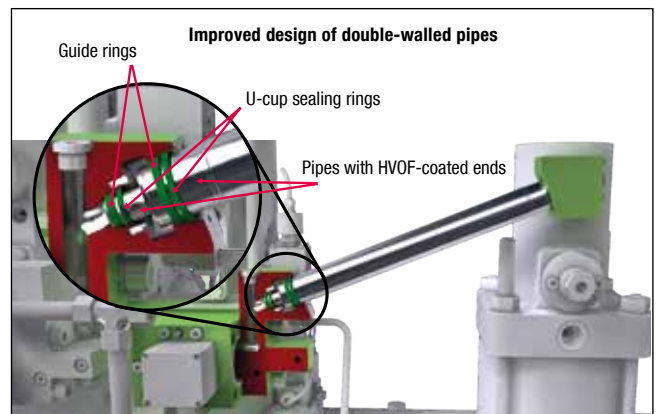
Fig. 26: ME-B dot 3 feedback from test bed

Fretting has been found on the double-walled pipe connecting the timing unit and exhaust valve actuator. The cause of the fretting is relative movements between the HCU with the timing unit and the exhaust valve actuator.

To counteract the fretting and ensure good reliability for the sealing rings, the pipe system has been upgraded as described in the following. HVOF-coating, using the same spray powder as for the exhaust valve spindle, is added on the ends of the pipes together with a PTFE sliding ring and a PTFE U-cup sealing ring. Furthermore, a wiper ring is added on the outer pipe to minimise the risk of particles, or the like, entering the sealing area. Modifications are shown in Fig. 26.

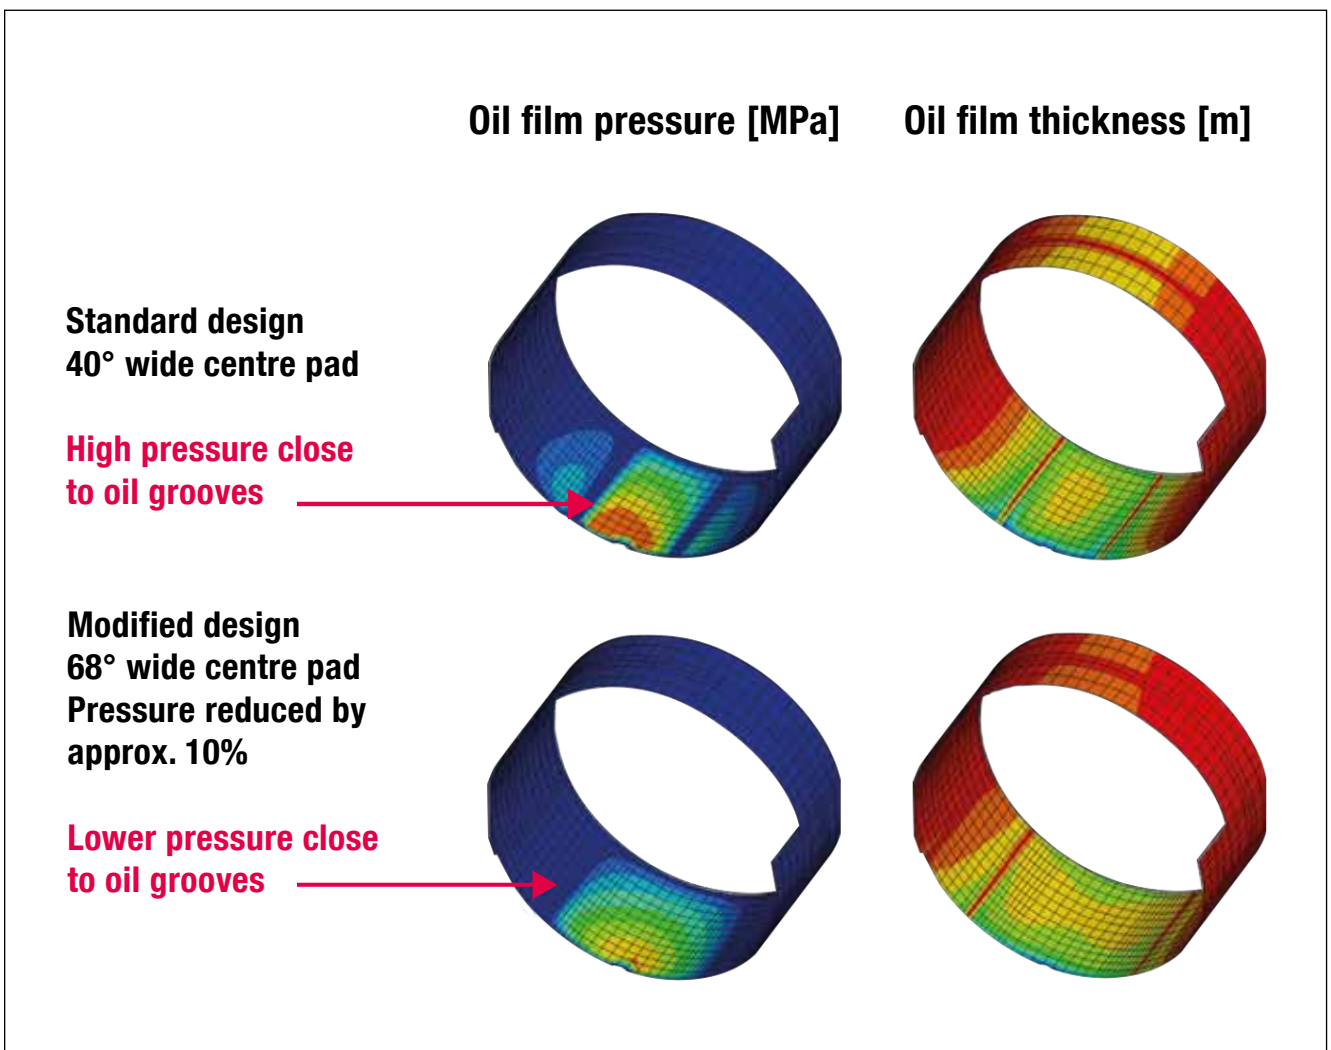
Fig. 30: K98 crosshead bearings and T/C cut-out: modified bearing shell design

Due to the changed balance between inertia forces and gas forces, we will get an increased load on the crosshead bearing shells in T/C cut-out mode with the increased gas pressures at low rpm. On the K98 engine, this has resulted in minor slow-developing fatigue damage on the central pad in the lower crosshead bearing shell, see Fig. 29.

Modified designs of crosshead bearing shells are currently being tested in service. However, these will not be concluded quickly as the development of fatigue damage typically takes two years. Fig. 30 shows elasto-hydro dynamic (EHD) bearing calculations of one of the

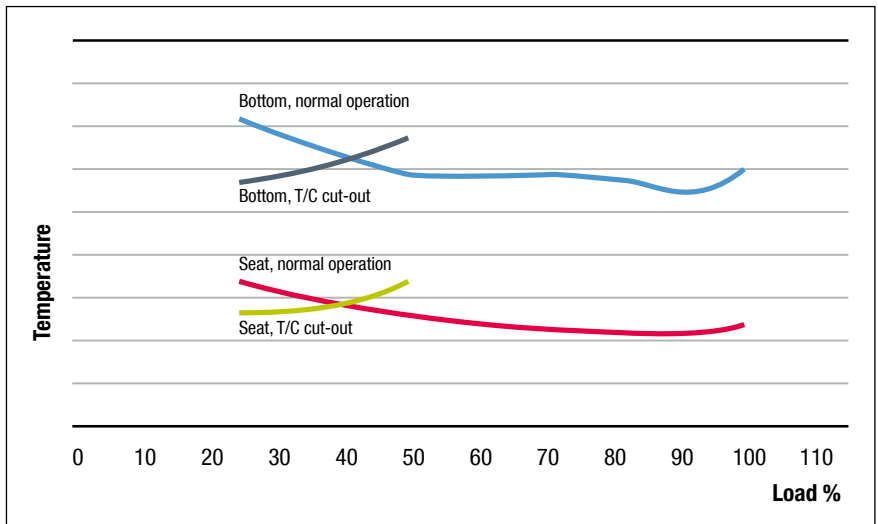
Fig. 33: Exhaust valve temperatures, 8K90MC-C

We have issued a Service Letter (SL2013-573) on exhaust valve condition during low-load operation. Examples showing the influence of T/C cut-out, see Fig. 33, operation down to 10% load as well as the cut-in point for the auxiliary blowers, see Fig. 34, indicate that strict guidelines cannot be given when considering low-load operation in general. The exhaust valve condition must be evaluated on the basis of inspections.

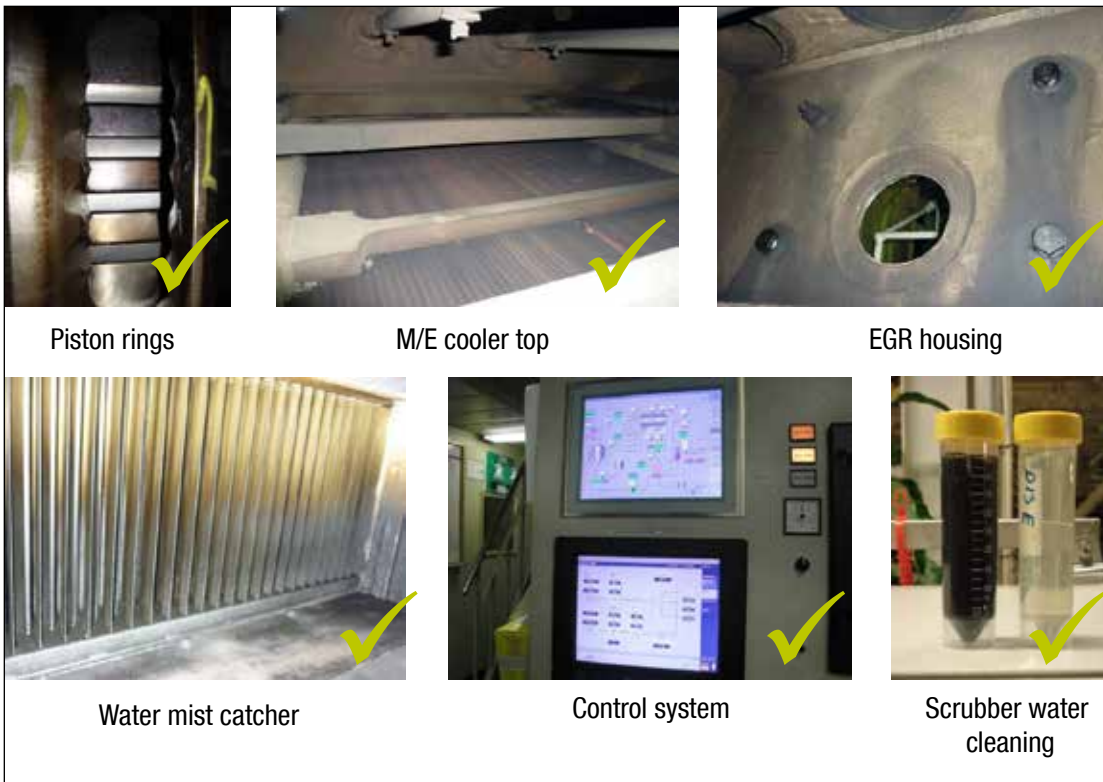
Fig. 37: EGR service test on *Alexander Maersk* with 3% sulphur HFO

During the testing period on *Alexander Maersk*, we confirmed the expected NO_x reduction of 60%, see Fig. 36. Furthermore, after a number of modifications, good and stable operation was confirmed for the various subsystems of the EGR and the WTS. Fig. 37 illustrates some of the areas where satisfactory condition was obtained:

- Good (unchanged) cylinder condition
- Good performance of the main engine cooler
- Good condition for the EGR housing
- Well-performing water mist catcher
- EGR control system verified
- Water treatment system delivering clean water for bleed off.

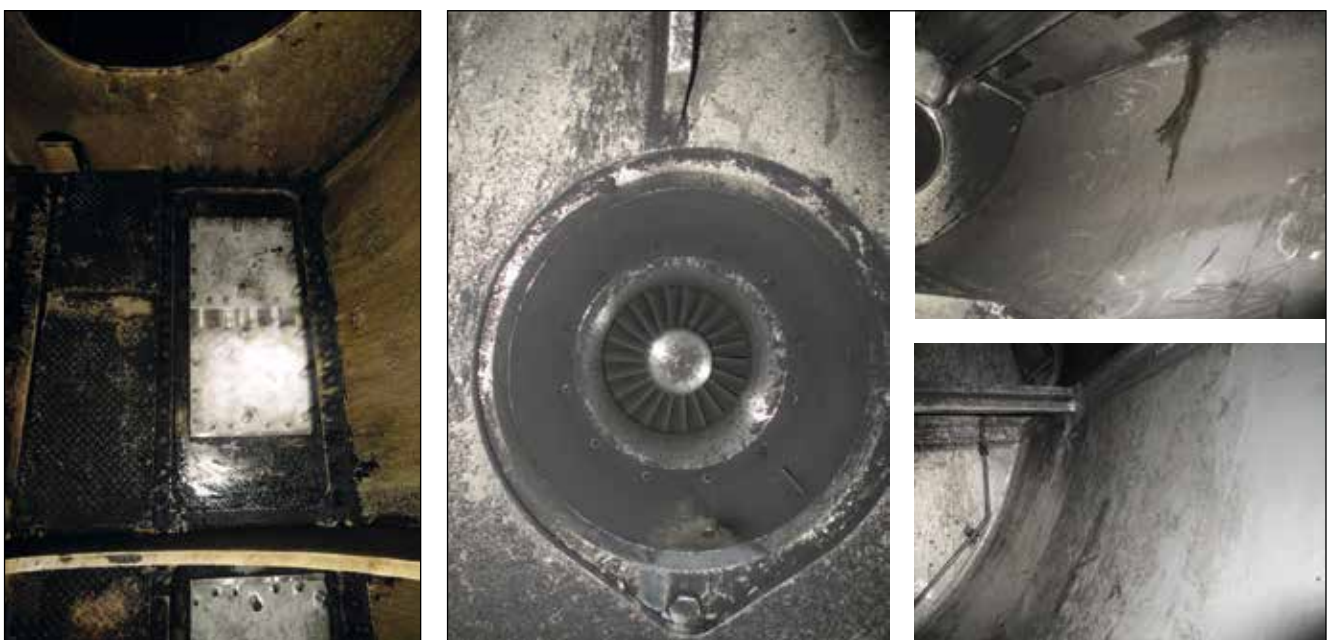
In the initial phase of EGR operation, greasy oily lumps have accumulated in the EGR blower suction chamber and at the blower inlet, see Fig. 41. No operational troubles were observed due to this occurrence. However, in order to stop this formation we blocked the non-return valves to the scavenge air receiver in way of the EGR unit, see Fig. 42. After this modification, a good condition has been confirmed for the EGR blower suction chamber and blower inlet, see Fig. 43.

Fig. 42: Blanking of non-return-valves

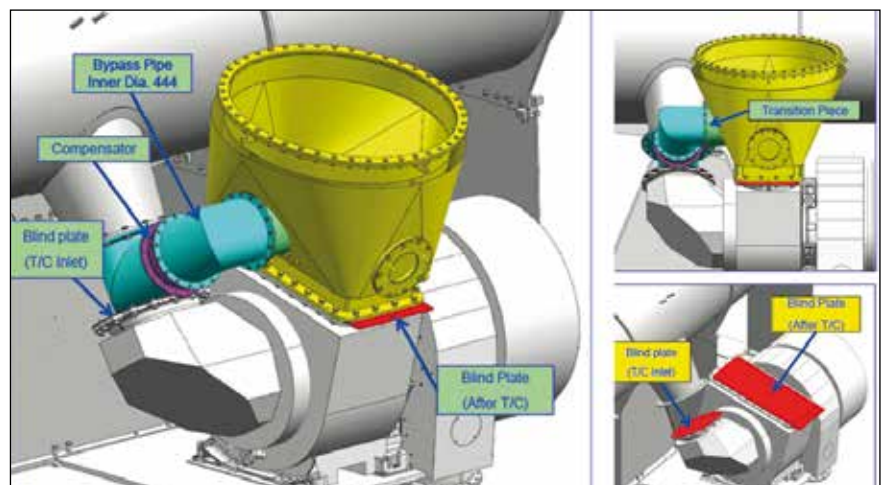
A solution of the problem has been to establish a Ø444-mm emergency bypass, see Fig. 46, to prevent exhaust gasses from passing the turbocharger turbine in the emergency running mode. The air amount is then increased to 7.9 kg/kWh at 15% load. This is in line with what has previously been found acceptable for other 70 bore engines, see Table 5. Tests have confirmed that the emergency bypass is working well, and

Fig. 46: Bypass pipe is installed between gas receiver outlet and transition piece

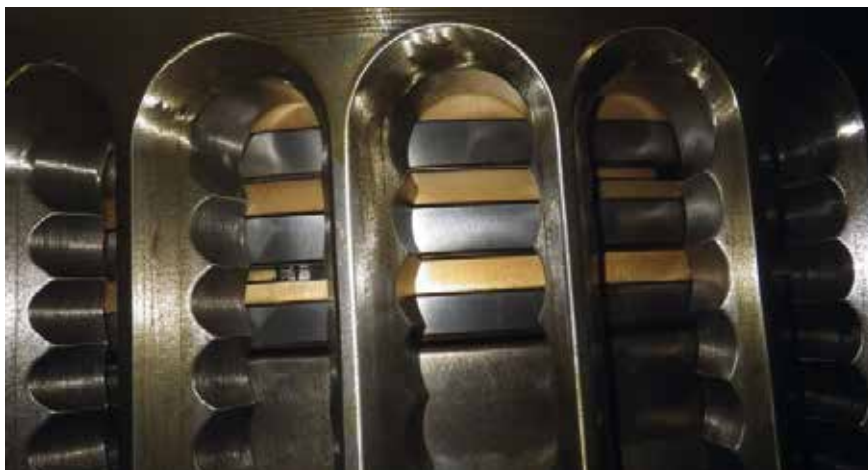
that black carbon deposits are avoided in the combustion chamber, see Fig. 47.

Fig. 47: T/C cut-out test with emergency bypass installed. No black carbon deposits visible.

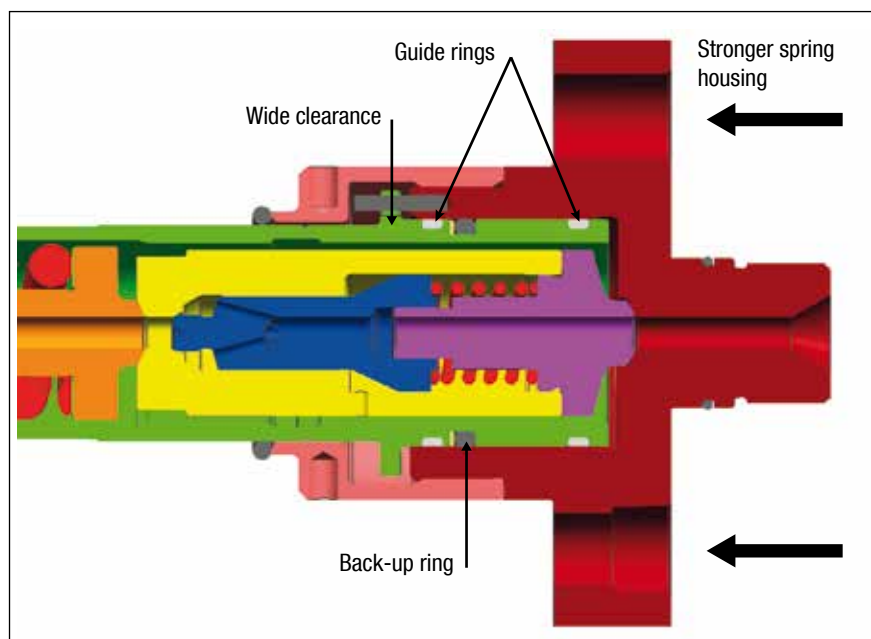
However, especially on some large bore engines, we still see fretting occurring in the top of the fuel injectors, see Fig. 48. We are therefore testing various design modifications to eliminate this fretting. At the time of writing, the most promising test result comes from a fuel injector with guide rings in the top part of the injector, see Fig. 49. This design also involves application of stronger

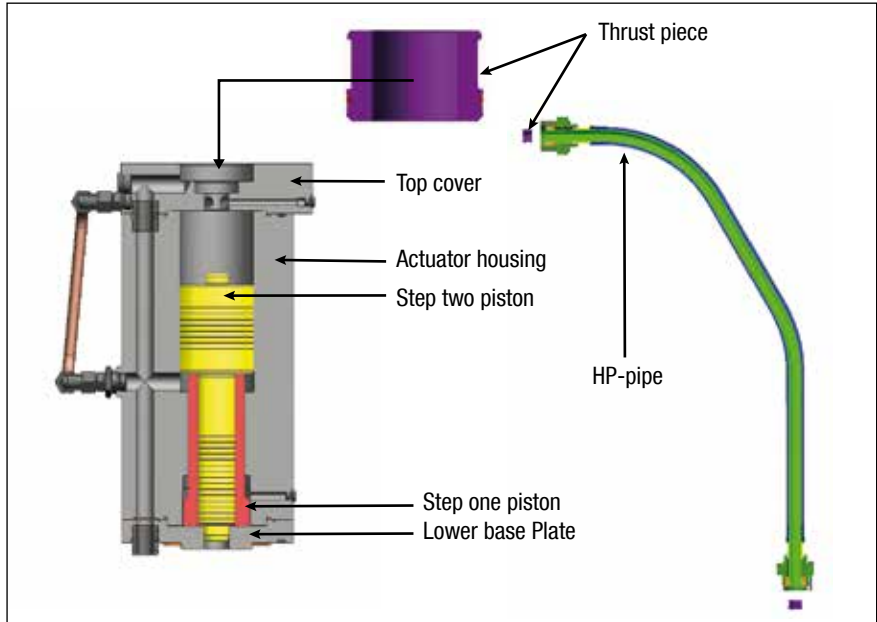
Fig. 51: Points of interest on exhaust actuator – low-force 300-bar

We have received reports of cavitation damage found in various areas in the standard 300-bar low force exhaust valve actuation system. At the time of writing, we are conducting tests to find a solution to this issue. Fig. 51 indicates the areas where cavitation has been found. The extent of cavitation on the thrust piece can be significantly reduced by using a new material. Cavitation has also been found around inlet holes, cooling bores and relief grooves in the actuator top cover, see Fig. 52. We are currently testing some modified actuator top covers, and Fig. 53 shows two alternative test executions where the inlet holes have been redesigned.

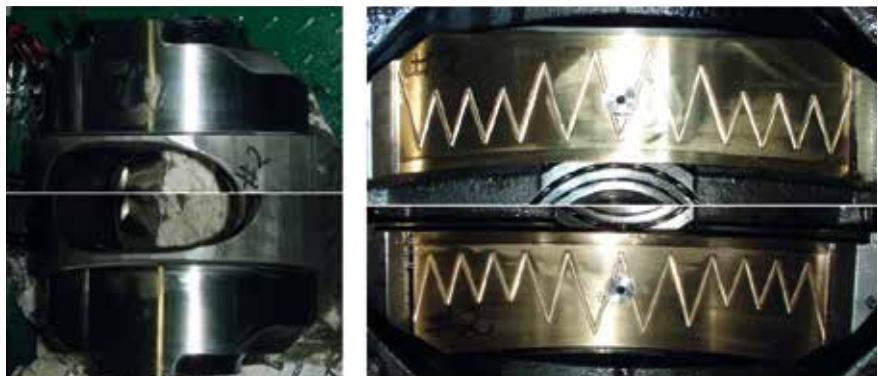
Fig. 58: ME engine Eaton main hydraulic pumps

Based on the poor service experience logged, we decided to stop specifying Eaton pumps as an alternative supplier. However, in parallel we have initiated service tests, together with Eaton, of bearing shells of a new design where steel is substituted by brass. At the time of writing, the initial inspection results look promising, see Fig. 58.
