# MERCHANT MARINE ACADEMY OF MACEDONIA DECK DEPARTMENT

# THESIS

# THE NORMAN ATLANTIC SHIPWRECK

STUDENT: KARALIOTAS FILIMON REGISTRATION NUMBER: 3375

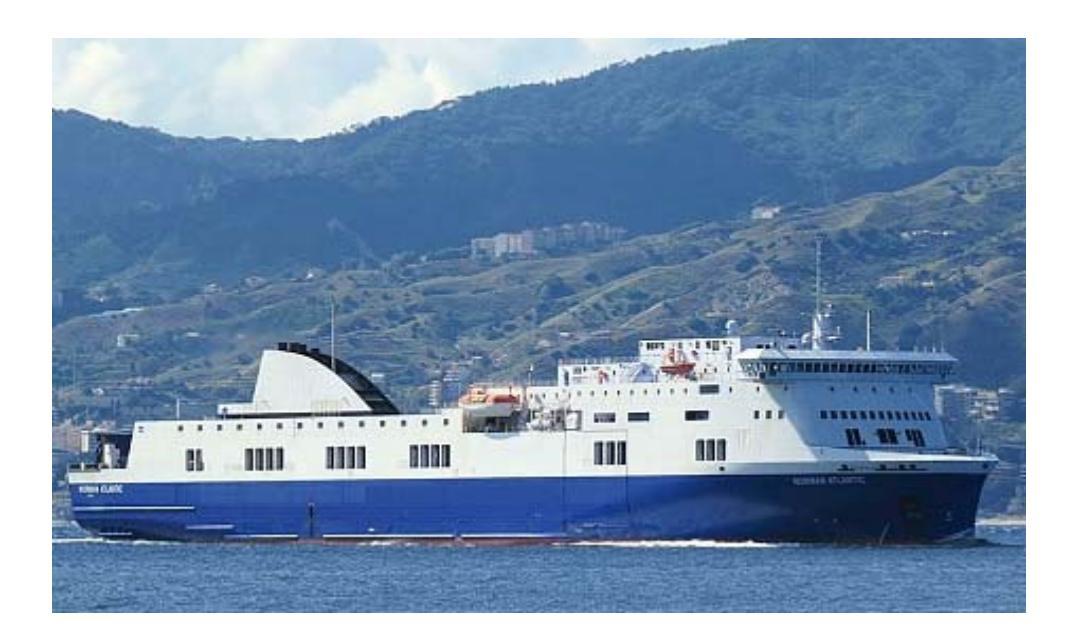
Figure 1. Norman Atlantic (Philips, 2014)

The ship is 186 meters (610 ft 3 in) long, with a radius of 25.6 meters (84 ft 0 in) and a depth of 6.71 meters (22 ft 0 in). She is powered by two MAN B & W 9L48 / 60B diesel engines that can propel the ship at 24 knots (44 km / h). The capacity of the ship is 850 passengers and around 2,286 lanes for vehicles.

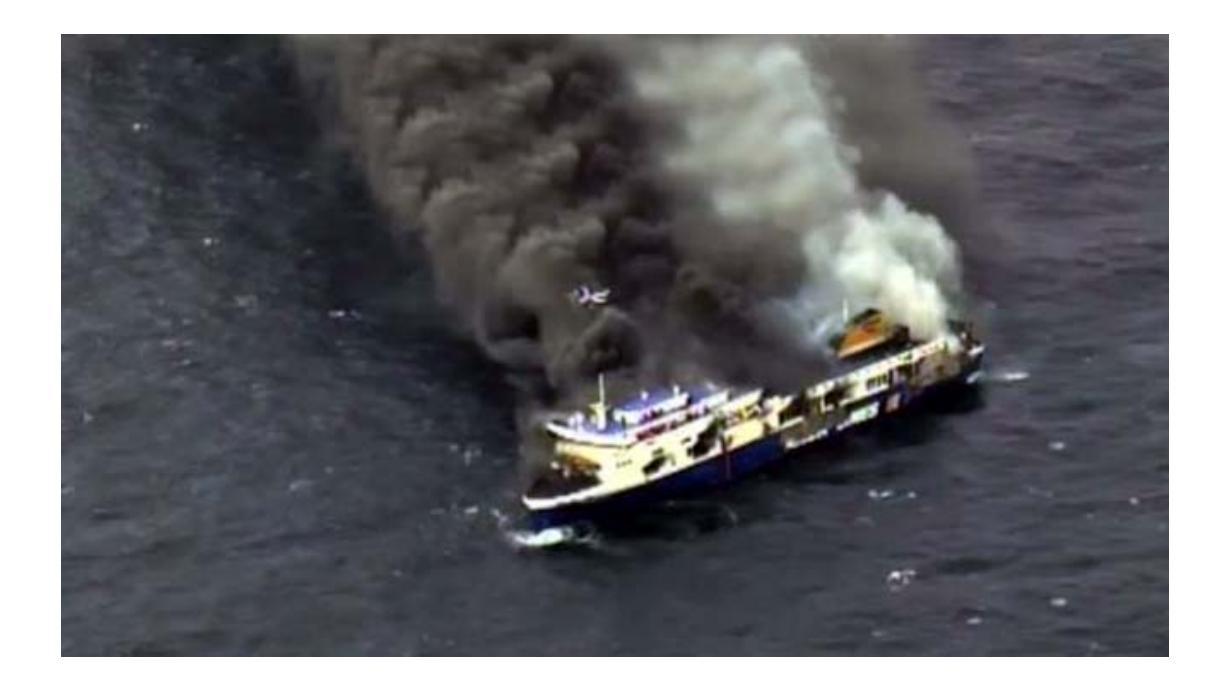
Figure 2. Fire in Norman Atlantic (Newsbeast, 2014)

On December 28, 2014, the ship sailed to the Strait of Otranto in the Adriatic Sea. The itinerary was from Patras to Igoumenitsa and Ancona. At that time, she was carrying 222 vehicles, 487 passengers and 55 crew members. A fire broke out on the deck of the vehicles shortly before 6:00 am local time, half an hour after leaving the port of Igoumenitsa, an intermediate stop, when she was 44 nautical miles (81 km) northwest of Corfu and 33 nautical miles (61 km) Northwest of Othonas. The incident occurred in Greek territorial waters but with night closing in , the ship began to drift to Albania. There were strong winds. The heat from the fire penetrated the entire ship, even began to melt the men's shoes on the reception bridge according to eye witnesses.

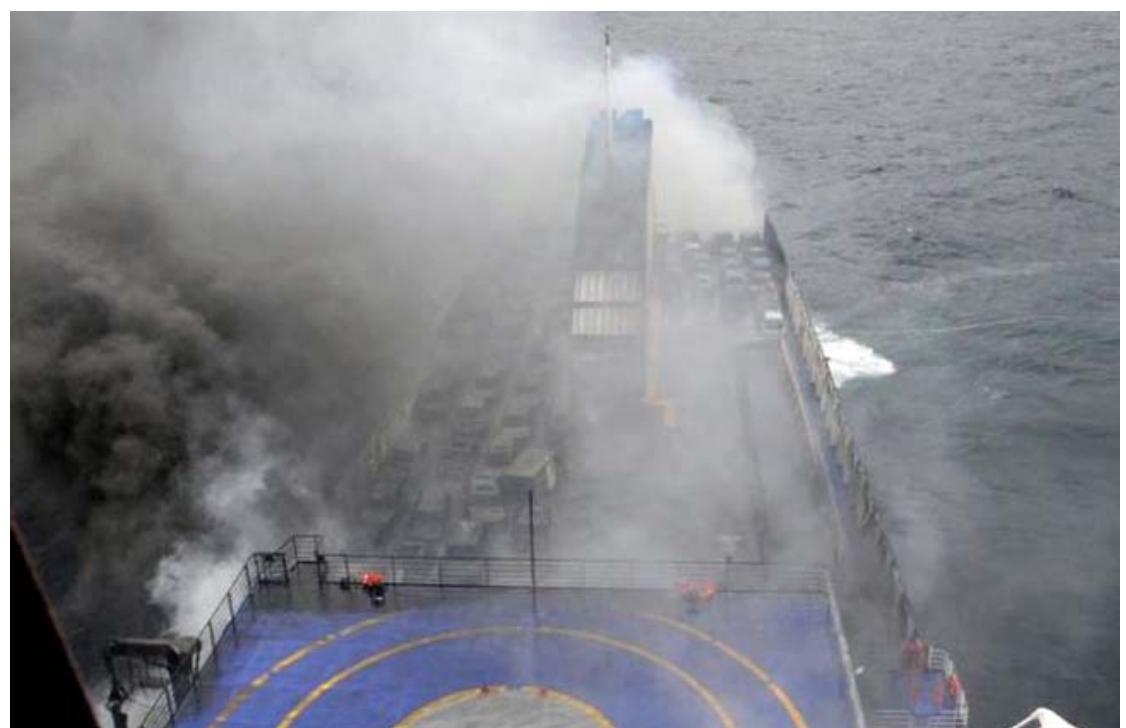
Figure 8. Smoke from the deck of vehicles (Newsbeast, 2014)

Preliminary underwater inspections by Norman Atlantic revealed that the water intake pipes of the fire brigade had been blocked with mussels. Additional inspections are necessary to ascertain whether this obstruction has contributed to the spread of fire. Although the travel data recorder (black box) was recovered, no data was extracted until mid-March, obviously because the heat of the fire caused the melting of the plastic on the hard disk. Recordings of the Voyage data recorder, published October 7, 2015, state that the sprinkler system was not working properly, and instead of water spraying, there was smoke from the system. Investigations also indicate that there was a truck that had the engine running. Smoke came from the truck before the fire.
